**APPENDIX A:  
TREE SURVEY**

**Tree Survey**  
**The Hamptons**

*Prepared by:*  
**HortScience, Inc.**  
**325 Ray Street**  
**Pleasanton, CA 94566**

**May 2015**

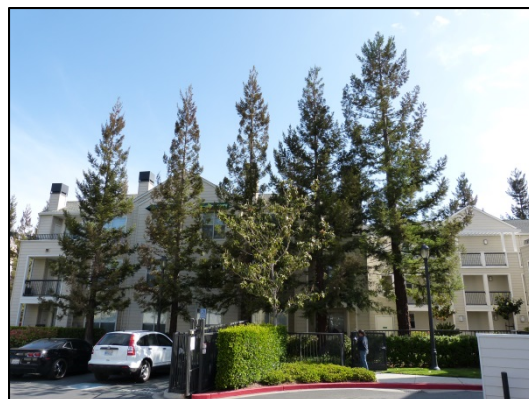
Coast redwood was the most frequently occurring species with 190 trees (Photo 1). Redwoods functioned as important screens and buffers both within the property and between the property and adjacent streets. Health and structural condition of coast redwoods was generally good with 157 of 190 trees receiving that rating. Eleven (11) redwoods were in excellent condition while 17 were fair and 5 were poor. All redwoods had good form and structure. The main determinant to tree condition was canopy density. Lack of irrigation was likely the primary cause of thin canopies. Redwoods were generally young and semi-mature in development. Trunk diameters ranged from 6" to 39". Most redwoods (142 trees) were between 10" and 19". Four redwoods were 30" or larger: #79 (30"), 428 (34"), 430 (34") and 432 (32"). All four trees were in good condition.

**Photo 1.** Typical row of coast redwood trees. Note good form and thin canopies.

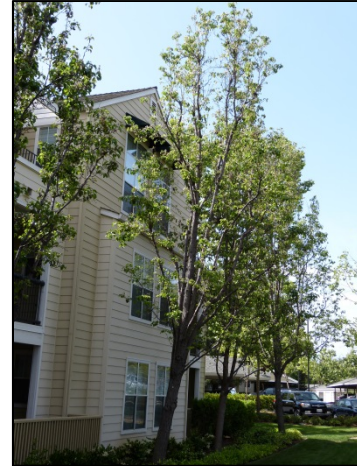
Forty (40) Callery pears were present (Photo 2). Trees were one of the cultivars with a narrow upright form such as Chanticleer. Trees were young and semi-mature in development with trunk diameters between 6" and 14". Tree condition was generally fair (31) with 8 trees in poor condition. Callery pear #8 (8") was in good condition. Trees had good form but very thin canopies. The bacterial disease fireblight was a problem on some trees. Most trees should develop full canopies in the next few months.

**Photo 2.** Typical Callery pear: planted next to a building with a narrow crown and very thin canopy of foliage.

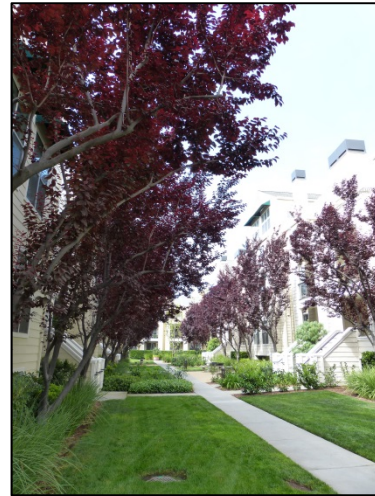
Thirty-nine (39) purpleleaf plums were concentrated in two areas of the community (Photo 3). Trees were mature in development with trunk diameters between 6" and 12". Trees had been pruned to lift and open the canopies. Tree condition was a mix of good (27 trees) and fair (12).

**Photo 3.** One of two large plantings of purpleleaf plum.

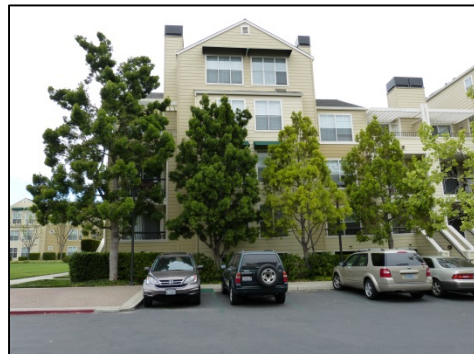
Twenty (20) fern pines were planted adjacent to buildings (Photo 4). Tree condition varied from fair (8 trees) to good (10) to excellent (#123, 160). Trunk diameters ranged from 6" to 15". Trees in good and excellent condition were larger in size with dense, green canopies of foliage.

**Photo 4.** Examples of fern pine. Tree #123 in on the left.
