Preliminary Arborist Report

The Oaks Shopping Center
Cupertino, CA

Prepared by:
HortScience, Inc.
325 Ray Street
Pleasanton CA 94566

July 2018

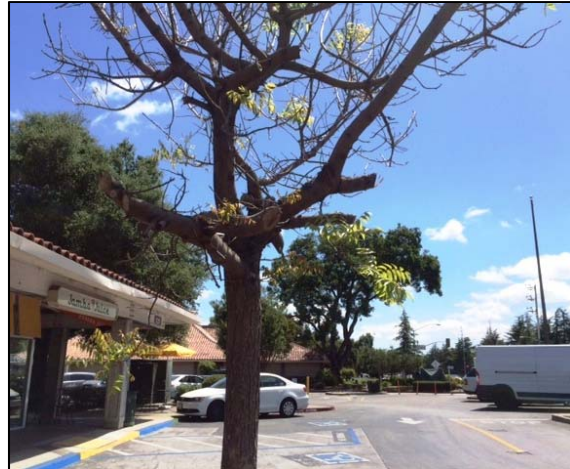
Twenty-four (24) Chinese pistache and 24 evergreen ash were assessed at the site and represented the two most frequently occurring species. Chinese pistache were located in the parking lot islands on the east (#11-14), north (#45-57) and south (#70-76) sides of the buildings. The trees were all young, with diameters between 5" and 11". Condition was poor (18 trees) to fair (6 trees) as a result of the topping that compromised the structure of the trees (**Photo 1**).

Photo 1: Looking east at Chinese pistache #76. The tree was young, at 5" in diameter and in poor condition. It had been topped and the branches reduced to stubs. This was the typical treatment of all Chinese pistache at the site.

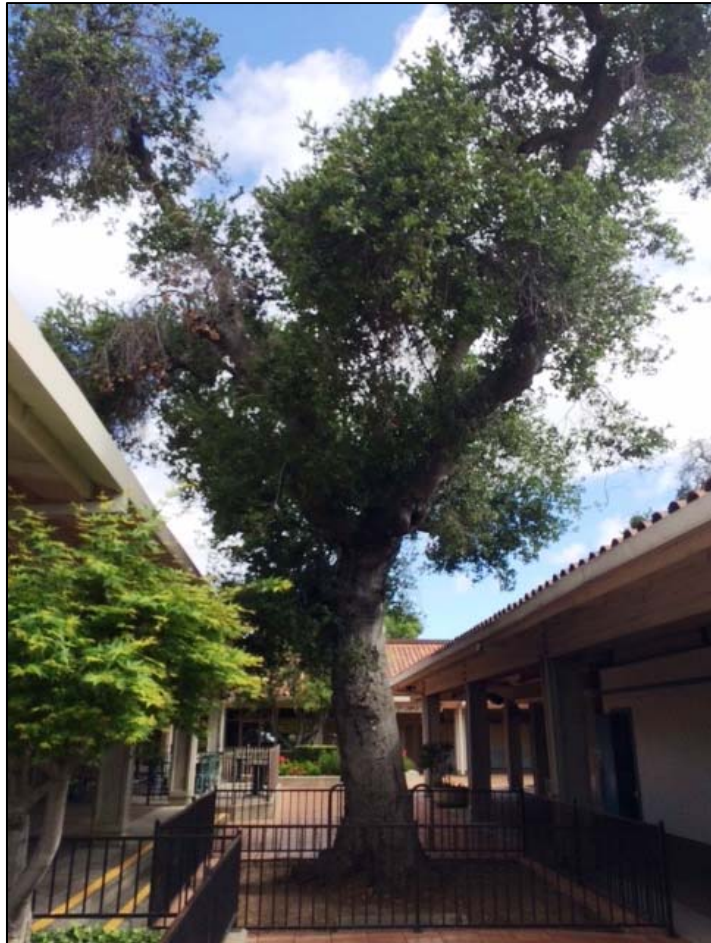
Coast live oak, with 18 trees, was also well represented. The species was concentrated on the west half of the site and included a range of age classes. There were 6 young trees (5-11" in diameter), 6 semi-mature (12-24"), 3 mature (24-36"), and 3 over-mature trees (36-50"). In general, they were in fair condition (10 trees), with 5 in good and 3 in poor. The over-mature trees were all in fair condition. These trees had seen many years of maintenance, producing large pruning wounds, cavities filled with concrete and non-industry standard cabling (**Photo 2**, following page). Coast live oaks in good condition included 3 young trees (5, 15 and 87), semi-mature coast live oak #16 and mature coast live oak #30. Coast live oaks #17, 19 and 77 were in poor condition; #17 leaned heavily north, and #19 and 77 had extensive dieback.

Photo 2: Looking east at coast live oak #19. The tree was mature, at 29" in diameter. It was in poor condition, with extensive dieback in the crown. Non-industry standard cables had been installed.
