City of Cupertino

Facility Condition Assessment

Final Report

December 2, 2022

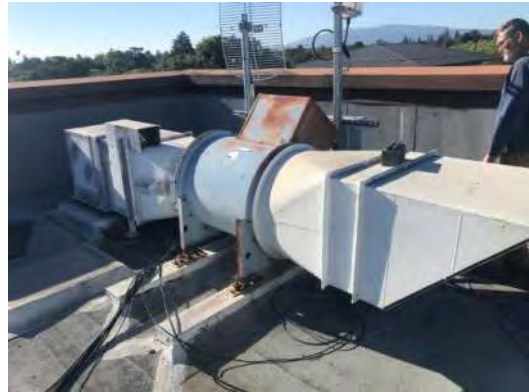
Comments: *Exhaust fan*

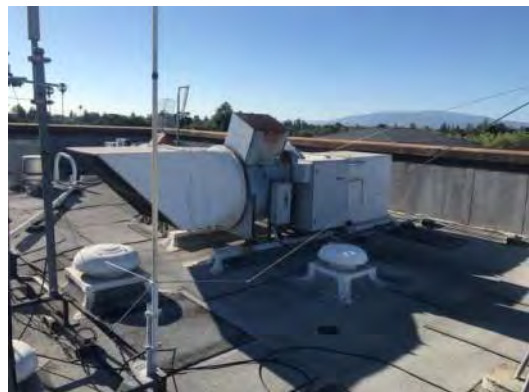
Comments: *Exhaust fan*

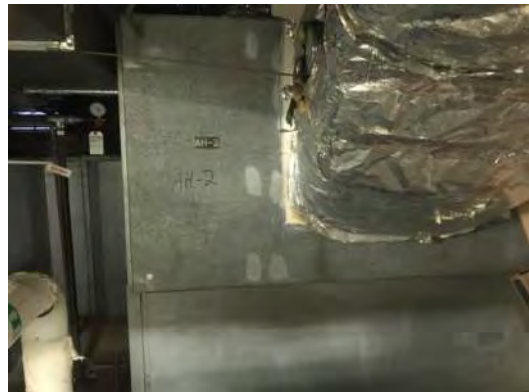
Record ID: 166
System: D3050 - FACILITY HVAC DISTRIBUTION SYSTEMS
Item No.: D3050.50.006
Floor/Room: 1
Priority: 2
Quantity/Unit of Measure: 1/EA
Total Deficiency Cost: \$78,310
Deficiency Description: *Air handler is approaching the end of its expected useful life.*
Description of Work: *Provide equipment replacement and installation.*
Comments: *Poor ventilation reported in previous 2018 FCA.*
Air Handler

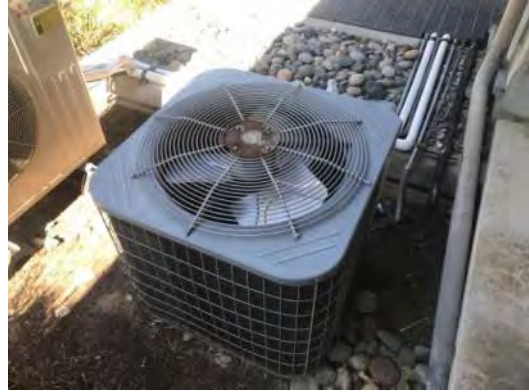
Comments: *HVAC - Split System*

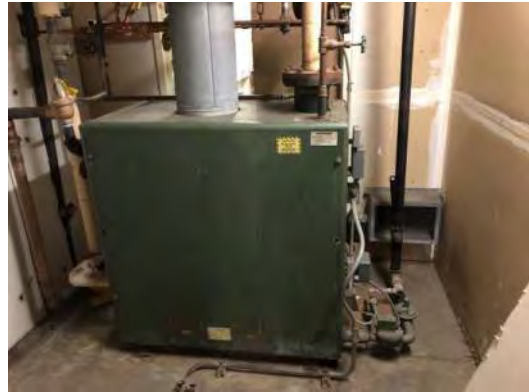
Comments: *Boiler*

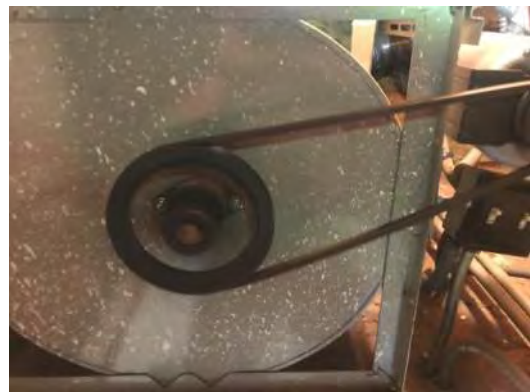
Comments: *Exhaust Fan*

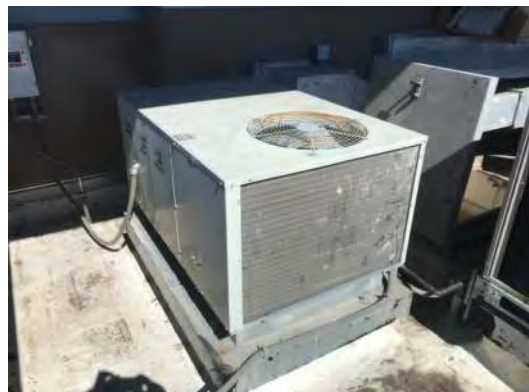
Comments: *Packaged Unit*

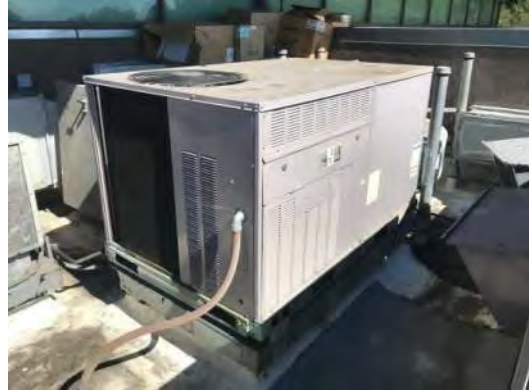
Comments: *Packaged Unit*

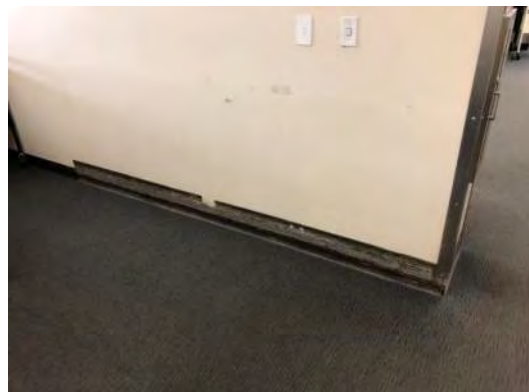
Comments: *Base molding is damaged and needs to be replaced*

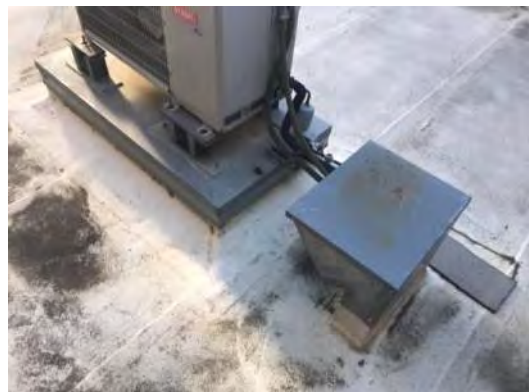
Comments: *HVAC - Split System*

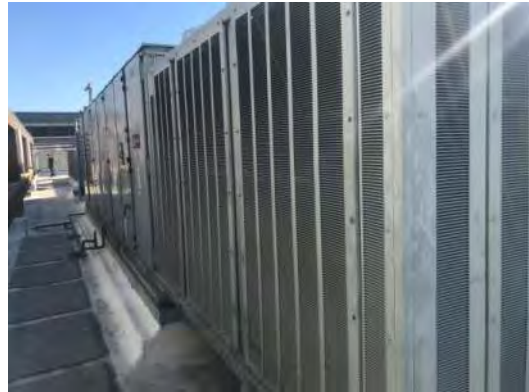
Record ID: 55
System: D3050 - FACILITY HVAC DISTRIBUTION SYSTEMS
Item No.: D3050.50.006
Floor/Room: Roof
Priority: 3
Quantity/Unit of Measure: 1/EA
Total Deficiency Cost: \$81,780
Deficiency Description: *Air handler is approaching the end of its expected useful life.*
Description of Work: *Provide equipment replacement and installation.*
Comments: *Air Handler*

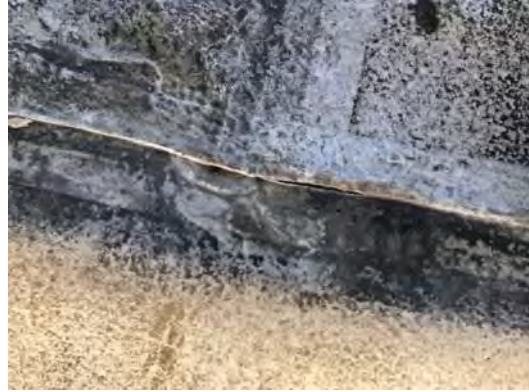
Comments: *Tears in roof membrane at various location. Roofing system is still under warranty, spot check and repair as needed.*

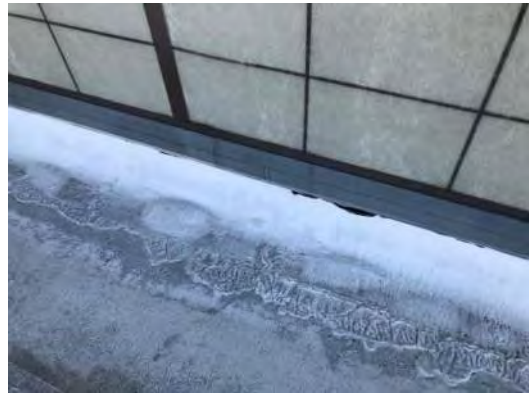
Comments: *Roofing membrane is not properly covered by flashing*

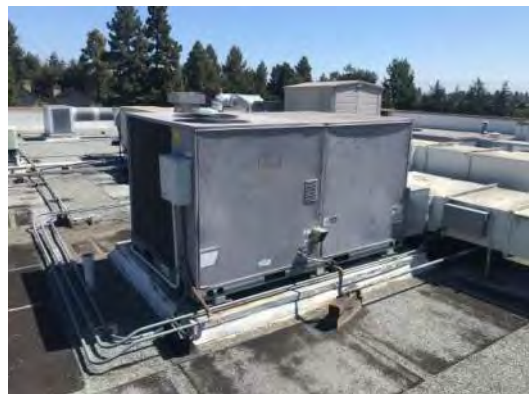
Comments: *Packaged Unit*

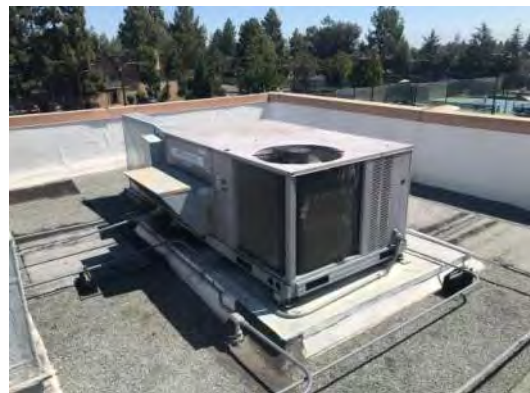
Comments: *Packaged Unit*

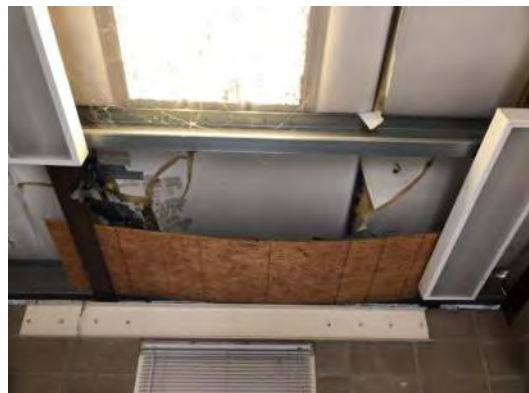
Comments: *Insulation is torn and falling in several locations.*

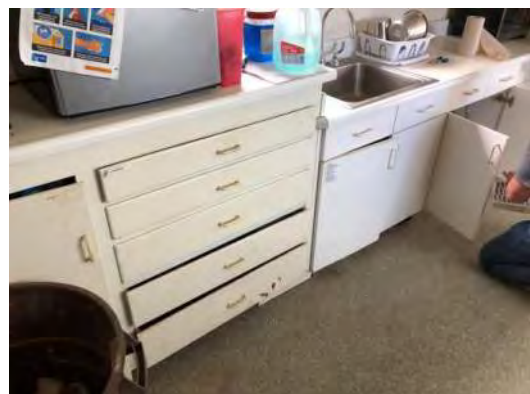
Record ID: 1088
System: E2010 - FIXED FURNISHINGS
Item No.: E2010.30.004
Floor/Room: 1
Priority: 3
Quantity/Unit of Measure: 25/LF
Total Deficiency Cost: \$40,900
Deficiency Description: *The existing casework is at or is approaching the end of its useful life.*
Description of Work: *Replace original wood cabinets and countertops.*
Comments:
