PHASE I ENVIRONMENTAL SITE ASSESSMENT REPORT

1655 South De Anza Boulevard and 7357 Prospect Road Cupertino, California 95014

Report Date: April 13, 2020 Partner Project No. 20-279581.1

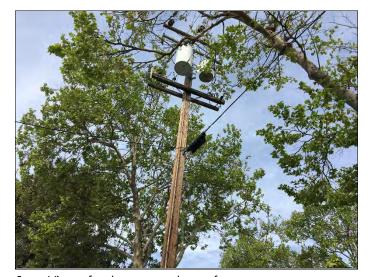
The on-site reconnaissance addressed indoor and outdoor transformers that may contain PCBs. Two pole-mounted transformers were observed on the subject property. The transformers are not labeled indicating PCB content. No staining or leakage was observed in the vicinity of the transformers. Based on the good condition of the equipment, the transformers are not expected to represent a significant environmental concern.

6. View of pole-mounted transformer.

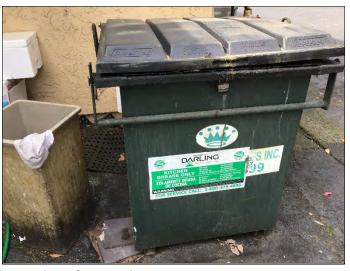
Solid waste generated at the subject property is disposed of in commercial dumpsters located on the north side of the subject property. An independent solid waste disposal contractor, Recology, removes solid waste from the subject property. According to property personnel, only commercial trash and food waste is collected in the on-site solid waste dumpsters. No evidence of illegal dumping of solid waste was observed during the Partner site reconnaissance.

8. View of grease dumpster.

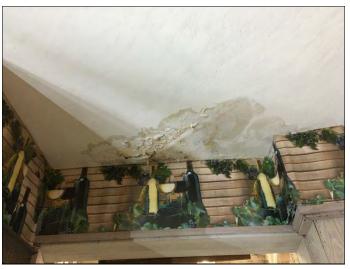
Ceiling of Liquor Store Water staining/intrusion

The area of water damage was observed to impact an area less than 5 square feet and is not considered a significant environmental concern.

10. View of water intrusion.

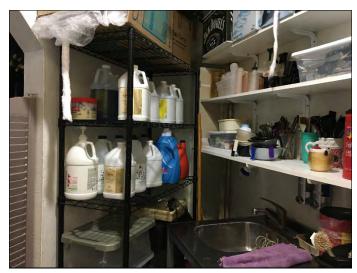
No evidence of the use of reportable quantities of hazardous substances was observed on the subject property. Small quantities of general maintenance supplies and salon chemicals were found to be properly labeled and stored at the time of the assessment with no signs of leaks, stains, or spills. The storage and use of maintenance supplies does not appear to pose a significant threat to the environmental integrity of the subject property at this time.

16. View of chemicals in hair salon.
