City of Cupertino

Facility Condition Assessment

Final Report

December 2, 2022

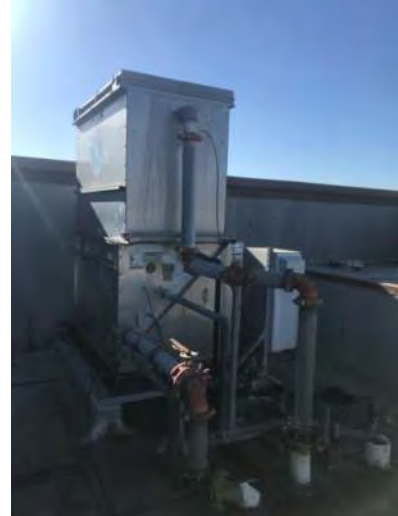
Comments: *Cooling Tower*

Description of Work: *Provide equipment replacement and installation.*

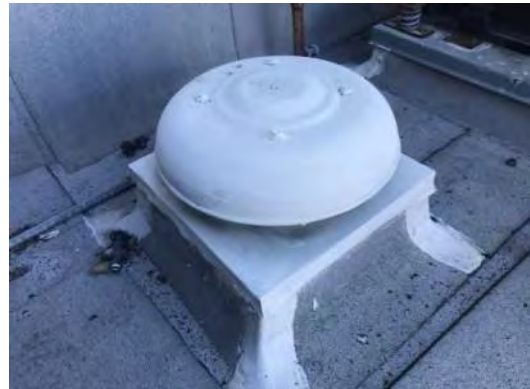
Record ID: 134
System: D3060 - VENTILATION

Item No.: D3060.30.007
Floor/Room: Roof
Priority: 3
Quantity/Unit of Measure: 1/EA
Total Deficiency Cost: \$7,270
Deficiency Description: *Ventilator is approaching the end of its expected useful life.*

Comments: *Exhaust Fan*

Description of Work: *Provide equipment replacement and installation.*

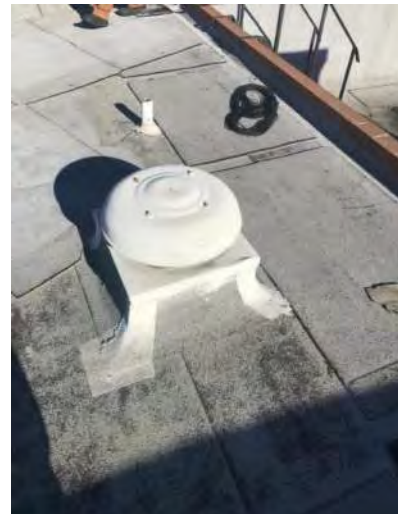
Record ID: 135
System: D3060 - VENTILATION

Item No.: D3060.30.007
Floor/Room: Roof
Priority: 3
Quantity/Unit of Measure: 1/EA
Total Deficiency Cost: \$7,270
Deficiency Description: *Ventilator is approaching the end of its expected useful life.*

Comments: *Exhaust Fan*

Description of Work: *Provide equipment replacement and installation.*

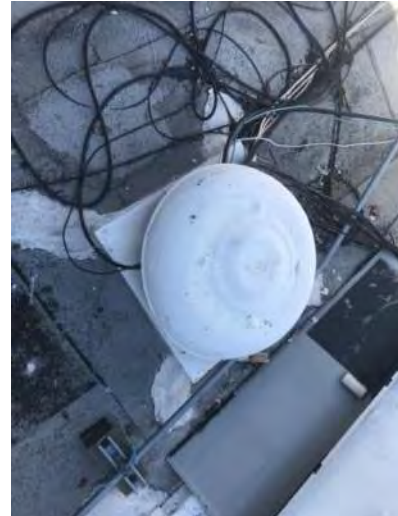
Comments: *Exhaust fan*

Description of Work: *Provide equipment replacement and installation.*

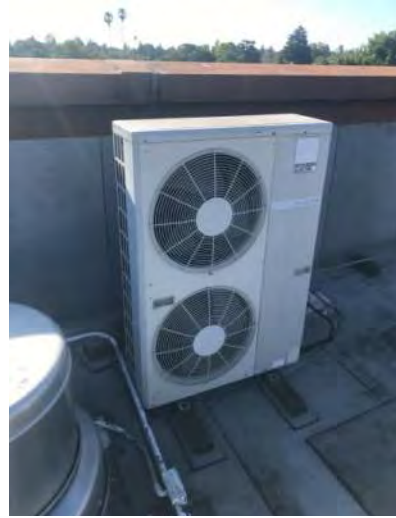
Comments: *HVAC - Split System*

Description of Work: *Provide equipment replacement and installation.*

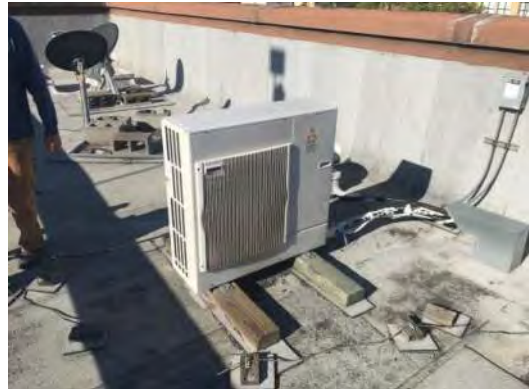
Record ID 143
System D3030 - COOLING SYSTEMS

Item No. D3030.70.042
Floor/Room: Roof
Priority: 3
Quantity/Unit of Measure: 1/EA
Total Deficiency Cost: \$26,980
Deficiency Description: *Split system with fan coil and outdoor condensing unit is approaching the end of its expected useful life.*

Comments: *HVAC - Split System*

Description of Work: *Provide equipment replacement and installation.*

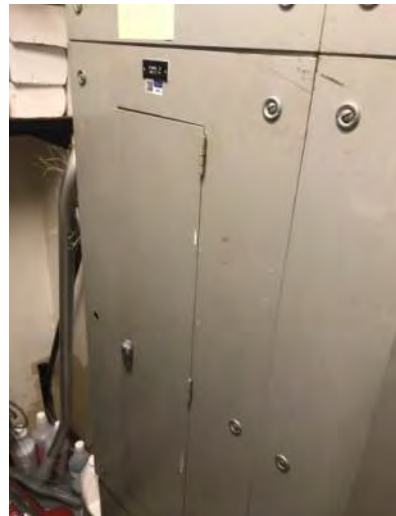
Record ID 148
System D5020 - ELECTRICAL SERVICE AND DISTRIBUTION

Item No. D5020.30.1008
Floor/Room: 1
Priority: 3
Quantity/Unit of Measure: 1/EA
Total Deficiency Cost: \$21,020
Deficiency Description: *The 225A (42 ckts, 120/208, 3P) panelboard is approaching the end of its expected useful life.*

Comments: *Panelboard*

Description of Work: *Replace the existing panelboard with a new panelboard.*

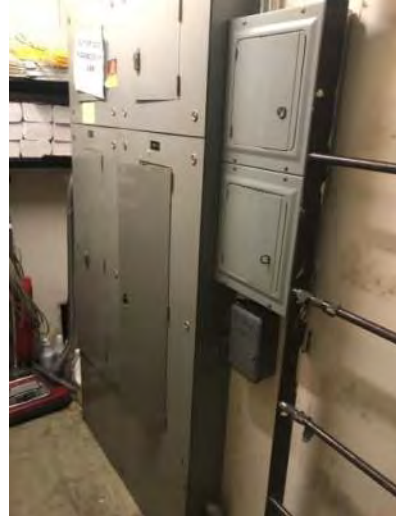
Record ID: 149
System: D5020 - ELECTRICAL SERVICE AND DISTRIBUTION
Item No.: D5020.30.1008
Floor/Room: 1
Priority: 3
Quantity/Unit of Measure: 1/EA
Total Deficiency Cost: \$21,020
Deficiency Description: *The 225A (42 ckts, 120/208, 3P) panelboard is approaching the end of its expected useful life.*
Description of Work: *Replace the existing panelboard with a new panelboard.*
Comments: *Panelboard*

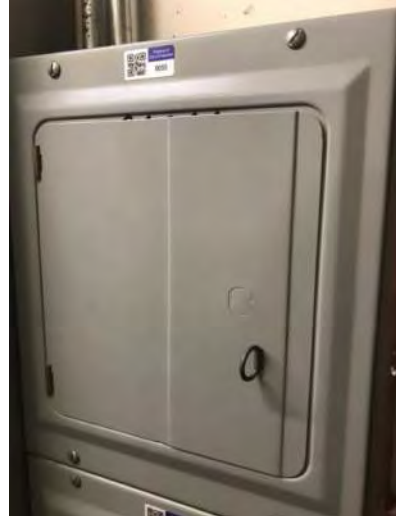
Record ID: 150
System: D5020 - ELECTRICAL SERVICE AND DISTRIBUTION
Item No.: D5020.30.4002
Floor/Room: 1
Priority: 3
Quantity/Unit of Measure: 1/EA
Total Deficiency Cost: \$6,910
Deficiency Description: *The load center is approaching the end of its expected useful life.*
Description of Work: *Replace the existing load center with a new load center.*
Comments: *Load Center*

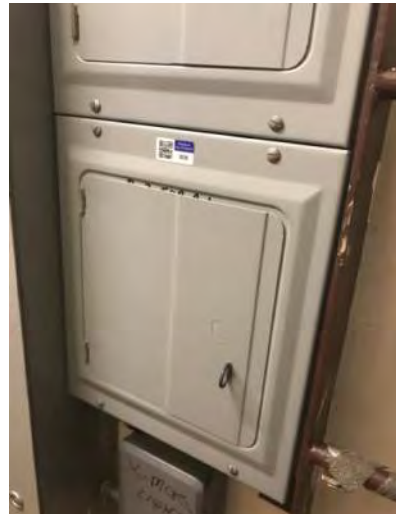
Record ID: 151
System: D5020 - ELECTRICAL SERVICE AND DISTRIBUTION
Item No.: D5020.30.4002
Floor/Room: 1
Priority: 3
Quantity/Unit of Measure: 1/EA
Total Deficiency Cost: \$6,910
Deficiency Description: *The load center is approaching the end of its expected useful life.*
Description of Work: *Replace the existing load center with a new load center.*
Comments: *Load Center*

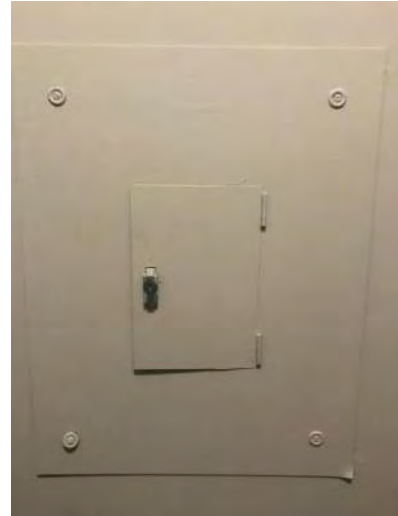
Comments: *Load Center*

Description of Work: *Replace the existing load center with a new load center.*

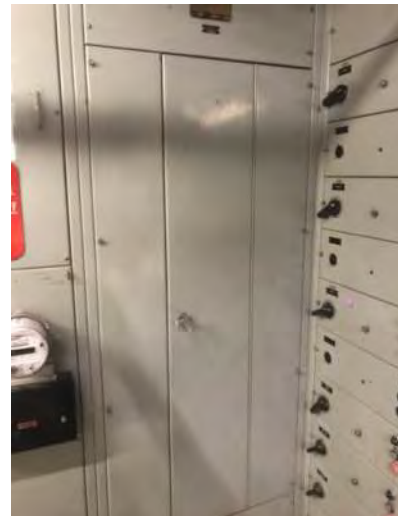
Record ID: 157
System: D5020 - ELECTRICAL SERVICE AND DISTRIBUTION

Item No.: D5020.30.0013
Floor/Room: 1
Priority: 3
Quantity/Unit of Measure: 1/EA
Total Deficiency Cost: \$71,060
Deficiency Description: *The 1600A switchboard is approaching the end of its expected useful life.*

Comments: *Panelboard*

Description of Work: *Replace the existing switchboard with a new switchboard.*

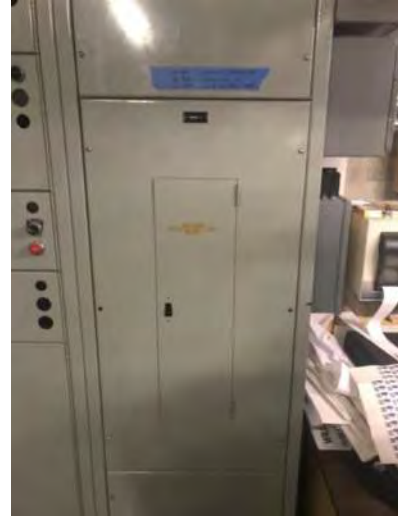
Record ID: 158
System: D5020 - ELECTRICAL SERVICE AND DISTRIBUTION
Item No.: D5020.30.1008
Floor/Room: 1
Priority: 3
Quantity/Unit of Measure: 1/EA
Total Deficiency Cost: \$21,020
Deficiency Description: *The 225A (120/208, 3P) panelboard is approaching the end of its expected useful life.*
Description of Work: *Replace the existing panelboard with a new panelboard.*
Comments: *Panelboard*

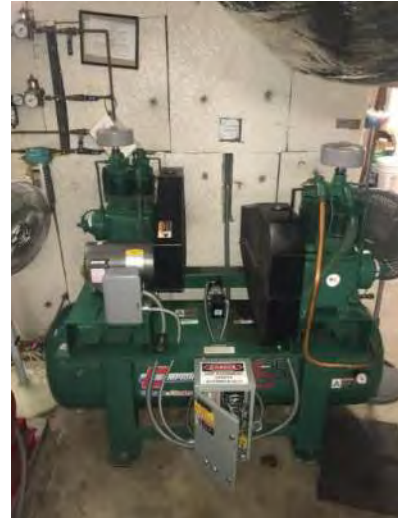
Record ID: 159
System: D2060 - PROCESS SUPPORT PLUMBING SYSTEMS
Item No.: D2060.10.001
Floor/Room: 1
Priority: 3
Quantity/Unit of Measure: 1/EA
Total Deficiency Cost: \$18,200
Deficiency Description: *Air compressor is approaching the end of its expected useful life.*
Description of Work: *Provide equipment replacement and installation.*
Comments: *Air Compressor*

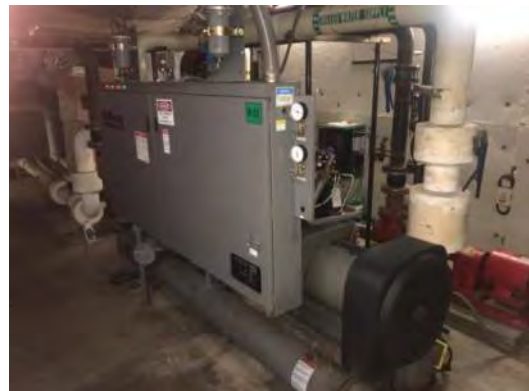
Record ID: 160
System: D3030 - COOLING SYSTEMS
Item No.: D3030.10.007
Floor/Room: 1
Priority: 3
Quantity/Unit of Measure: 1/EA
Total Deficiency Cost: \$351,750
Deficiency Description: *Water cooled chiller is approaching the end of its expected useful life.*
Description of Work: *Provide equipment replacement and installation.*
Comments: *Water Chiller*

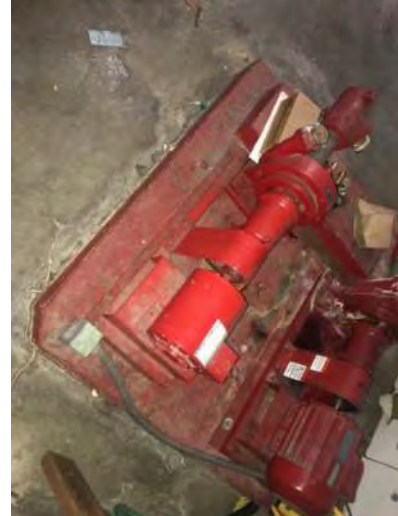
Record ID: 161
System: D3050 - FACILITY HVAC DISTRIBUTION SYSTEMS
Item No.: D3050.10.002
Floor/Room: 1
Priority: 3
Quantity/Unit of Measure: 1/EA
Total Deficiency Cost: \$14,010
Deficiency Description: *Hydronic pump and motor is approaching the end of its expected useful life.*
Description of Work: *Provide equipment replacement and installation.*
Comments: *Hydronic Pump*

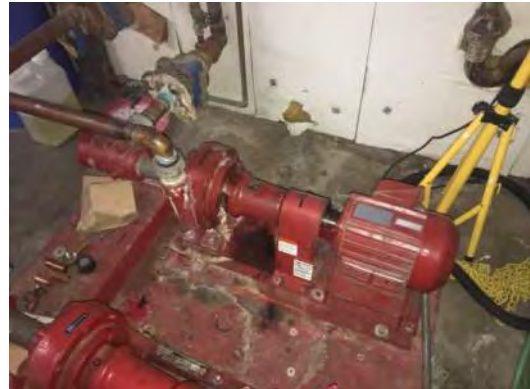
Record ID: 162
System: D3050 - FACILITY HVAC DISTRIBUTION SYSTEMS
Item No.: D3050.10.002
Floor/Room: 1
Priority: 3
Quantity/Unit of Measure: 1/EA
Total Deficiency Cost: \$14,010
Deficiency Description: *Hydronic pump and motor is approaching the end of its expected useful life.*
Description of Work: *Provide equipment replacement and installation.*
Comments: *Hydronic Pump*

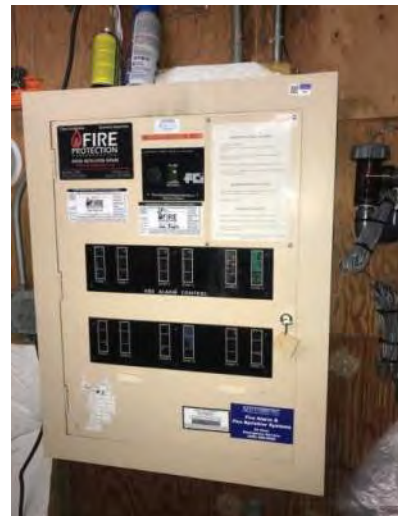
Record ID: 163
System: D7050 - DETECTION AND ALARM
Item No.: D7050.10.025
Floor/Room: 1
Priority: 1
Quantity/Unit of Measure: 23,040/SF
Total Deficiency Cost: \$459,760
Deficiency Description: *The existing fire alarm system is approaching the end of its useful life and should be replaced.*
Description of Work: *Replace the existing fire alarm system with a complete, site-wide, fully addressable fire alarm system.*
Comments: *Fire Alarm Panel*

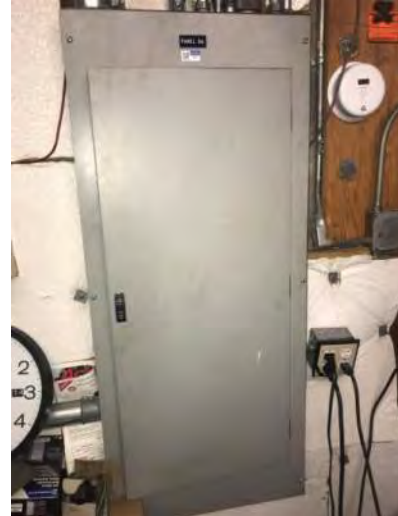
Record ID: 164
System: D5020 - ELECTRICAL SERVICE AND DISTRIBUTION
Item No.: D5020.30.1008
Floor/Room: 1
Priority: 3
Quantity/Unit of Measure: 1/EA
Total Deficiency Cost: \$21,020
Deficiency Description: *The 225A (120/208, 3P) panelboard is approaching the end of its expected useful life.*
Description of Work: *Replace the existing panelboard with a new panelboard.*
Comments: *Panelboard*

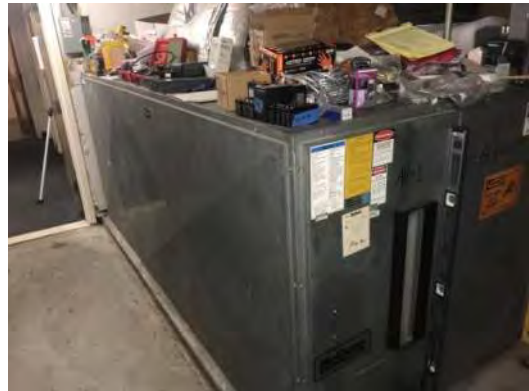
Record ID: 165
System: D3050 - FACILITY HVAC DISTRIBUTION SYSTEMS
Item No.: D3050.50.006
Floor/Room: 1
Priority: 2
Quantity/Unit of Measure: 1/EA
Total Deficiency Cost: \$78,310
Deficiency Description: *Air handler is approaching the end of its expected useful life.*
Description of Work: *Provide equipment replacement and installation.*
Comments: *Poor ventilation reported in previous 2018 FCA.*
Air Handler

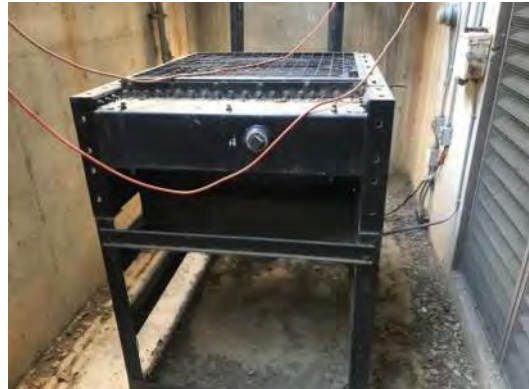
Comments: *HVAC - Condensing Unit*

Description of Work: *Provide equipment replacement and installation.*

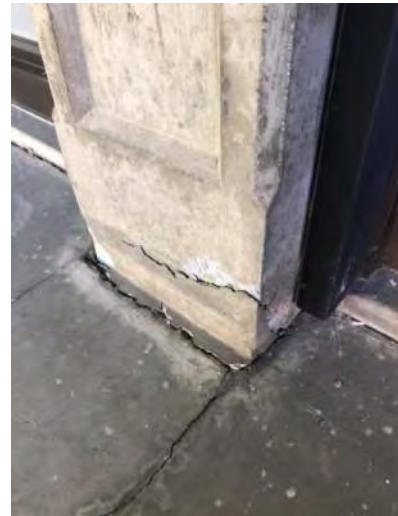
Record ID: 228
System: -

The exterior wood board siding has several locations that are deteriorating. The concrete railing finish is broken in several places. Damage was noted at the column foundations that should be investigated by a structural engineer. The fascia board along the roof perimeter is significantly deteriorated.

Item No.:
Floor/Room: Site
Priority: 6
Quantity/Unit of Measure: /
Total Deficiency Cost: N/A - See Executive Summary
Deficiency Description: *Concrete column is cracking and has exposed aggregate. Signs of settlement visible.*

Description of Work: *Recommend a structural engineer investigate.*

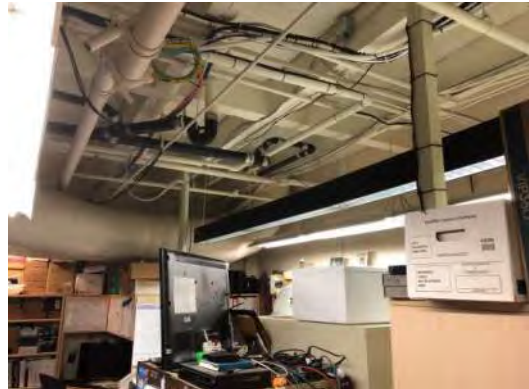
Record ID: 296
System: D6010 - DATA COMMUNICATIONS

Item No.: D6010.10.001
Floor/Room: Ground / City Channel Open Office
Priority: 3
Quantity/Unit of Measure: 380/SF
Total Deficiency Cost: \$7,970
Deficiency Description: *Data distribution infrastructure is awkward and will need to be reworked in many locations in order to accommodate building refurbishment/renovation.*

Comments: *Loose cabling above head supported by existing utilities. Rework required.*

Description of Work: *Rework the data distribution to both utilize and accommodate building refurbishment/renovation.*

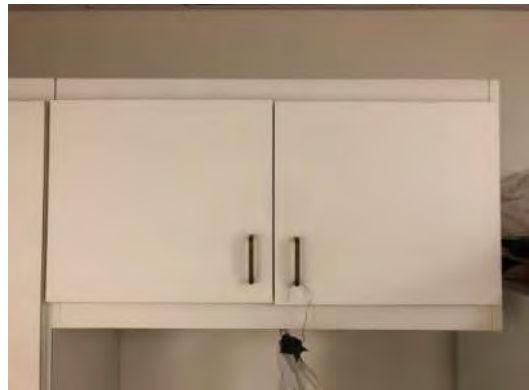
Record ID: 298
System: E2010 - FIXED FURNISHINGS

Item No.: E2010.30.009
Floor/Room: Ground / Lounge
Priority: 4
Quantity/Unit of Measure: 20/LF
Total Deficiency Cost: \$50,940
Deficiency Description: *The existing casework is at or is approaching the end of its useful life.*

Description of Work: *Replace original wood cabinets and countertops.*

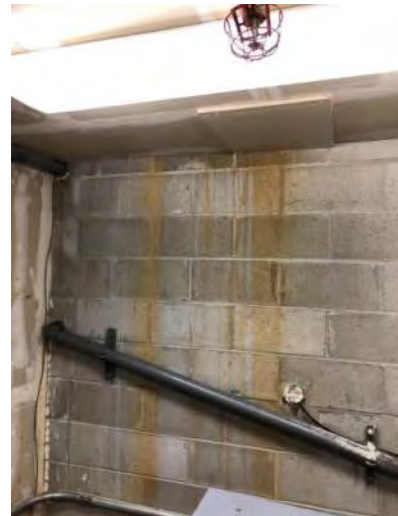
Record ID 304
System D2010 - DOMESTIC WATER DISTRIBUTION

Comments: *Evidence of leak from overhead plumbing. Inspect plumbing to verify/repair any leaks.*

Description of Work: *Investigate cause of leak and provide repairs and adjustments as necessary.*

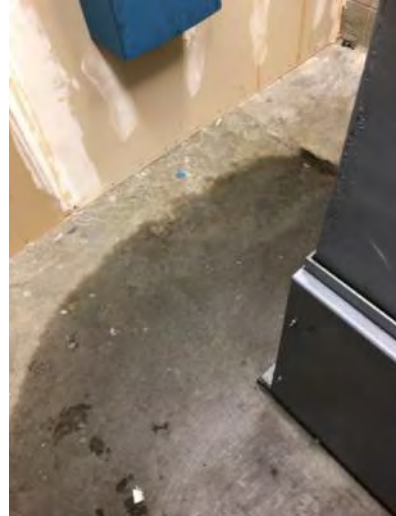
Comments: *Evidence of oil leaking onto concrete floor, inspect unit and repair or replace as required.*

Description of Work: *Provide equipment repair.*

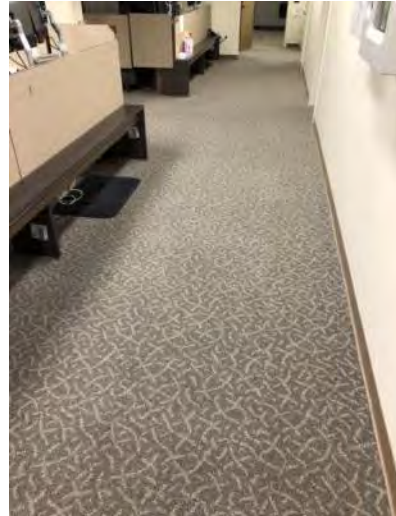
Record ID: 308
System: C2030 - FLOORING

Item No.: C2030.75.002
Floor/Room: / Varies
Priority: 3
Quantity/Unit of Measure: 18,000/SF
Total Deficiency Cost: \$523,250
Deficiency Description: *Rolled carpeting is approaching the end of its useful life.*

Description of Work: *Remove existing rolled carpeting and replace it with new 40 oz. nylon carpet.*

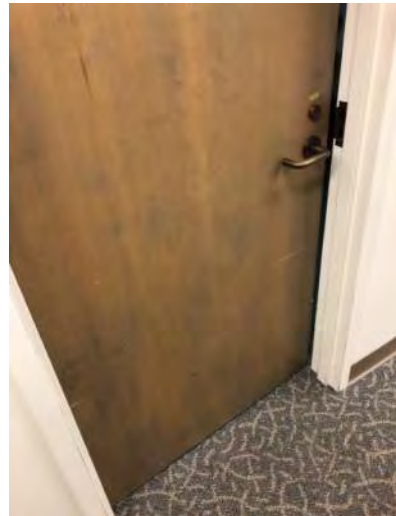
Record ID: 309
System: C1030 - INTERIOR DOORS

Item No.: C1030.10.004
Floor/Room: / Varies
Priority: 5
Quantity/Unit of Measure: 45/EA
Total Deficiency Cost: \$567,600
Deficiency Description: *Interior wood door, frame and hardware is at or approaching the end of its useful life.*

Description of Work: *Replace interior wood door, frame and hardware.*

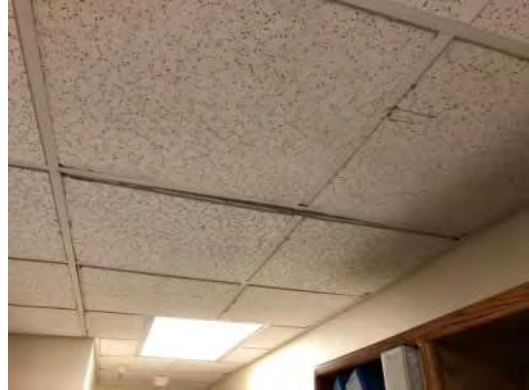
Comments: *Signs of water damage. Tiles appear brittle and at end of useful life.*

Description of Work: *Replace the ceiling grid, including the tiles.*

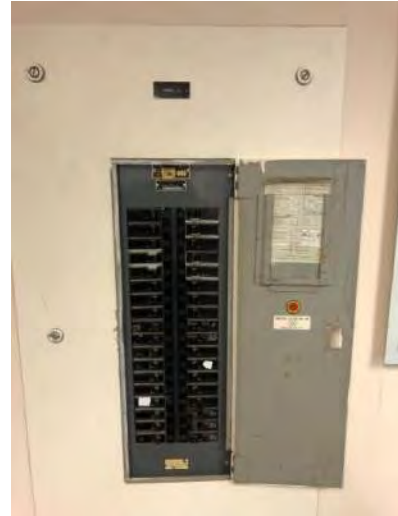
Record ID: 313
System: D5020 - ELECTRICAL SERVICE AND DISTRIBUTION

Item No.: D5020.30.1008
Floor/Room: 1 / GND 14 - Panel A
Priority: 3
Quantity/Unit of Measure: 1/EA
Total Deficiency Cost: \$21,020
Deficiency Description: *The 225A (120/208, 3P) panelboard is past its expected useful life.*

Comments: *Panelboard*

Description of Work: *Replace the existing panelboard with a new panelboard.*

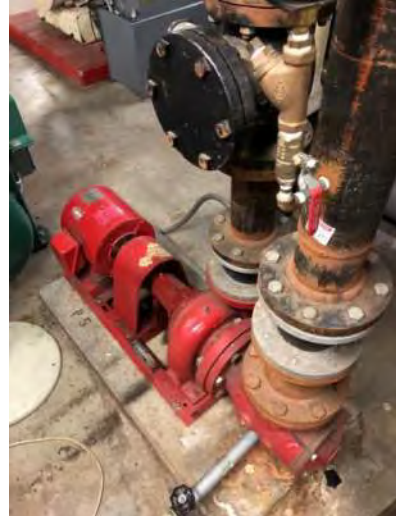
Record ID: 317
System: D3050 - FACILITY HVAC DISTRIBUTION SYSTEMS
Item No.: D3050.10.002
Floor/Room: Ground / TER 28 - Supply Pump
Priority: 3
Quantity/Unit of Measure: 1/EA
Total Deficiency Cost: \$14,010
Deficiency Description: *Hydronic pump and motor is approaching the end of its expected useful life.*
Description of Work: *Provide equipment replacement and installation.*
Comments: *Hydronic Pump*

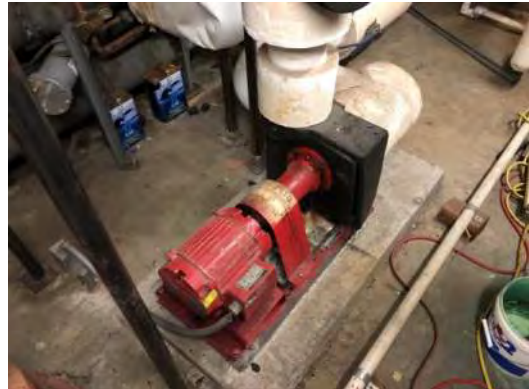
Record ID: 318
System: D3050 - FACILITY HVAC DISTRIBUTION SYSTEMS
Item No.: D3050.10.002
Floor/Room: Ground / TER 28 - Return Pump
Priority: 3
Quantity/Unit of Measure: 1/EA
Total Deficiency Cost: \$14,010
Deficiency Description: *Hydronic pump and motor is approaching the end of its expected useful life.*
Description of Work: *Provide equipment replacement and installation.*
Comments: *Hydronic Pump*

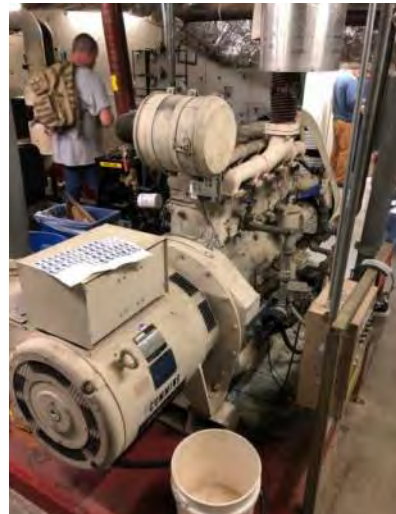
Record ID: 319
System: D5010 - FACILITY POWER GENERATION
Item No.: D5010.10.019
Floor/Room: 1 / TER 28 - Diesel Generator
Priority: 3
Quantity/Unit of Measure: 125/KW
Total Deficiency Cost: \$235,080
Deficiency Description: *The existing generator is past its expected useful life.*
Description of Work: *Replace the existing generator with a new generator.*
Comments: *Generator*

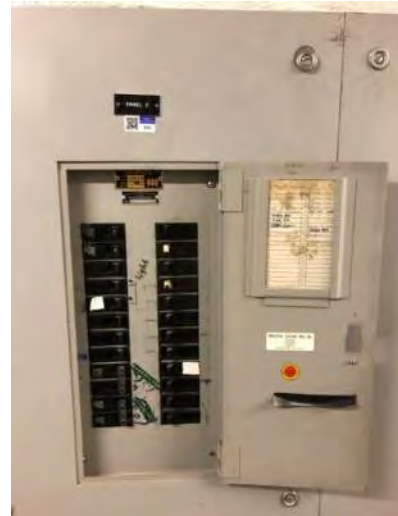
Record ID 323
System D5020 - ELECTRICAL SERVICE AND DISTRIBUTION
Item No. D5020.30.4001
Floor/Room: 1 / TER 28
Priority: 3
Quantity/Unit of Measure: 1/EA
Total Deficiency Cost: \$5,550
Deficiency Description: *The load center is approaching the end of its expected useful life.*

Comments: *Panelboard*

Description of Work: *Replace the existing load center with a new load center.*

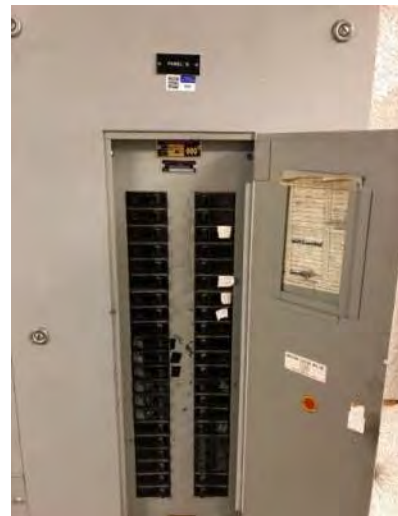
Record ID 324
System D5020 - ELECTRICAL SERVICE AND DISTRIBUTION
Item No. D5020.30.1008
Floor/Room: 1 / TER 28
Priority: 3
Quantity/Unit of Measure: 1/EA
Total Deficiency Cost: \$21,020
Deficiency Description: *The panelboard is approaching the end of its expected useful life.*

Comments: *Panelboard*

Description of Work: *Replace the existing panelboard with a new panelboard.*

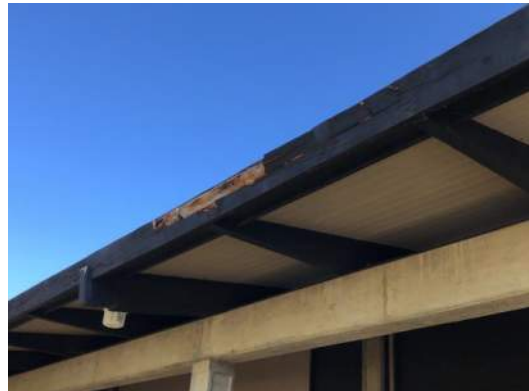
Record ID: 329
System: B3010 - ROOFING

Priority: 3
Quantity/Unit of Measure: 540/LF
Total Deficiency Cost: \$54,970
Deficiency Description: *Wood fascia and trim chipped and have peeling paint.*

Comments: *Fascia is beyond it's useful life. Repair or replace as needed.*

Description of Work: *Clean, repair, and paint the trim and/or fascia.*

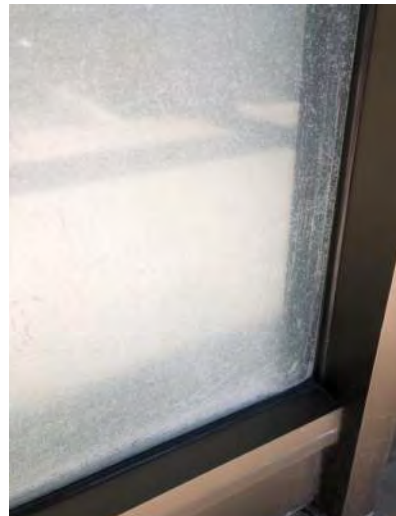
Record ID: 332
System: B2020 - EXTERIOR WINDOWS

Priority: 3
Quantity/Unit of Measure: 1,200/SF
Total Deficiency Cost: \$143,930
Deficiency Description: *Aluminum storefront is at or approaching the end of its useful life.*

Description of Work: *Replace with 3/8" plate glass in 2"x4" aluminum frame.*

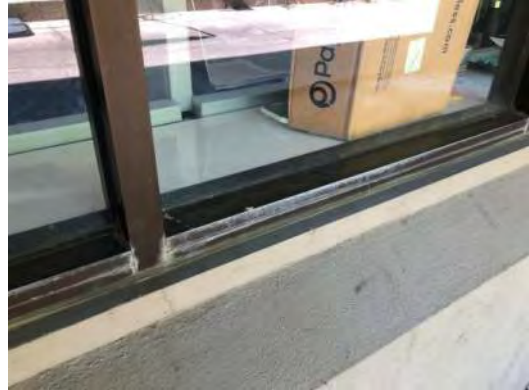
Item No.: B2020.20.004
Floor/Room: / Exterior
Priority: 3
Quantity/Unit of Measure: 400/SF
Total Deficiency Cost: \$87,220
Deficiency Description: *Aluminum window is approaching/past it's expected useful life.*

Description of Work: *Replace aluminum window.*

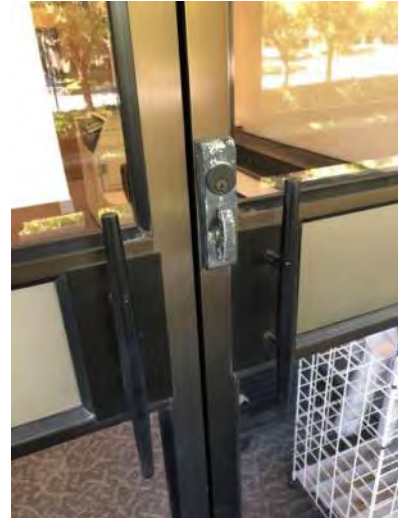
Record ID: 335
System: B2050 - EXTERIOR DOORS AND GRILLES

Item No.: B2050.10.002
Floor/Room: / Exterior Door
Priority: 3
Quantity/Unit of Measure: 11/EA
Total Deficiency Cost: \$107,930
Deficiency Description: *Exterior aluminum (storefront) entrance door is approaching the end of its useful life.*

Description of Work: *Replace aluminum door (storefront).*

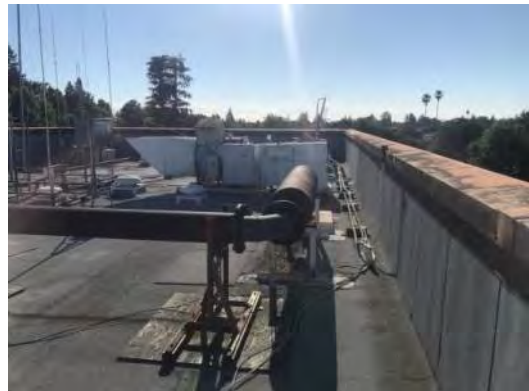
Record ID: 1062
System: B2010 - EXTERIOR WALLS

Item No.: B2010.50.001
Floor/Room: / Roof
Priority: 3
Quantity/Unit of Measure: 250/LF
Total Deficiency Cost: \$18,200
Deficiency Description: *The top of the parapet wall is not protected.*

Description of Work: *Provide a sheet metal cap.*

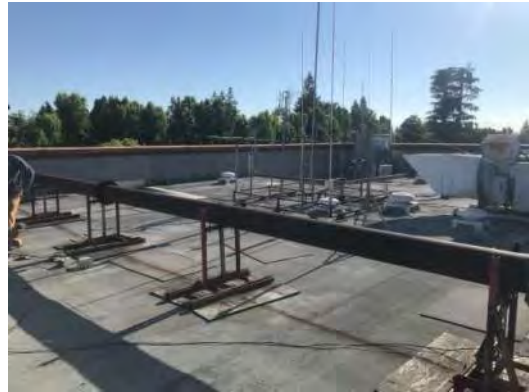
Item No.: B3010.50.004
Floor/Room: / Roof
Priority: 3
Quantity/Unit of Measure: 3,300/SF
Total Deficiency Cost: \$137,940
Deficiency Description: *Modified bitumen roofing is at or approaching the end of its useful life.*

Description of Work: *Replace modified bitumen roofing.*

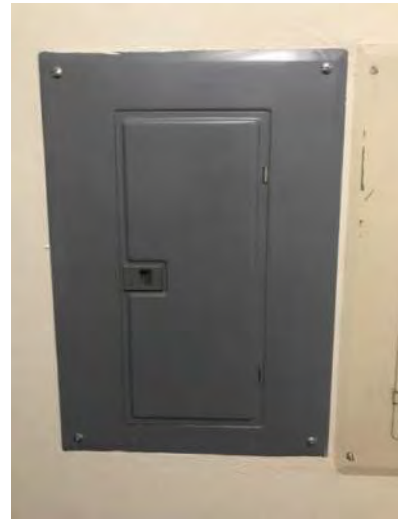
Record ID 187
System D5020 - ELECTRICAL SERVICE AND DISTRIBUTION
Item No. D5020.30.4001
Floor/Room: 1
Priority: 3
Quantity/Unit of Measure: 1/EA
Total Deficiency Cost: \$5,550
Deficiency Description: *The load center is approaching the end of its expected useful life.*

Comments: *Load Center*

Description of Work: *Replace the existing load center with a new load center.*

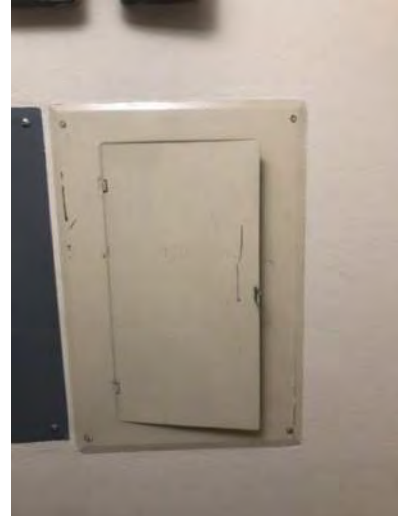
Record ID 188
System D5020 - ELECTRICAL SERVICE AND DISTRIBUTION
Item No. D5020.30.4001
Floor/Room: 1
Priority: 3
Quantity/Unit of Measure: 1/EA
Total Deficiency Cost: \$5,550
Deficiency Description: *The load center is approaching the end of its expected useful life.*

Comments: *Load Center*

Description of Work: *Replace the existing load center with a new load center.*

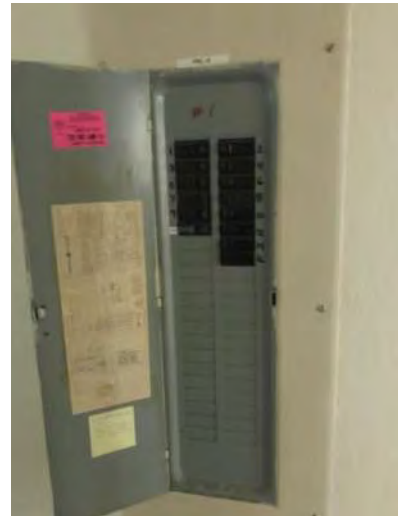
Record ID 190
System D5020 - ELECTRICAL SERVICE AND DISTRIBUTION
Item No. D5020.30.4001
Floor/Room: 1
Priority: 3
Quantity/Unit of Measure: 1/EA
Total Deficiency Cost: \$5,550
Deficiency Description: *The load center is approaching the end of its expected useful life.*

Comments: *Panelboard*

Description of Work: *Replace the existing load center with a new load center.*

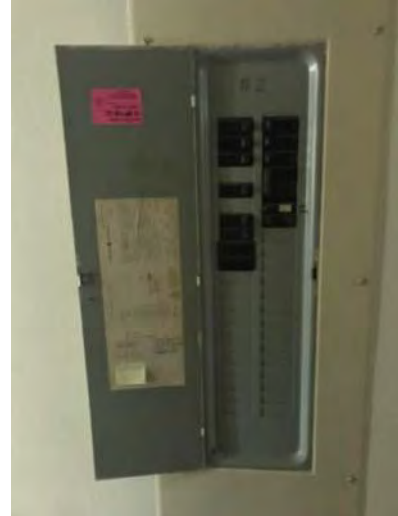
Record ID: 191
System: D5020 - ELECTRICAL SERVICE AND DISTRIBUTION
Item No.: D5020.30.4001
Floor/Room: 1
Priority: 3
Quantity/Unit of Measure: 1/EA
Total Deficiency Cost: \$5,550
Deficiency Description: *The load center is approaching the end of its expected useful life.*
Description of Work: *Replace the existing load center with a new load center.*
Comments: *Panelboard*

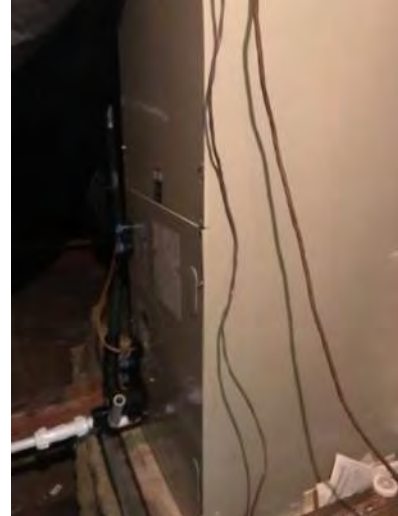
Record ID: 192
System: D3020 - HEATING SYSTEMS
Item No.: D3020.10.007
Floor/Room: 1
Priority: 1
Quantity/Unit of Measure: 1/EA
Total Deficiency Cost: \$17,660
Deficiency Description: *Furnace is approaching the end of its expected useful life.*
Description of Work: *Provide equipment replacement and installation.*
Comments: *Furnance*

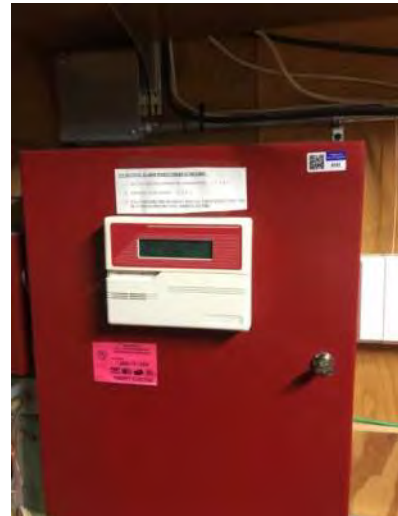
Record ID: 194
System: D7050 - DETECTION AND ALARM
Item No.: D7050.10.025
Floor/Room: 1
Priority: 1
Quantity/Unit of Measure: 6,400/SF
Total Deficiency Cost: \$127,730
Deficiency Description: *The existing fire alarm system is approaching the end of its useful life and should be replaced.*
Description of Work: *Replace the existing fire alarm system with a complete, site-wide, fully addressable fire alarm system.*
Comments: *Fire Alarm Panel*

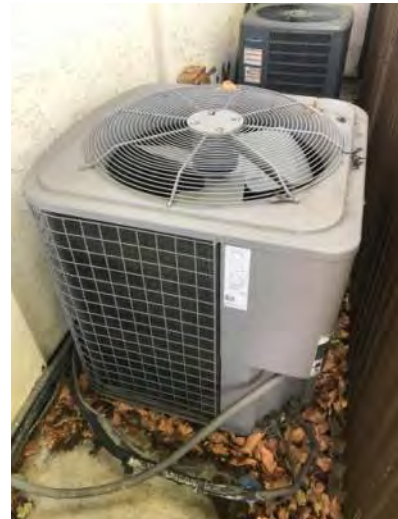
Item No.: D3030.70.001
Floor/Room: 1
Priority: 3
Quantity/Unit of Measure: 1/EA
Total Deficiency Cost: \$27,060
Deficiency Description: *Heat pump is approaching the end of its expected useful life.*

Comments: *HVAC - Split System*

Description of Work: *Provide equipment replacement and installation.*

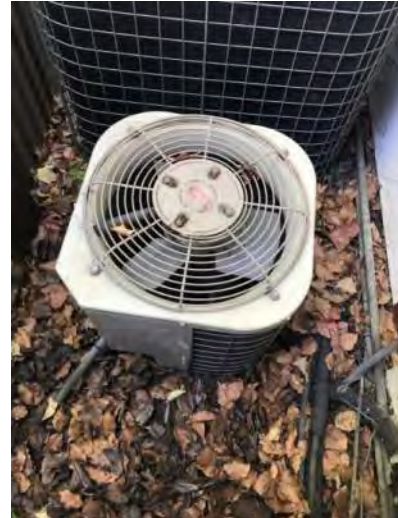
Record ID: 197
System: D3030 - COOLING SYSTEMS

Item No.: D3030.70.042
Floor/Room: 1
Priority: 1
Quantity/Unit of Measure: 1/EA
Total Deficiency Cost: \$24,690
Deficiency Description: *Split system with fan coil and outdoor condensing unit is approaching the end of its expected useful life.*

Comments: *HVAC - Split System*

Description of Work: *Provide equipment replacement and installation.*

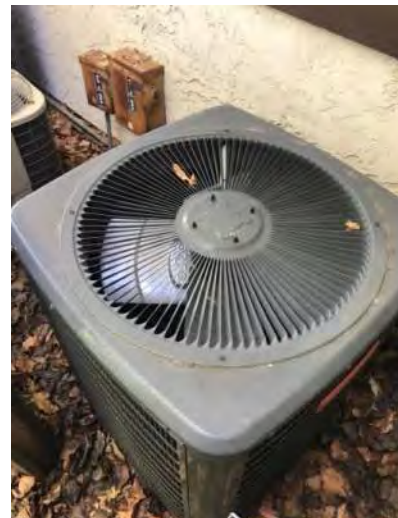
Record ID: 198
System: D3030 - COOLING SYSTEMS

Item No.: D3030.70.044
Floor/Room: 1
Priority: 4
Quantity/Unit of Measure: 1/EA
Total Deficiency Cost: \$36,140
Deficiency Description: *Split system with fan coil and outdoor condensing unit is approaching the end of its expected useful life.*

Comments: *HVAC - Split System*

Description of Work: *Provide equipment replacement and installation.*

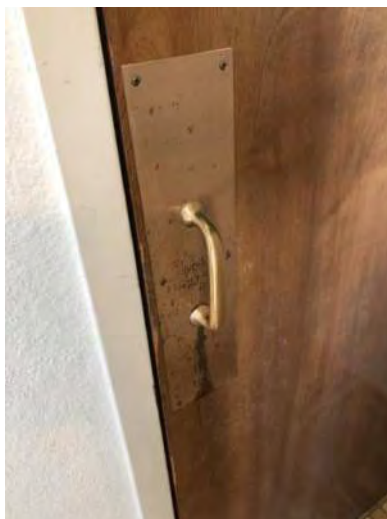
Deficiency Description: *Exterior wood entrance door, frame and hardware is approaching the end of its useful life.*

Description of Work: *Replace wood door, frame, and hardware.*

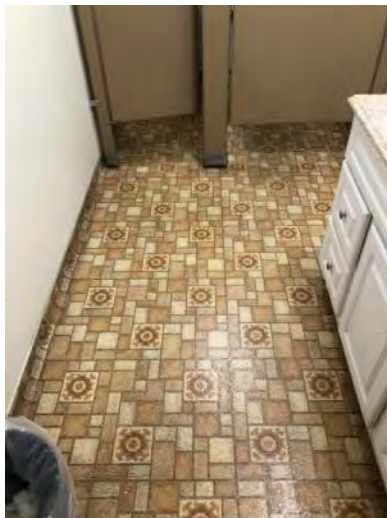
Record ID 252
System C2030 - FLOORING

Deficiency Description: *Sheet vinyl is approaching the end of its useful life.*

Description of Work: *Remove the existing sheet vinyl and replace.*

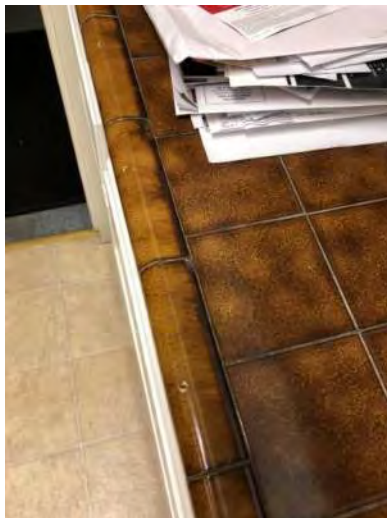
Record ID 254
System E2010 - FIXED FURNISHINGS

Deficiency Description: *Solid Surface countertops are at or are approaching the end of their useful life.*

Description of Work: *Remove and replace the solid surface countertops.*

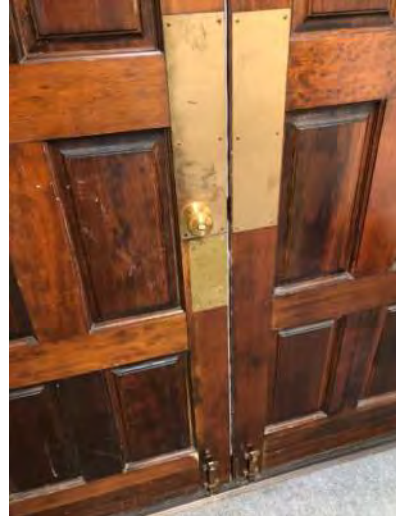
Deficiency Description: *Exterior exit door is at or approaching the end of its useful life.*

Description of Work: *Provide new 3' x 7' HM exterior exit door and frame with panic hardware and closer.*

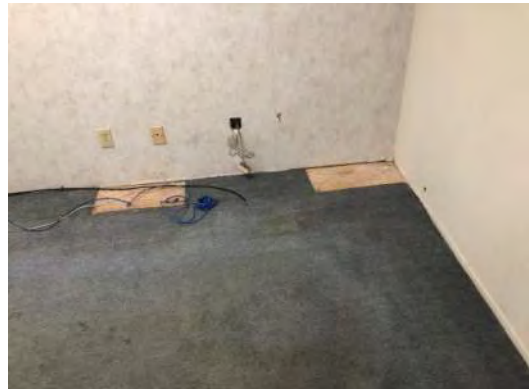
Record ID 262
System C2030 - FLOORING

Deficiency Description: *Rolled carpeting is approaching the end of its useful life.*

Description of Work: *Remove existing rolled carpeting and replace it with new 40 oz. nylon carpet.*

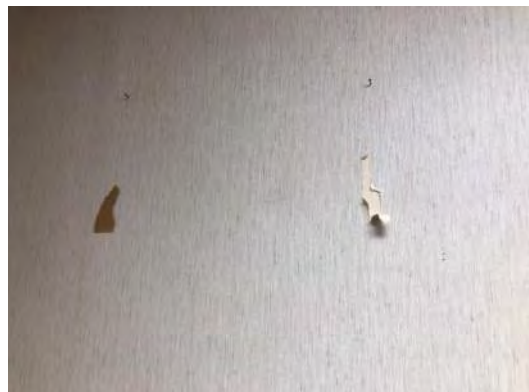
Record ID 264
System C2010 - WALL FINISHES

Deficiency Description: *Vinyl wall covering is approaching the end of its useful life.*

Description of Work: *Install a new vinyl wall covering.*

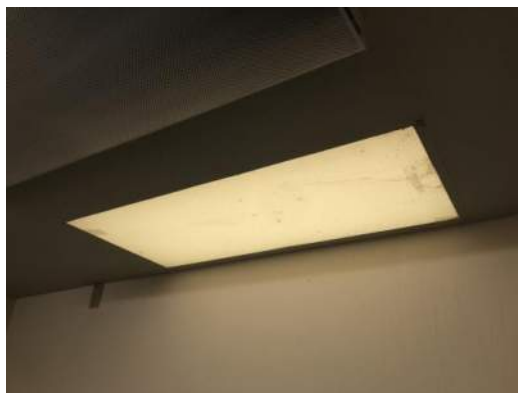
Priority: 3
Quantity/Unit of Measure: 45/SF
Total Deficiency Cost: \$12,290
Deficiency Description: *Skylights are leaking, damaged and discolored.*

Description of Work: *Remove the existing skylight and replace it with a new skylight.*

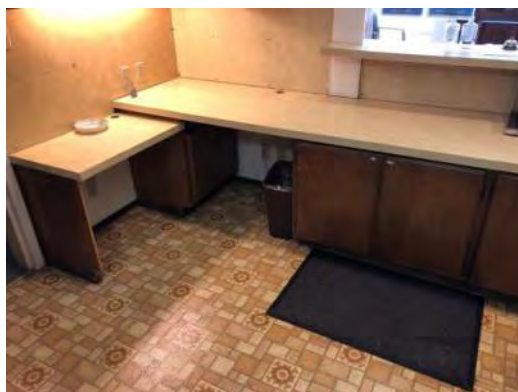
Record ID: 266
System: E2010 - FIXED FURNISHINGS

Priority: 3
Quantity/Unit of Measure: 25/LF
Total Deficiency Cost: \$18,200
Deficiency Description: *The existing casework is in need of refurbishment.*

Description of Work: *Repair, refurbish, and refinish the existing wood casework and counters.*

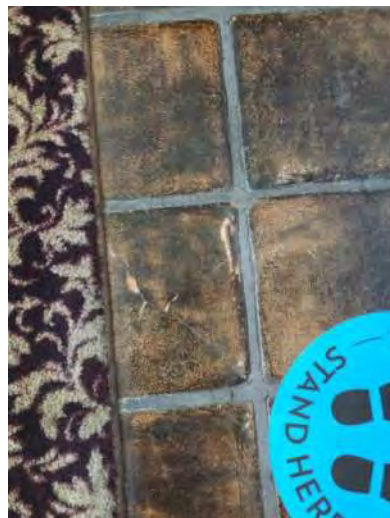
Record ID: 267
System: C2030 - FLOORING

Priority: 5
Quantity/Unit of Measure: 300/SF
Total Deficiency Cost: \$23,430
Deficiency Description: *Ceramic tile floor is approaching the end of its useful life.*

Description of Work: *Remove the existing ceramic tile flooring and replace.*

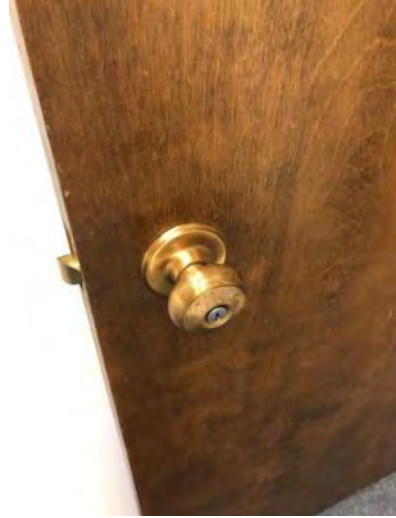
Item No.: C1030.10.001
Floor/Room: 1 / Varies
Priority: 4
Quantity/Unit of Measure: 30/EA
Total Deficiency Cost: \$249,990
Deficiency Description: *Interior wood door is at or approaching the end of its useful life.*

Description of Work: *Replace with new wood door.*

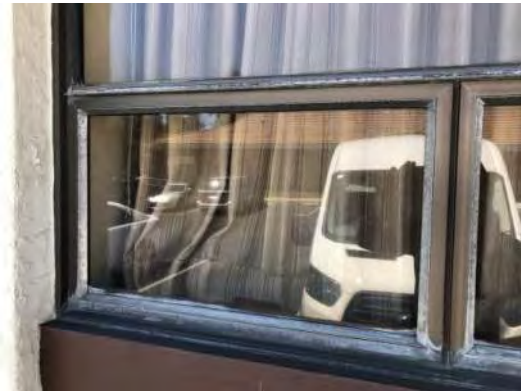
Record ID: 270
System: B2020 - EXTERIOR WINDOWS

Item No.: B2020.20.003
Floor/Room: / Varies
Priority: 3
Quantity/Unit of Measure: 800/SF
Total Deficiency Cost: \$174,420
Deficiency Description: *Metal window is approaching the end of its useful life.*

Description of Work: *Replace metal window.*

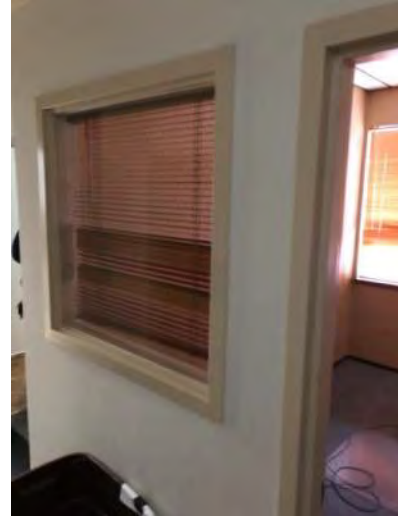
Item No.: C1020.20.006
Floor/Room:
Priority: 5
Quantity/Unit of Measure: 72/SF
Total Deficiency Cost: \$34,940
Deficiency Description: *Interior fixed steel window is at or approaching the end of its useful life.*

Description of Work: *Replace fixed steel window.*

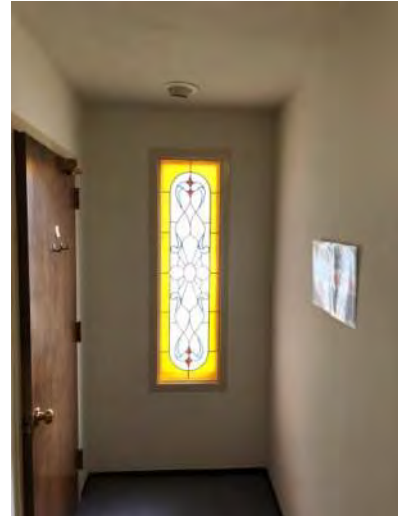
Record ID: 1066
System: B2020 - EXTERIOR WINDOWS

Item No.: B2020.50.002
Floor/Room:
Priority: 3
Quantity/Unit of Measure: 13/EA
Total Deficiency Cost: \$354,300
Deficiency Description: *Stained art glass panels in refurbished windows are in need of restoration.*

Description of Work: *Refurbish stained glass panels in windows.*

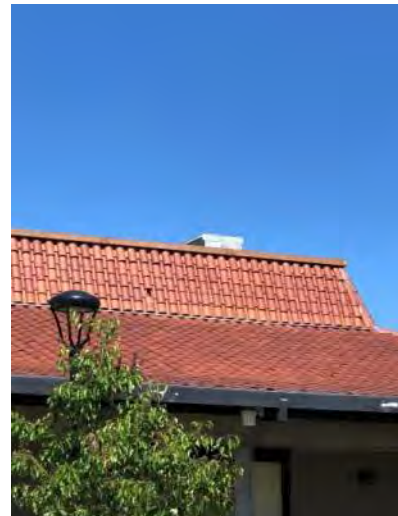
Record ID: 1067
System: B3010 - ROOFING

Item No.: B3010.10.003
Floor/Room: / Roof
Priority: 3
Quantity/Unit of Measure: 6,700/SF
Total Deficiency Cost: \$438,250
Deficiency Description: *Clay tile roofing is at or approaching end of expected useful service life.*

Description of Work: *Remove and replace clay tile roofing.*

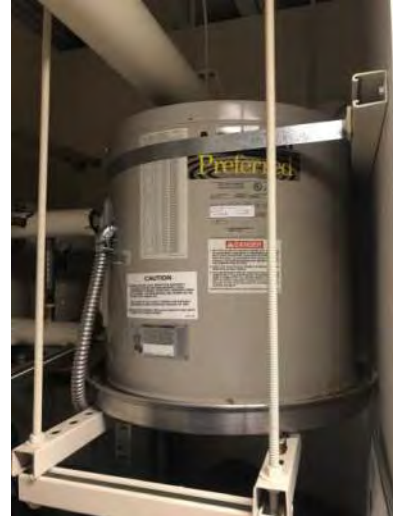
Comments: *Water Heater*

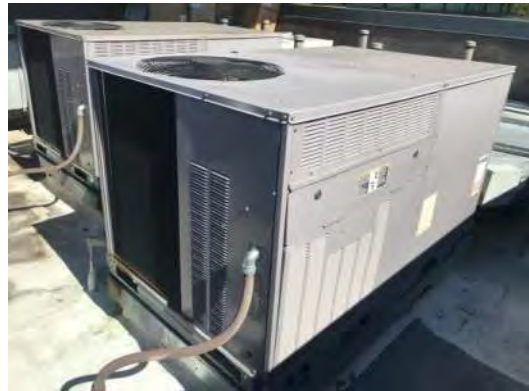
Item No.: D3030.10.018
Floor/Room: Roof
Priority: 2
Quantity/Unit of Measure: 1/EA
Total Deficiency Cost: \$52,230
Deficiency Description: *Packaged AC unit is approaching the end of its expected useful life.*

Comments: *Packaged Unit*

Description of Work: *Provide equipment replacement and installation.*

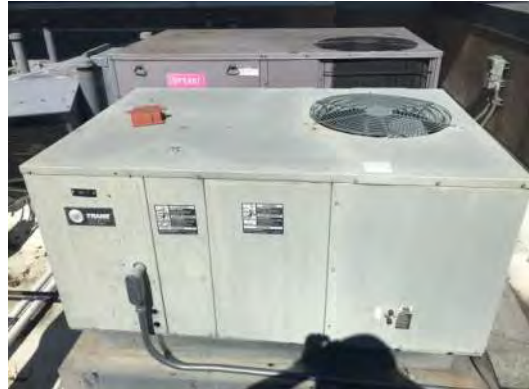
Item No.: D3030.10.017
Floor/Room: Roof
Priority: 2
Quantity/Unit of Measure: 1/EA
Total Deficiency Cost: \$17,430
Deficiency Description: *Packaged AC unit is approaching the end of its expected useful life.*

Comments: *Packaged Unit*

Description of Work: *Provide equipment replacement and installation.*

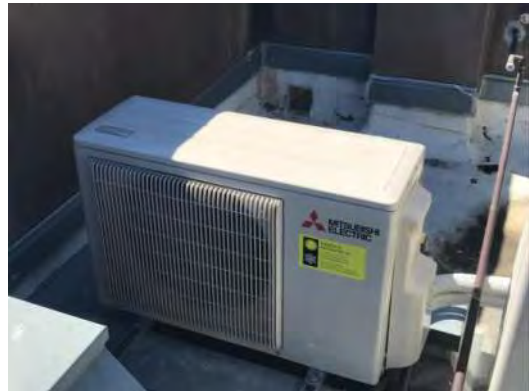
Item No.: D3030.70.041
Floor/Room: Roof
Priority: 3
Quantity/Unit of Measure: 1/EA
Total Deficiency Cost: \$19,300
Deficiency Description: *Split system with wall mounted AC and outdoor condensing unit is approaching the end of its expected useful life.*

Comments: *HVAC - Split System*

Description of Work: *Provide equipment replacement and installation.*

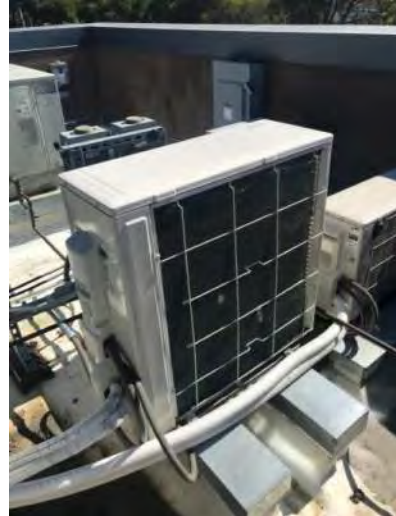
Item No.: D3030.70.042
Floor/Room: Roof
Priority: 3
Quantity/Unit of Measure: 1/EA
Total Deficiency Cost: \$26,980
Deficiency Description: *Split system with fan coil and outdoor condensing unit is approaching the end of its expected useful life.*

Comments: *HVAC - Split System*

Description of Work: *Provide equipment replacement and installation.*

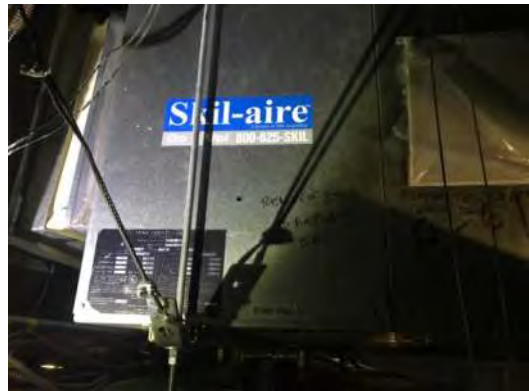
Item No.: D3030.70.001
Floor/Room: 1
Priority: 3
Quantity/Unit of Measure: 1/EA
Total Deficiency Cost: \$27,060
Deficiency Description: *Heat pump is approaching the end of its expected useful life.*

Comments: *Heat Pump*

Description of Work: *Provide equipment replacement and installation.*

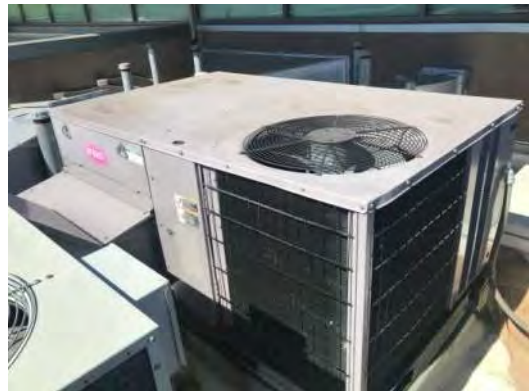
Item No.: D3030.10.018
Floor/Room: Roof
Priority: 2
Quantity/Unit of Measure: 1/EA
Total Deficiency Cost: \$52,230
Deficiency Description: *Packaged AC unit is approaching the end of its expected useful life.*

Comments: *Packaged Unit*

Description of Work: *Provide equipment replacement and installation.*

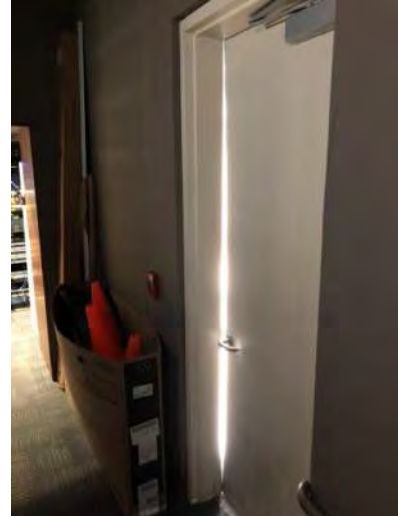
Deficiency Description: *Exterior exit door is at or approaching the end of its useful life.*

Comments: *Daylighting occurring, door is not creating a proper seal and appears warped.*

Description of Work: *Provide new 3' x 7' HM exterior exit door and frame with panic hardware and closer.*

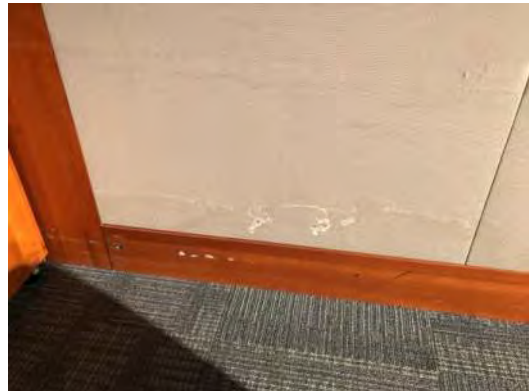
Deficiency Description: *Fabric wall covering is approaching the end of its useful life.*

Description of Work: *Install a new fabric wall covering.*

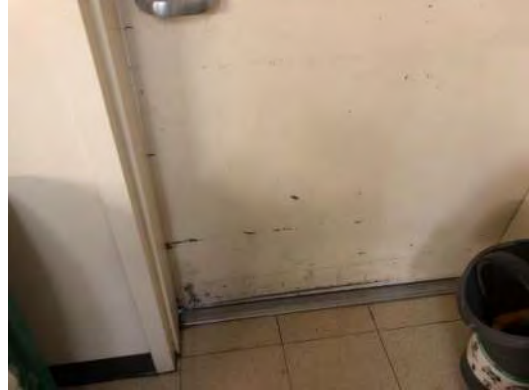
Item No.: B2050.20.002
Floor/Room: 1
Priority: 4
Quantity/Unit of Measure: 1/EA
Total Deficiency Cost: \$4,570
Deficiency Description: *Metal door is damaged or deteriorated.*

Description of Work: *Repair door and repaint.*

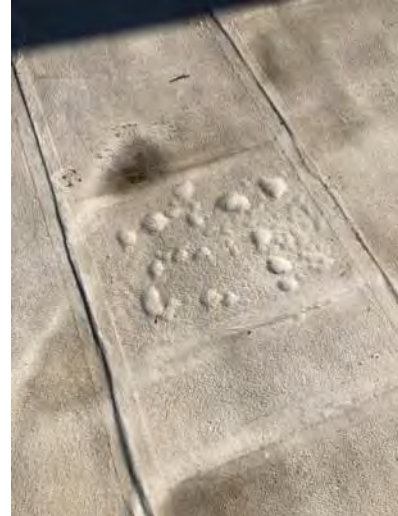
Item No. B3010.90.003
Floor/Room: / Roof
Priority: 3
Quantity/Unit of Measure: 50/SF
Total Deficiency Cost: \$940
Deficiency Description: *Roofing membrane needs a recoating.*

Comments: *Roof membrane is bubbling in multiple locations.*

Description of Work: *Repair and recoat the roof membrane. Provide a white (light color) neoprene coating and replace the roof membrane as scheduled.*

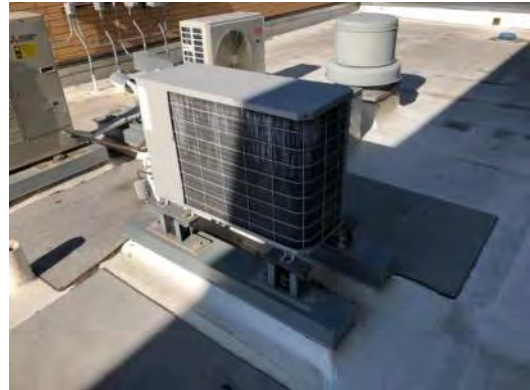
Item No. D3030.70.002
Floor/Room: Roof / Roof - AC Unit
Priority: 2
Quantity/Unit of Measure: 1/EA
Total Deficiency Cost: \$17,870
Deficiency Description: *Split system with wall mounted AC and outdoor condensing unit is approaching the end of its expected useful life.*

Comments: *HVAC - Split System*

Description of Work: *Provide equipment replacement and installation.*

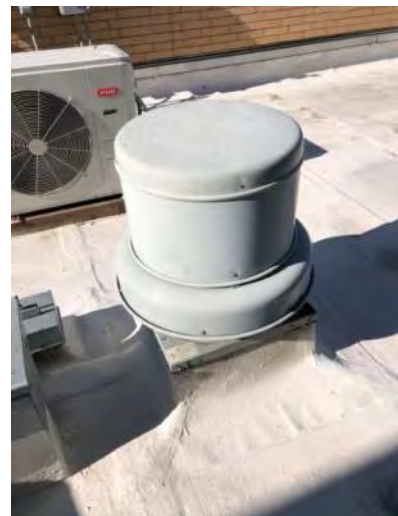
Item No. D3060.30.005
Floor/Room: Roof / Roof - EF-3
Priority: 4
Quantity/Unit of Measure: 1/EA
Total Deficiency Cost: \$8,360
Deficiency Description: *Roof exhaust fan is approaching the end of its expected useful life.*

Comments: *Exhaust Fan*

Description of Work: *Provide equipment replacement and installation.*
