City of Cupertino

Facility Condition Assessment

Final Report

December 2, 2022

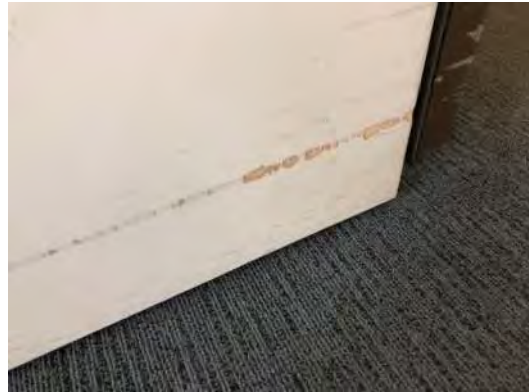
Item No.: C1030.10.008
Floor/Room: 1 / Conference Room - 141
Priority: 3
Quantity/Unit of Measure: 1/EA
Total Deficiency Cost: \$1,130
Deficiency Description: *Interior wood door is in visual need of refurbishment.*

Description of Work: *Refurbish and restain the wood door.*

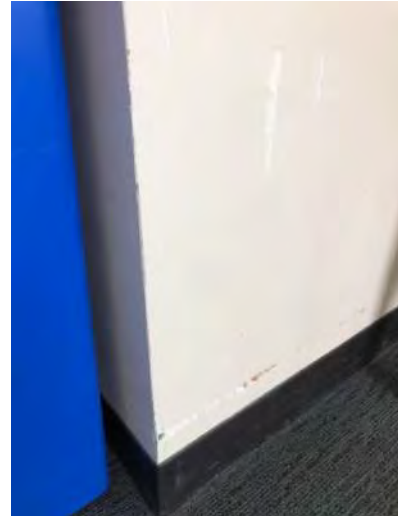
Item No.: C2010.30.004
Floor/Room: / General
Priority: 3
Quantity/Unit of Measure: 50,000/SF
Total Deficiency Cost: \$341,570
Deficiency Description: *Interior wall paint is in need of refresh.*

Description of Work: *Paint interior walls with 2 coat finish (includes surface prep and primer).*

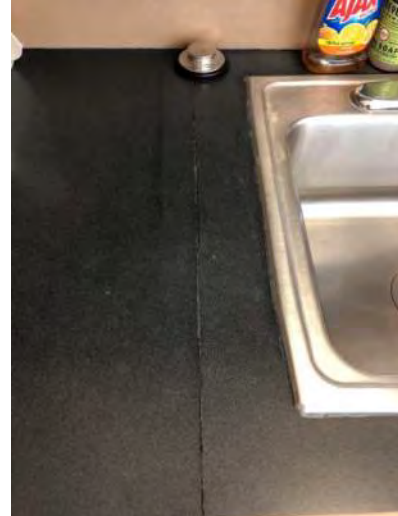
Item No.: E2010.30.001
Floor/Room: 1 / Break room - 123
Priority: 3
Quantity/Unit of Measure: 18/LF
Total Deficiency Cost: \$2,640
Deficiency Description: *Plastic laminate countertops are at or are approaching the end of their useful life.*

Comments: *Water damage at seam between countertops*

Description of Work: *Repair or replace plastic laminate countertops.*

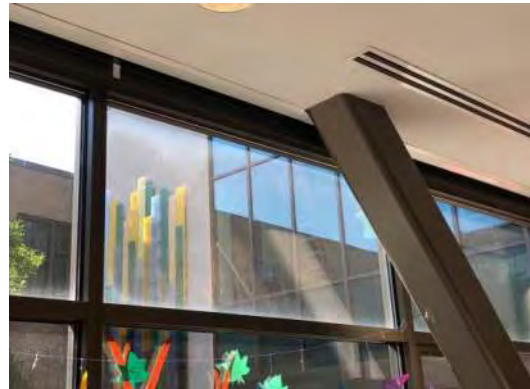
Item No.: B2020.20.004
Floor/Room: 1 / Seating - 113
Priority: 3
Quantity/Unit of Measure: 10/SF
Total Deficiency Cost: \$2,210
Deficiency Description: *Aluminum window is approaching/past its expected useful life.*

Comments: *Insulated glass is failing, discoloration and fogging*

Description of Work: *Replace aluminum window.*

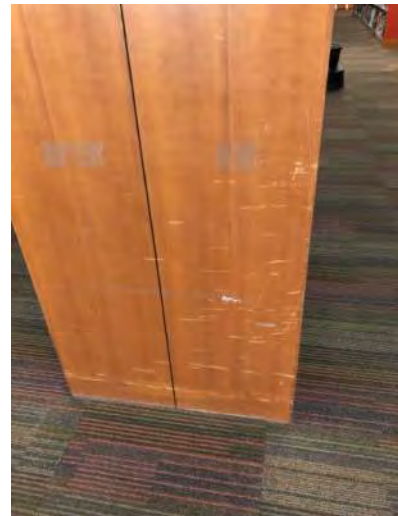
Item No.: E2010.30.005
Floor/Room: 1 / Children's Collection - 111
Priority: 4
Quantity/Unit of Measure: 400/LF
Total Deficiency Cost: \$303,020
Deficiency Description: *The existing casework is in need of refurbishment.*

Description of Work: *Repair, refurbish, and refinish the existing wood casework and counters.*

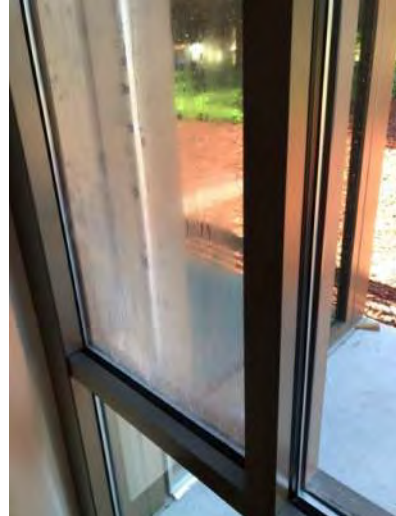
Item No.: B2020.20.004
Floor/Room: 1 / Story Time - 120
Priority: 3
Quantity/Unit of Measure: 8/SF
Total Deficiency Cost: \$1,660
Deficiency Description: *Aluminum window is approaching/past it's expected useful life.*

Comments: *Window failing, allowing water intrusion. Facilities Management noted 10 windows per year are being replaced, inspect origins of window failure.*

Description of Work: *Replace aluminum window.*

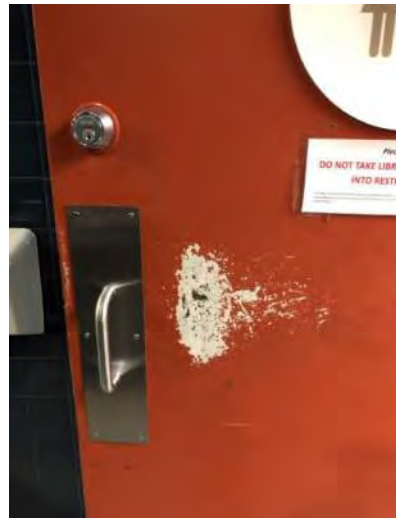
Item No.: C1030.10.009
Floor/Room: 2 / Bathroom - 208
Priority: 3
Quantity/Unit of Measure: 1/EA
Total Deficiency Cost: \$12,370
Deficiency Description: *Interior hollow metal door is in visual need of refurbishment.*

Description of Work: *Refurbish/repair interior hollow metal door.*

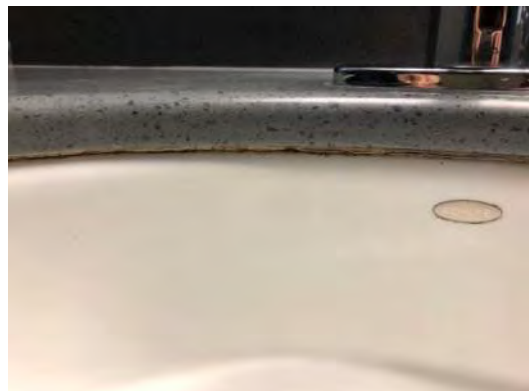
Item No.: D2010.60.030
Floor/Room: 2 / Bathroom - 208
Priority: 3
Quantity/Unit of Measure: 1/EA
Total Deficiency Cost: \$9,100
Deficiency Description: *Porcelain sink is approaching the end of its expected useful life.*

Description of Work: *Provide equipment replacement and installation.*

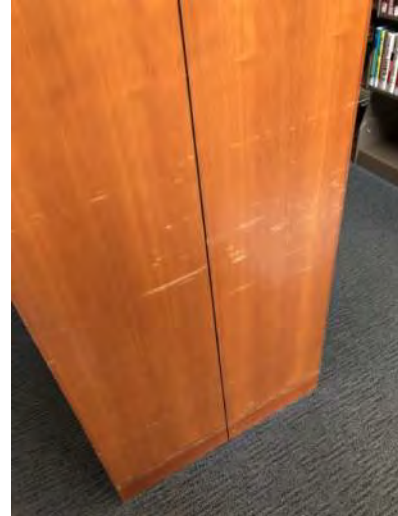
Deficiency Description: *The existing casework is in need of refurbishment.*

Description of Work: *Repair, refurbish, and refinish the existing wood casework and counters.*

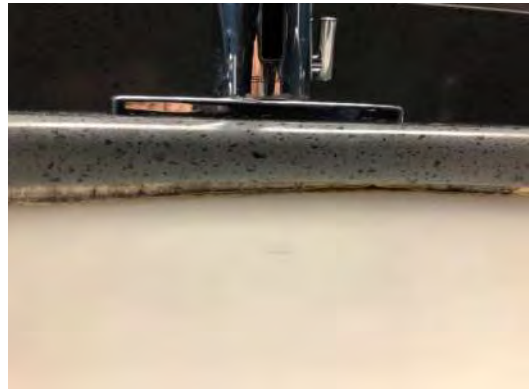
Deficiency Description: *Porcelain sink is approaching the end of its expected useful life.*

Description of Work: *Provide equipment replacement and installation.*

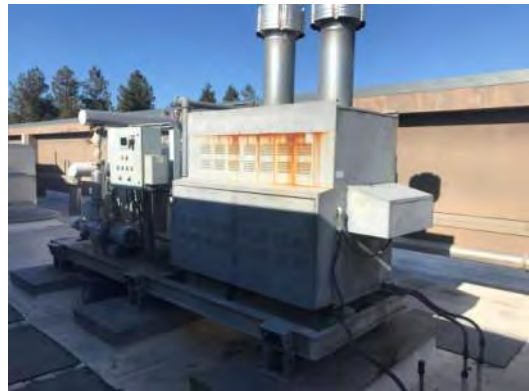
Record ID: 56
System: D3020 - HEATING SYSTEMS
Item No.: D3020.10.002
Floor/Room: 1
Priority: 3
Quantity/Unit of Measure: 1/EA
Total Deficiency Cost: \$94,490
Deficiency Description: *Boiler is approaching the end of its expected useful life.*
Description of Work: *Provide equipment replacement and installation.*
Comments: *Boiler*

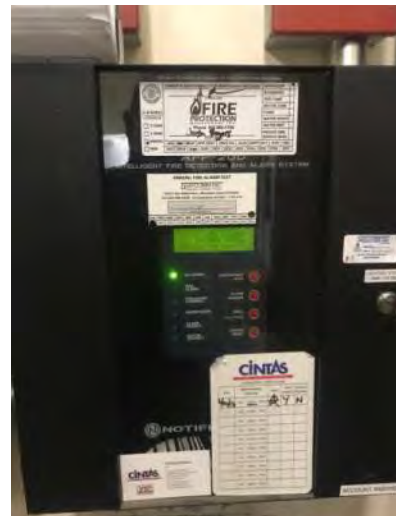
Record ID: 62
System: D7050 - DETECTION AND ALARM
Item No.: D7050.10.025
Floor/Room: 1
Priority: 1
Quantity/Unit of Measure: 54,000/SF
Total Deficiency Cost: \$1,077,530
Deficiency Description: *The existing fire alarm system is approaching the end of its useful life and should be replaced.*
Description of Work: *Replace the existing fire alarm system with a complete, site-wide, fully addressable fire alarm system.*
Comments: *Fire Alarm Panel*

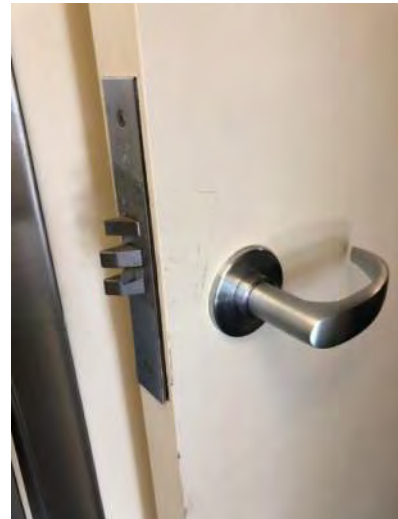
Item No.: C1030.90.005
Floor/Room: 1 / Storage - 127
Priority: 3
Quantity/Unit of Measure: 1/EA
Total Deficiency Cost: \$1,280
Deficiency Description: *Interior door hardware is at or approaching the end of its useful life.*

Description of Work: *Replace interior door hardware.*

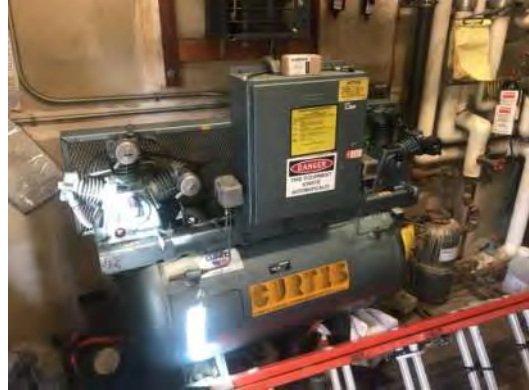
Air Compressor

Comments: *Pneumatic control system for building HVAC. Inefficient. Recommend moving to electric controls.*

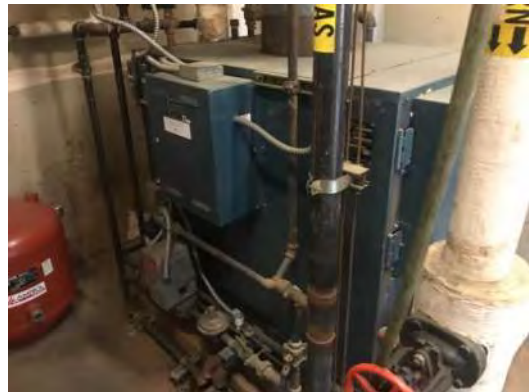
Boiler

Record ID: 339
System: D3020 - HEATING SYSTEMS
Item No.: D3020.10.002
Floor/Room: 1
Priority: 2
Quantity/Unit of Measure: 1/EA
Total Deficiency Cost: \$90,480
Deficiency Description: *Boiler is approaching the end of its expected useful life.*

Comments: *Reported in 2018 FCA that equipment is unreliable.*

Description of Work: *Provide equipment replacement and installation.*

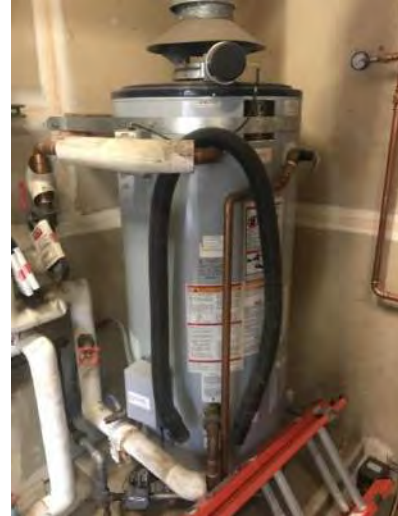
Comments: *Water Heater*

Description of Work: *Provide equipment replacement and installation.*

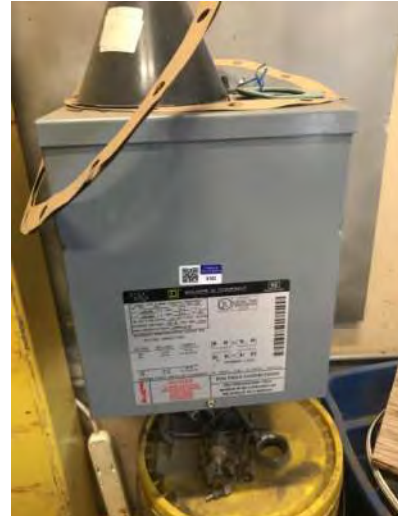
Item No.: D5020.10.202
Floor/Room: 1
Priority: 5
Quantity/Unit of Measure: 1/EA
Total Deficiency Cost: \$8,530
Deficiency Description: *The 7.5kVA transformer is past its approaching the end of its expected useful life.*

Comments: *Transformer*

Description of Work: *Replace the existing transformer with a new transformer.*

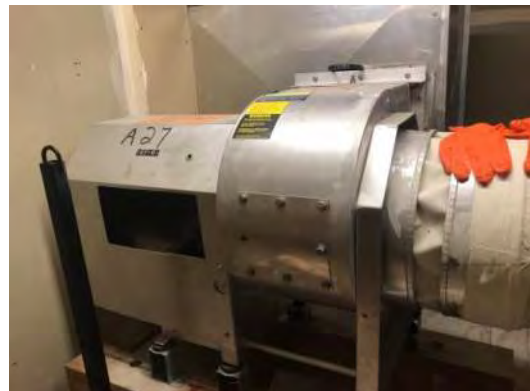
Item No.: D3060.30.011
Floor/Room: 1
Priority: 4
Quantity/Unit of Measure: 1/EA
Total Deficiency Cost: \$18,970
Deficiency Description: *Utility exhaust fan is approaching the end of its expected useful life.*

Comments: *Exhaust Fan*

Description of Work: *Provide equipment replacement and installation.*

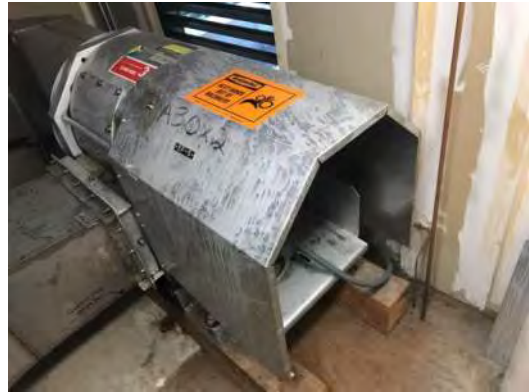
Comments: *Exhaust Fan*

Description of Work: *Provide equipment replacement and installation.*

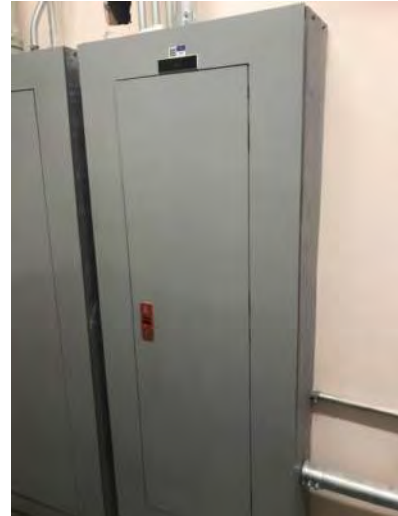
Item No.: D5020.30.1008
Floor/Room: 1
Priority: 3
Quantity/Unit of Measure: 1/EA
Total Deficiency Cost: \$21,020
Deficiency Description: *The 225A (120/208, 3P) panelboard is past its expected useful life.*

Comments: *Panelboard*

Description of Work: *Replace the existing panelboard with a new panelboard.*

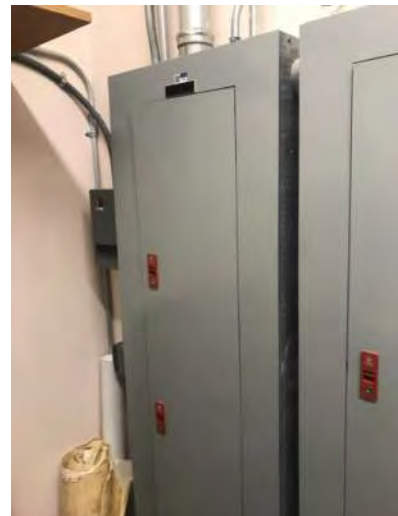
Item No.: D5020.30.1008
Floor/Room: 1
Priority: 3
Quantity/Unit of Measure: 1/EA
Total Deficiency Cost: \$21,020
Deficiency Description: *The 225A (120/208, 3P) panelboard is past its expected useful life.*

Comments: *Panelboard*

Description of Work: *Replace the existing panelboard with a new panelboard.*

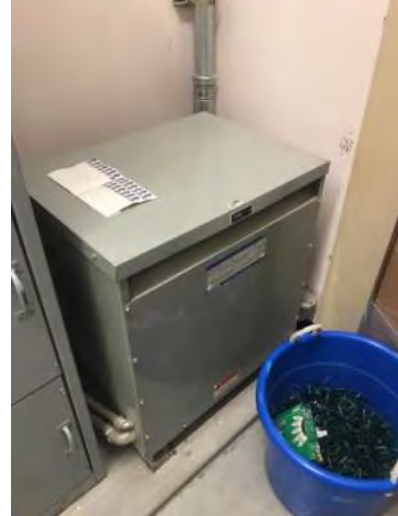
Record ID: 354
System: D5020 - ELECTRICAL SERVICE AND DISTRIBUTION
Item No.: D5020.10.217
Floor/Room: 1
Priority: 3
Quantity/Unit of Measure: 1/EA
Total Deficiency Cost: \$18,730
Deficiency Description: *The 75kVA transformer (3P dry-type, 480-120/208V) is past its expected useful life.*
Description of Work: *Replace the existing transformer with a new transformer.*
Comments: *Transformer*

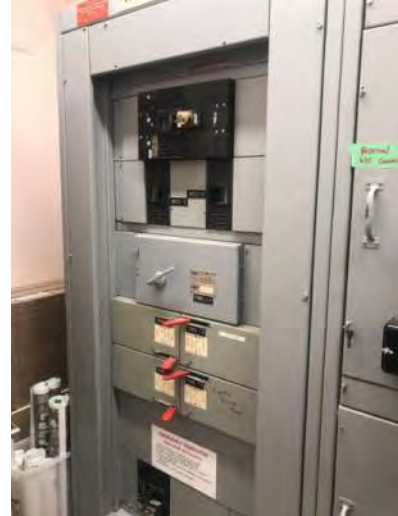
Record ID: 355
System: D5020 - ELECTRICAL SERVICE AND DISTRIBUTION
Item No.: D5020.10.311
Floor/Room: 1
Priority: 3
Quantity/Unit of Measure: 1/EA
Total Deficiency Cost: \$24,150
Deficiency Description: *The 800A metered main switchboard (3P, 277/480) is past its expected useful life.*
Description of Work: *Replace the existing metered main switchboard with a new metered main switchboard.*
Comments: *Switchboard*

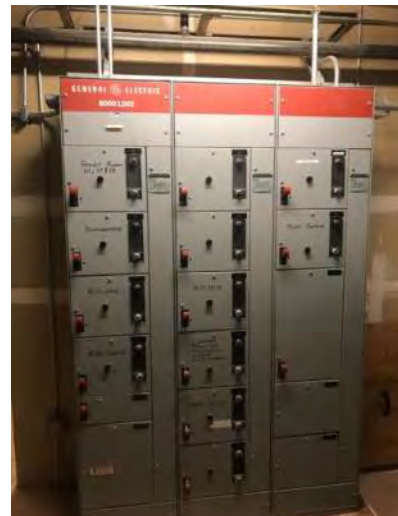
Record ID: 359
System: D5020 - ELECTRICAL SERVICE AND DISTRIBUTION
Item No.: D5020.30.2001
Floor/Room: 1
Priority: 3
Quantity/Unit of Measure: 480/AMP
Total Deficiency Cost: \$69,790
Deficiency Description: *The motor control center is past its expected useful life.*
Description of Work: *Replace the existing motor control center with a new motor control center.*
Comments: *Motor Control Center*

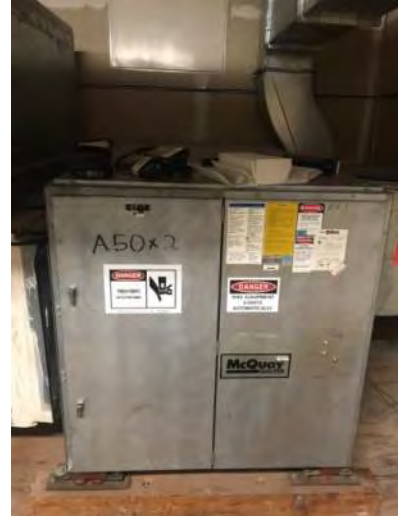
Item No.: D3030.70.012
Floor/Room: 1
Priority: 2
Quantity/Unit of Measure: 1/EA
Total Deficiency Cost: \$18,120
Deficiency Description: *Fan coil unit is approaching the end of its expected useful life.*

Comments: *Fan Coil Unit*

Description of Work: *Provide equipment replacement and installation.*

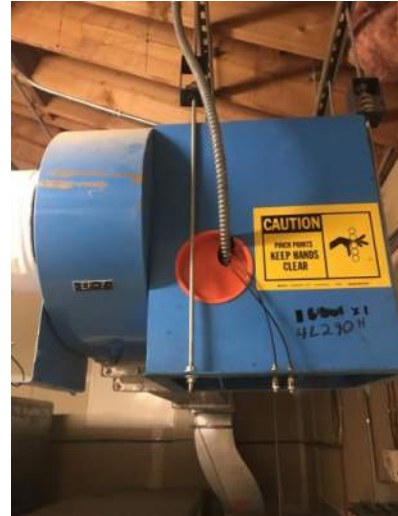
Record ID: 362
System: D3060 - VENTILATION

Item No.: D3060.30.011
Floor/Room: 1
Priority: 4
Quantity/Unit of Measure: 1/EA
Total Deficiency Cost: \$18,970
Deficiency Description: *Utility exhaust fan is approaching the end of its expected useful life.*

Comments: *Exhaust Fan*

Description of Work: *Provide equipment replacement and installation.*

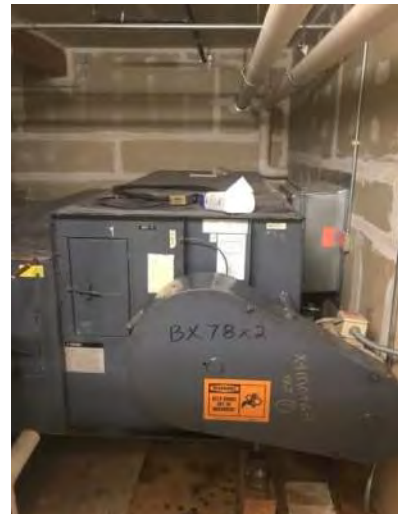
Record ID: 363
System: D3050 - FACILITY HVAC DISTRIBUTION SYSTEMS

Item No.: D3050.50.006
Floor/Room: 1
Priority: 2
Quantity/Unit of Measure: 1/EA
Total Deficiency Cost: \$78,310
Deficiency Description: *Air handler is approaching the end of its expected useful life.*

Comments: *Reported in 2018 FCA that equipment is unreliable.*

Description of Work: *Provide equipment replacement and installation.*

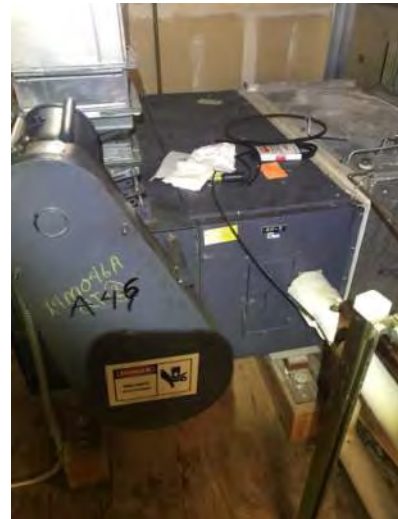
Record ID: 365
System: D3050 - FACILITY HVAC DISTRIBUTION SYSTEMS
Item No.: D3050.50.006
Floor/Room: 1
Priority: 2
Quantity/Unit of Measure: 1/EA
Total Deficiency Cost: \$78,310
Deficiency Description: *Air handler is approaching the end of its expected useful life.*

Comments: *Reported in 2018 FCA that equipment is unreliable.*
Air Handler

Description of Work: *Provide equipment replacement and installation.*

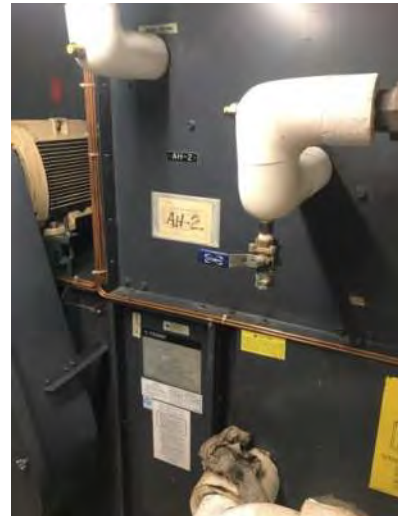
Record ID: 366
System: D3050 - FACILITY HVAC DISTRIBUTION SYSTEMS
Item No.: D3050.50.006
Floor/Room: 1
Priority: 2
Quantity/Unit of Measure: 1/EA
Total Deficiency Cost: \$78,310
Deficiency Description: *Air handler is approaching the end of its expected useful life.*

Comments: *Reported in 2018 FCA that equipment is unreliable.*
Air Handler

Description of Work: *Provide equipment replacement and installation.*

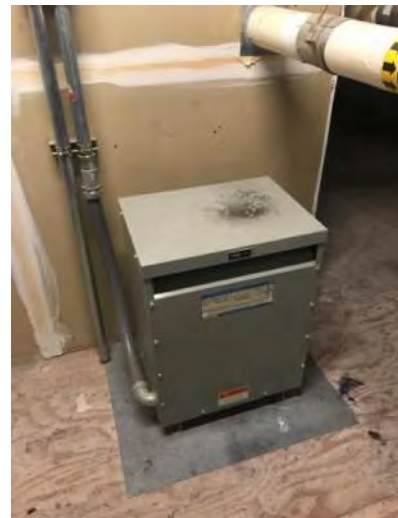
Record ID: 367
System: D5020 - ELECTRICAL SERVICE AND DISTRIBUTION
Item No.: D5020.10.215
Floor/Room: 1
Priority: 3
Quantity/Unit of Measure: 1/EA
Total Deficiency Cost: \$12,670
Deficiency Description: *The 30kVA transformer is past its expected useful life.*

Comments: *Transformer*

Description of Work: *Replace the existing transformer with a new transformer.*

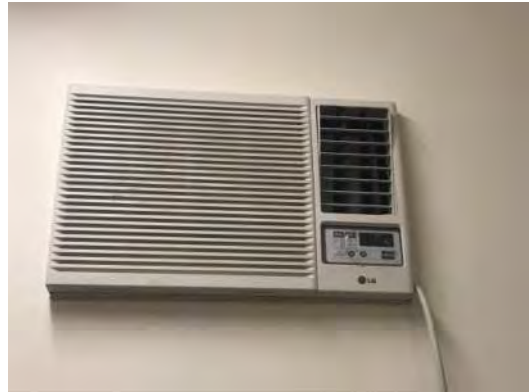
Item No.: D3030.70.032
Floor/Room: 1
Priority: 5
Quantity/Unit of Measure: 1/EA
Total Deficiency Cost: \$7,890
Deficiency Description: *Wall mounted AC unit is approaching the end of its expected useful life.*

Comments: *Air Conditioner - Wall Mounted*

Description of Work: *Provide equipment replacement and installation.*

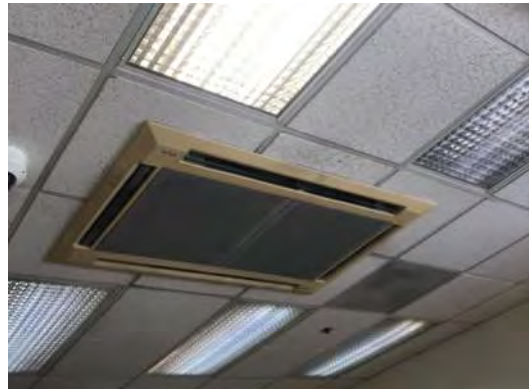
Record ID: 374
System: D3030 - COOLING SYSTEMS

Item No.: D3030.70.014
Floor/Room: 1
Priority: 2
Quantity/Unit of Measure: 1/EA
Total Deficiency Cost: \$26,120
Deficiency Description: *Fan coil unit is approaching the end of its expected useful life.*

Description of Work: *Provide equipment replacement and installation.*

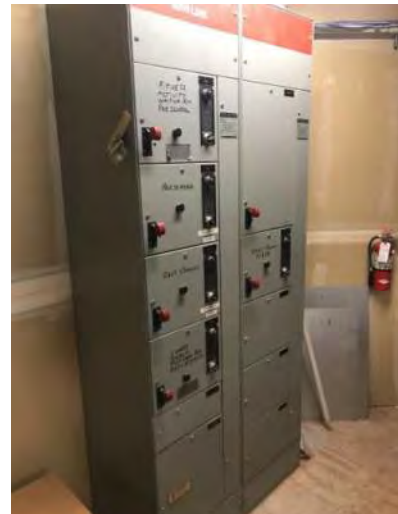
Record ID: 375
System: D5020 - ELECTRICAL SERVICE AND DISTRIBUTION

Item No.: D5020.30.2001
Floor/Room: 1
Priority: 3
Quantity/Unit of Measure: 480/AMP
Total Deficiency Cost: \$69,790
Deficiency Description: *The motor control center is past its expected useful life.*

Comments: *Motor Control Center*

Description of Work: *Replace the existing motor control center with a new motor control center.*

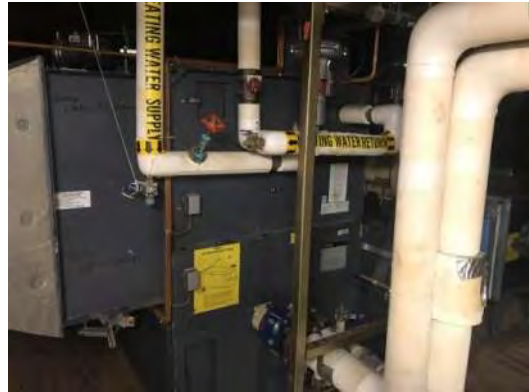
Record ID 377
System D3050 - FACILITY HVAC DISTRIBUTION SYSTEMS
Item No. D3050.50.006
Floor/Room: 1
Priority: 2
Quantity/Unit of Measure: 1/EA
Total Deficiency Cost: \$78,310
Deficiency Description: *Air handler is approaching the end of its expected useful life.*

Comments: *Reported in 2018 FCA that equipment is unreliable.*
Air Handler

Description of Work: *Provide equipment replacement and installation.*

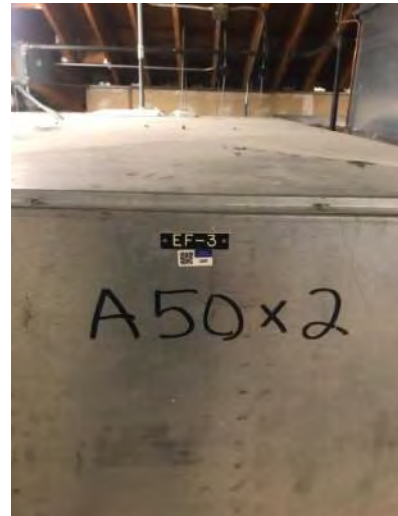
Record ID 378
System D3060 - VENTILATION
Item No. D3060.30.005
Floor/Room: 1
Priority: 2
Quantity/Unit of Measure: 1/EA
Total Deficiency Cost: \$7,680
Deficiency Description: *Roof exhaust fan is approaching the end of its expected useful life.*

Comments: *Exhaust Fan*

Description of Work: *Provide equipment replacement and installation.*

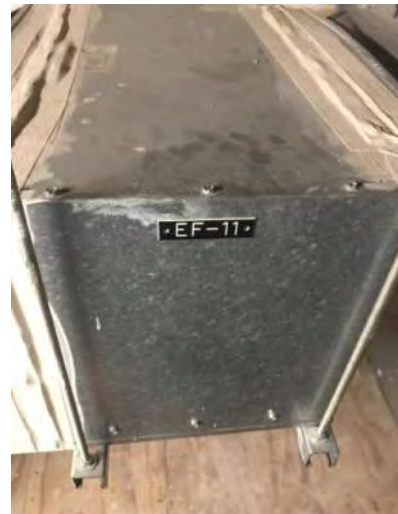
Record ID 380
System D3060 - VENTILATION
Item No. D3060.30.009
Floor/Room: 1
Priority: 4
Quantity/Unit of Measure: 1/EA
Total Deficiency Cost: \$35,430
Deficiency Description: *In-Line building exhaust fan is approaching the end of its expected useful life.*

Comments: *Exhaust Fan*

Description of Work: *Provide equipment replacement and installation.*

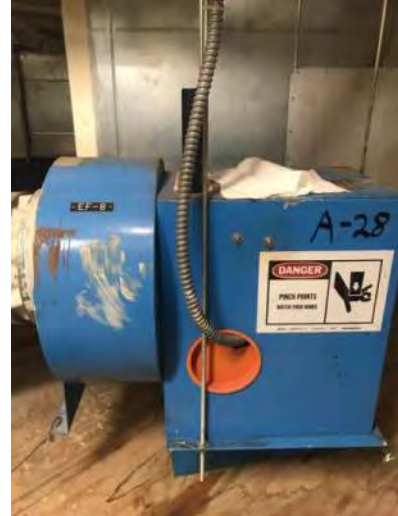
Item No.: D3060.30.011
Floor/Room: 1
Priority: 4
Quantity/Unit of Measure: 1/EA
Total Deficiency Cost: \$18,970
Deficiency Description: *Utility exhaust fan is approaching the end of its expected useful life.*

Comments: *Exhaust Fan*

Description of Work: *Provide equipment replacement and installation.*

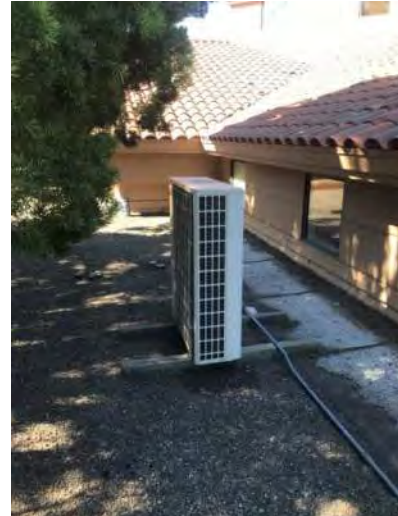
Record ID: 384
System: D3030 - COOLING SYSTEMS

Item No.: D3030.70.042
Floor/Room: Roof
Priority: 3
Quantity/Unit of Measure: 1/EA
Total Deficiency Cost: \$26,980
Deficiency Description: *Split system with fan coil and outdoor condensing unit is approaching the end of its expected useful life.*

Comments: *HVAC - Split System*

Description of Work: *Provide equipment replacement and installation.*

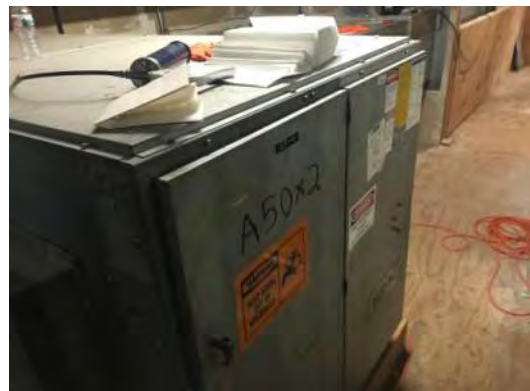
Record ID: 389
System: D3060 - VENTILATION

Item No.: D3060.30.009
Floor/Room: 1
Priority: 2
Quantity/Unit of Measure: 1/EA
Total Deficiency Cost: \$32,550
Deficiency Description: *In-Line building exhaust fan is approaching the end of its expected useful life.*

Comments: *Exhaust Fan*

Description of Work: *Provide equipment replacement and installation.*

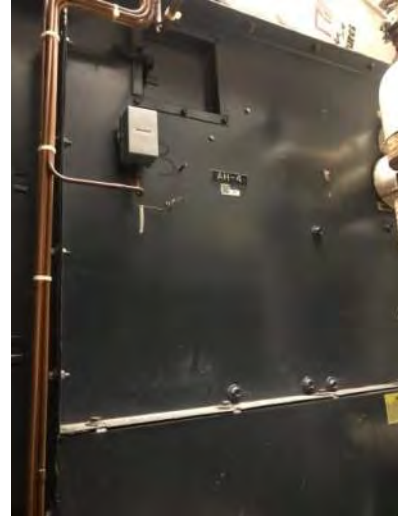
Record ID: 390
System: D3050 - FACILITY HVAC DISTRIBUTION SYSTEMS
Item No.: D3050.50.006
Floor/Room: 1
Priority: 2
Quantity/Unit of Measure: 1/EA
Total Deficiency Cost: \$78,310
Deficiency Description: *Air handler is approaching the end of its expected useful life.*

Comments: *Reported in 2018 FCA that equipment is unreliable.*
Air Handler

Description of Work: *Provide equipment replacement and installation.*

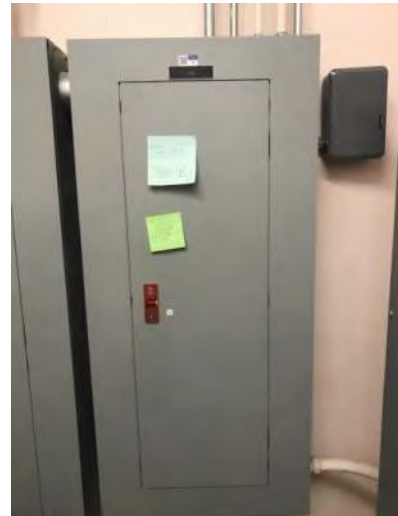
Record ID: 392
System: D5020 - ELECTRICAL SERVICE AND DISTRIBUTION
Item No.: D5020.30.1008
Floor/Room: 1
Priority: 3
Quantity/Unit of Measure: 1/EA
Total Deficiency Cost: \$21,020
Deficiency Description: *The 225A (120/208, 3P) panelboard is past its expected useful life.*

Comments: *Panelboard*

Description of Work: *Replace the existing panelboard with a new panelboard.*

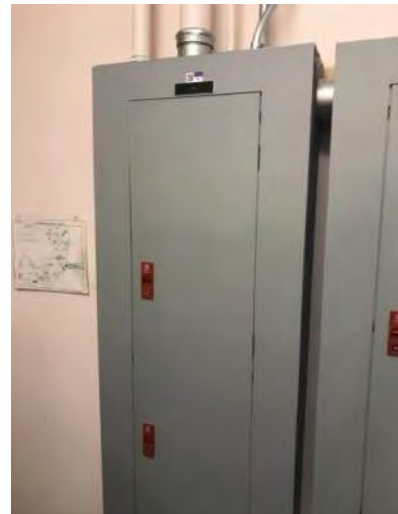
Record ID: 393
System: D5020 - ELECTRICAL SERVICE AND DISTRIBUTION
Item No.: D5020.30.1008
Floor/Room: 1
Priority: 3
Quantity/Unit of Measure: 1/EA
Total Deficiency Cost: \$21,020
Deficiency Description: *The 225A (120/208, 3P) panelboard is past its expected useful life.*

Comments: *Panelboard*

Description of Work: *Replace the existing panelboard with a new panelboard.*

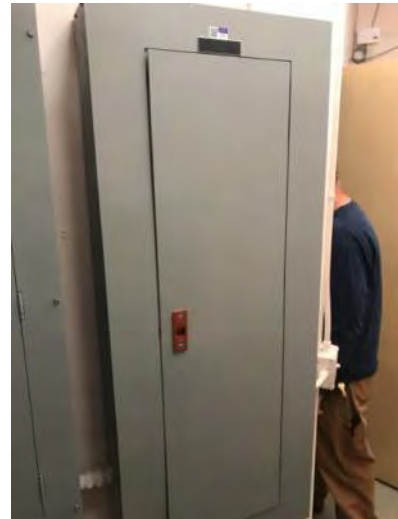
Record ID: 394
System: D5020 - ELECTRICAL SERVICE AND DISTRIBUTION
Item No.: D5020.30.1012
Floor/Room: 1
Priority: 3
Quantity/Unit of Measure: 1/EA
Total Deficiency Cost: \$29,690
Deficiency Description: *The 225A (277/480, 3P) panelboard is past its expected useful life.*
Description of Work: *Replace the existing panelboard with a new panelboard.*
Comments: *Panelboard*

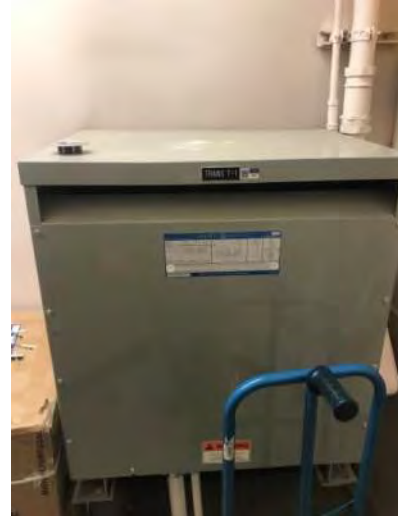
Record ID: 395
System: D5020 - ELECTRICAL SERVICE AND DISTRIBUTION
Item No.: D5020.10.217
Floor/Room: 1
Priority: 3
Quantity/Unit of Measure: 1/EA
Total Deficiency Cost: \$18,730
Deficiency Description: *The 75kVA transformer (3P dry-type, 480-120/208V) is past expected useful life.*
Description of Work: *Replace the existing transformer with a new transformer.*
Comments: *Transformer*

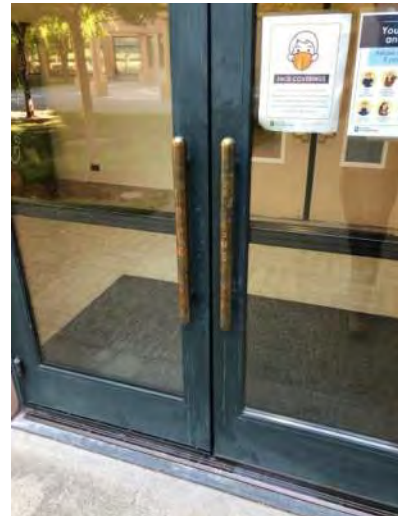
Record ID: 489
System: B2050 - EXTERIOR DOORS AND GRILLES
Item No.: B2050.10.002
Floor/Room: 1 / Exterior doors
Priority: 4
Quantity/Unit of Measure: 35/EA
Total Deficiency Cost: \$357,950
Deficiency Description: *Exterior aluminum (storefront) entrance door is approaching the end of its useful life.*
Description of Work: *Replace aluminum door (storefront).*
Comments:

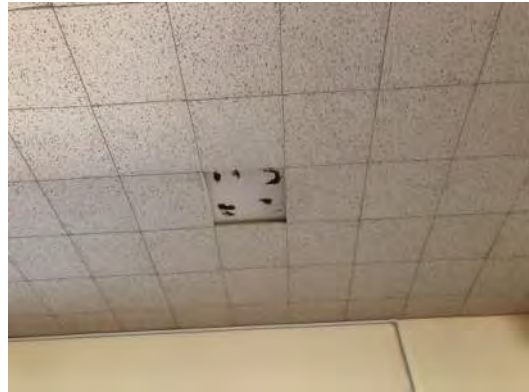
Record ID: 495
System: C2050 - CEILING FINISHES

Item No.: C2050.80.003
Floor/Room: 1 / Cupertino Room
Priority: 3
Quantity/Unit of Measure: 4,000/SF
Total Deficiency Cost: \$123,550
Deficiency Description: *Glue-On Acoustical Ceiling Tile is in poor condition.*

Description of Work: *Remove existing Glue-On Acoustical and replace with new Glue-On Acoustical Tiles.*

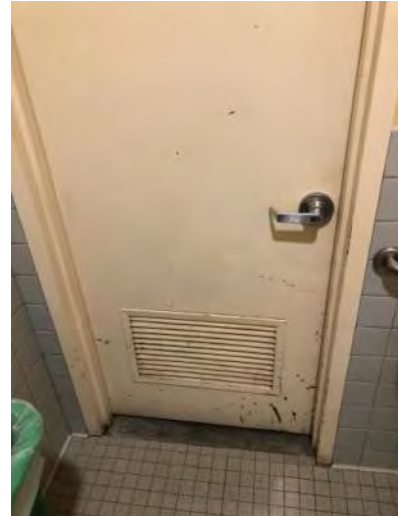
Record ID: 497
System: C1030 - INTERIOR DOORS

Item No.: C1030.10.009
Floor/Room: 1 / Restroom(s)
Priority: 3
Quantity/Unit of Measure: 6/EA
Total Deficiency Cost: \$74,140
Deficiency Description: *Interior hollow metal door is in visual need of refurbishment.*

Description of Work: *Refurbish/repair interior hollow metal door.*

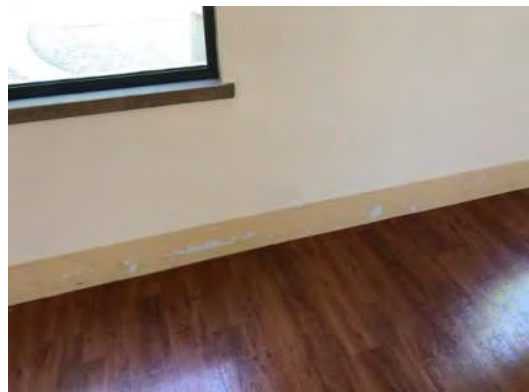
Record ID: 498
System: C2030 - FLOORING

Item No.: C2030.90.002
Floor/Room: 1 / Cupertino Room
Priority: 3
Quantity/Unit of Measure: 275/LF
Total Deficiency Cost: \$7,230
Deficiency Description: *Wood wall base is approaching the end of its useful life.*

Description of Work: *Replace the wood wall base.*

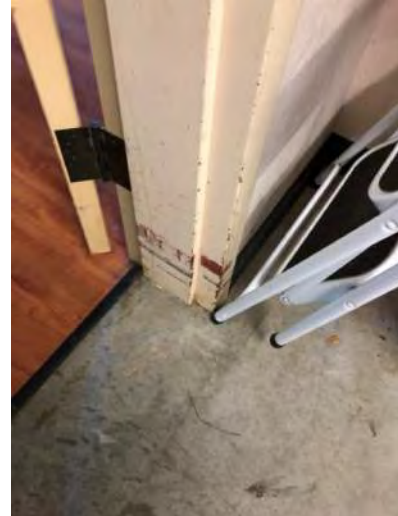
Item No.: C1030.90.001
Floor/Room: 1 / Storage
Priority: 3
Quantity/Unit of Measure: 1/EA
Total Deficiency Cost: \$11,650
Deficiency Description: *Door frames are approaching the end of their useful life.*

Description of Work: *Replace the door frames with a pressed metal frame.*

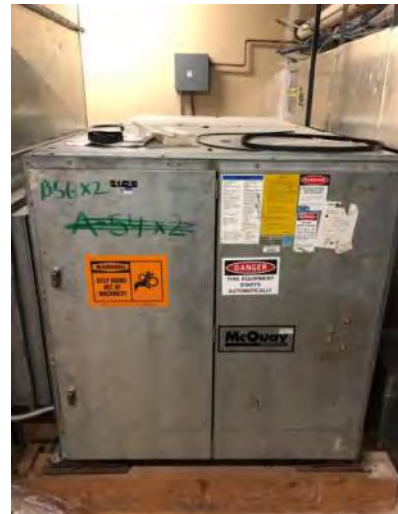
Record ID: 502
System: D3050 - FACILITY HVAC DISTRIBUTION SYSTEMS

Item No.: D3050.50.006
Floor/Room: Roof / EF 2
Priority: 2
Quantity/Unit of Measure: 1/EA
Total Deficiency Cost: \$78,310
Deficiency Description: *Air handler unit is approaching the end of its expected useful life.*

Comments: *Air Handler*

Description of Work: *Provide equipment replacement and installation.*

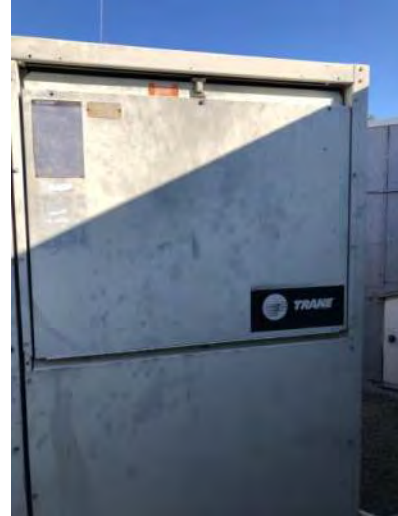
Item No.: D3030.10.013
Floor/Room: Roof / Trane Chiller
Priority: 1
Quantity/Unit of Measure: 1/EA
Total Deficiency Cost: \$73,180
Deficiency Description: *Chiller is approaching the end of its expected useful life.*

Comments: *Chiller*

Description of Work: *Provide equipment replacement and installation.*

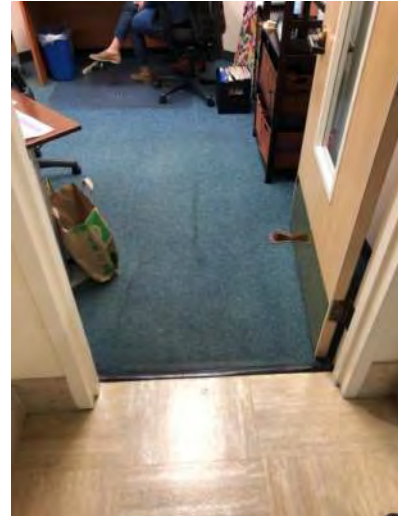
Record ID: 510
System: C2030 - FLOORING

Item No.: C2030.75.002
Floor/Room: 1
Priority: 3
Quantity/Unit of Measure: 1,200/SF
Total Deficiency Cost: \$34,910
Deficiency Description: *Rolled carpeting is approaching the end of its useful life.*

Description of Work: *Remove existing rolled carpeting and replace it with new 40 oz. nylon carpet.*

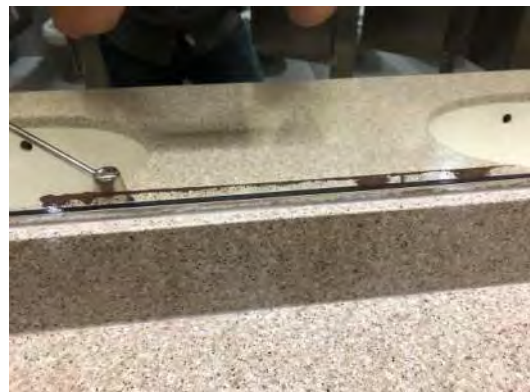
Record ID: 512
System: E2010 - FIXED FURNISHINGS

Item No.: E2010.90.001
Floor/Room: 1 / Restroom(s)
Priority: 3
Quantity/Unit of Measure: 70/SF
Total Deficiency Cost: \$7,650
Deficiency Description: *Mirror is damaged.*

Description of Work: *Remove and replace mirror.*

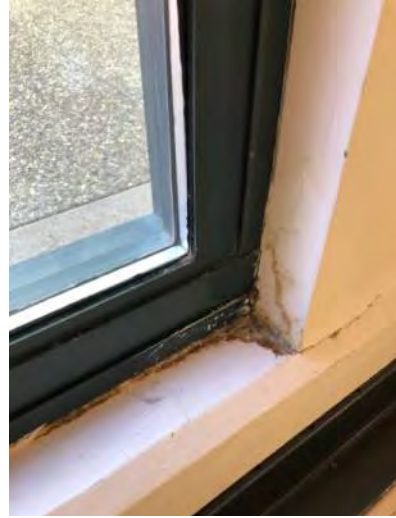
Item No.: B2020.20.004
Floor/Room: / Varies
Priority: 3
Quantity/Unit of Measure: 6,000/SF
Total Deficiency Cost: \$1,308,120
Deficiency Description: *Aluminum window is approaching/past it's expected useful life.*

Comments: *Water Intrusion/damage noted at exterior windows.*

Description of Work: *Replace aluminum window.*

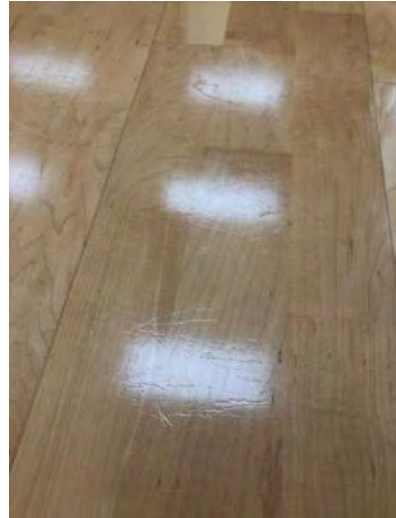
Record ID: 520
System: C2030 - FLOORING

Item No.: C2030.45.001
Floor/Room: 1 / Activity room
Priority: 3
Quantity/Unit of Measure: 3,400/SF
Total Deficiency Cost: \$40,170
Deficiency Description: *Wood flooring shows signs of wear.*

Description of Work: *Sand, repair and refinish the wood flooring.*

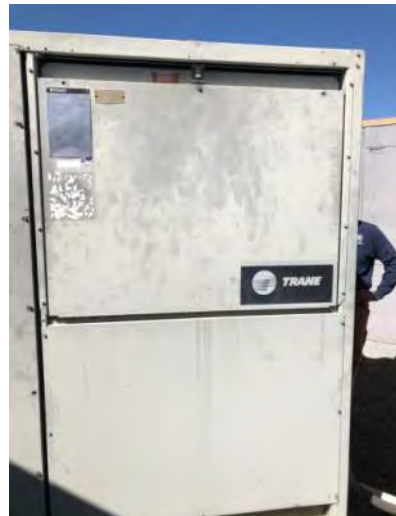
Record ID: 522
System: D3050 - FACILITY HVAC DISTRIBUTION SYSTEMS

Item No.: D3050.50.006
Floor/Room: 1
Priority: 2
Quantity/Unit of Measure: 1/EA
Total Deficiency Cost: \$78,310
Deficiency Description: *Air handler is approaching the end of its expected useful life.*

Comments: *Air Handler*

Description of Work: *Provide equipment replacement and installation.*

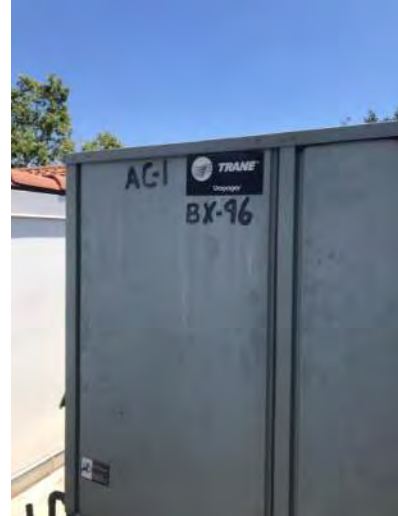
Comments: *Packaged Unit*

Description of Work: *Provide equipment replacement and installation.*

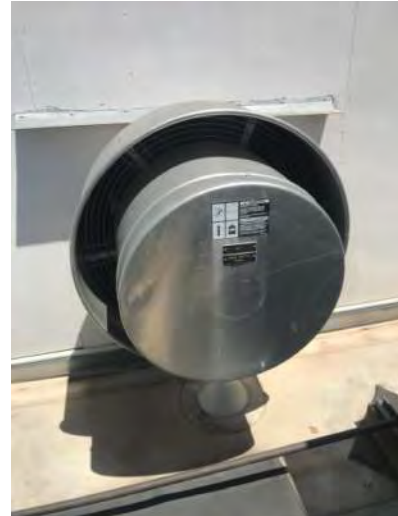
Record ID: 443
System: D3060 - VENTILATION

Item No.: D3060.30.005
Floor/Room: Roof
Priority: 4
Quantity/Unit of Measure: 1/EA
Total Deficiency Cost: \$8,360
Deficiency Description: *Roof exhaust fan is approaching the end of its expected useful life.*

Comments: *Exhaust Fan*

Description of Work: *Provide equipment replacement and installation.*

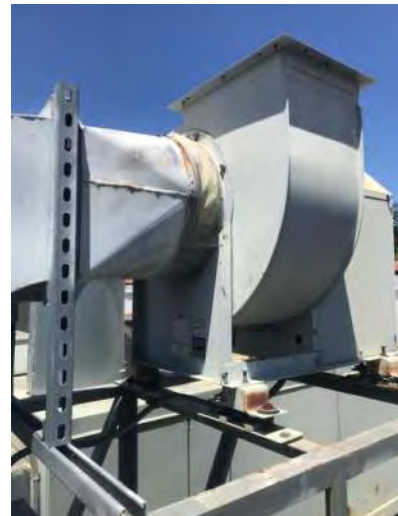
Record ID: 444
System: D3060 - VENTILATION

Item No.: D3060.30.011
Floor/Room: Roof
Priority: 4
Quantity/Unit of Measure: 1/EA
Total Deficiency Cost: \$18,970
Deficiency Description: *Utility exhaust fan is approaching the end of its expected useful life.*

Comments: *Exhaust Fan*

Description of Work: *Provide equipment replacement and installation.*

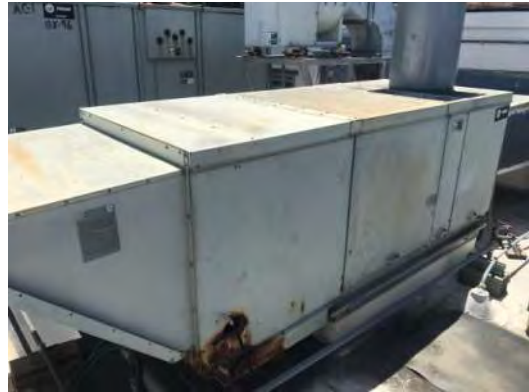
Record ID 445
System D3050 - FACILITY HVAC DISTRIBUTION SYSTEMS
Item No. D3050.50.006
Floor/Room: Roof
Priority: 2
Quantity/Unit of Measure: 1/EA
Total Deficiency Cost: \$78,310
Deficiency Description: *Air handler is approaching the end of its expected useful life.*
Description of Work: *Provide equipment replacement and installation.*
Comments: *Air Handler*

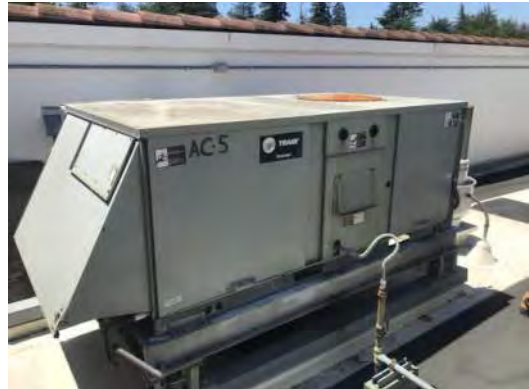
Record ID 446
System D3030 - COOLING SYSTEMS
Item No. D3030.10.018
Floor/Room: Roof
Priority: 2
Quantity/Unit of Measure: 1/EA
Total Deficiency Cost: \$52,230
Deficiency Description: *Packaged AC unit is approaching the end of its expected useful life.*
Description of Work: *Provide equipment replacement and installation.*
Comments: *Packaged Unit*

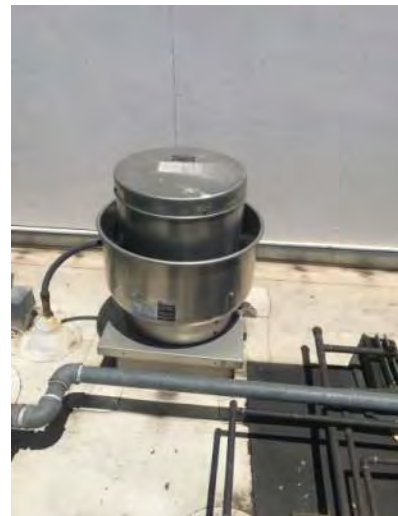
Record ID 447
System D3060 - VENTILATION
Item No. D3060.30.005
Floor/Room: Roof
Priority: 4
Quantity/Unit of Measure: 1/EA
Total Deficiency Cost: \$8,360
Deficiency Description: *Roof exhaust fan is approaching the end of its expected useful life.*
Description of Work: *Provide equipment replacement and installation.*
Comments: *Exhaust Fan*

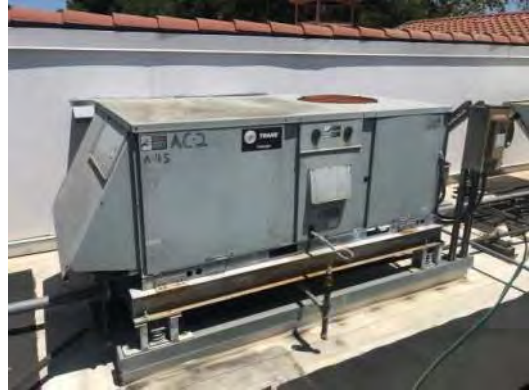
Item No.: D3030.10.018
Floor/Room: Roof
Priority: 2
Quantity/Unit of Measure: 1/EA
Total Deficiency Cost: \$52,230
Deficiency Description: *Packaged AC unit is approaching the end of its expected useful life.*

Comments: *Packaged Unit*

Description of Work: *Provide equipment replacement and installation.*

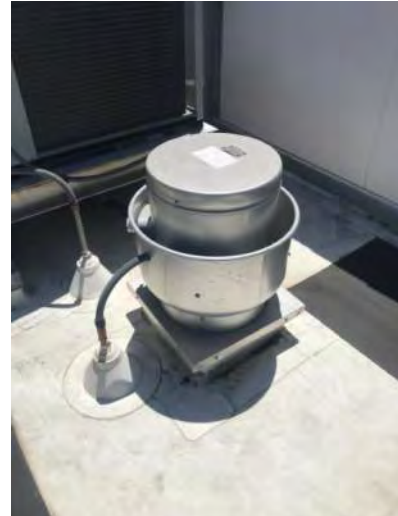
Record ID: 449
System: D3060 - VENTILATION

Item No.: D3060.30.005
Floor/Room: Roof
Priority: 4
Quantity/Unit of Measure: 1/EA
Total Deficiency Cost: \$8,360
Deficiency Description: *Roof exhaust fan is approaching the end of its expected useful life.*

Comments: *Exhaust Fan*

Description of Work: *Provide equipment replacement and installation.*

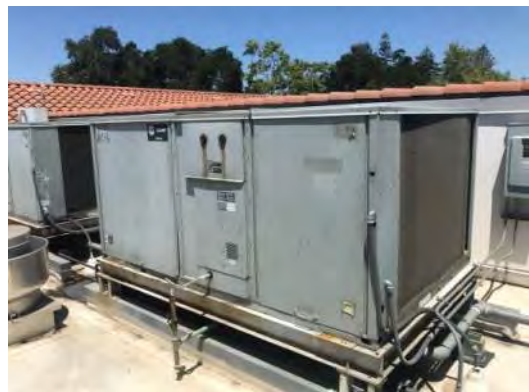
Record ID: 450
System: D3030 - COOLING SYSTEMS

Item No.: D3030.10.019
Floor/Room: Roof
Priority: 2
Quantity/Unit of Measure: 1/EA
Total Deficiency Cost: \$87,030
Deficiency Description: *Packaged AC unit is approaching the end of its expected useful life.*

Comments: *Packaged Unit*

Description of Work: *Provide equipment replacement and installation.*

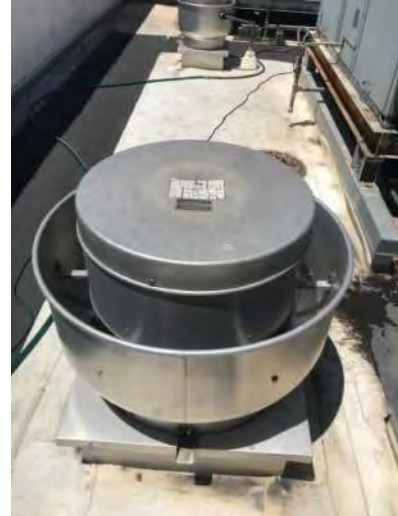
Item No.: D3060.30.005
Floor/Room: Roof
Priority: 4
Quantity/Unit of Measure: 1/EA
Total Deficiency Cost: \$8,360
Deficiency Description: *Roof exhaust fan is approaching the end of its expected useful life.*

Comments: *Exhaust Fan*

Description of Work: *Provide equipment replacement and installation.*

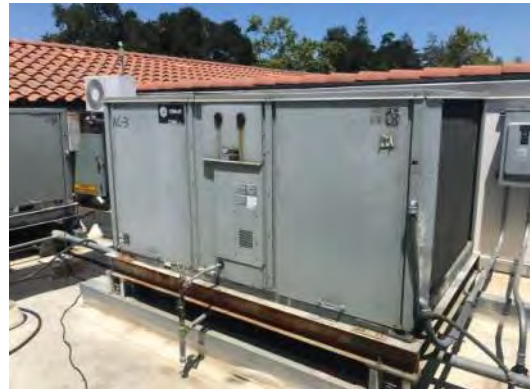
Record ID: 452
System: D3030 - COOLING SYSTEMS

Item No.: D3030.10.019
Floor/Room: Roof
Priority: 2
Quantity/Unit of Measure: 1/EA
Total Deficiency Cost: \$87,030
Deficiency Description: *Packaged AC unit is approaching the end of its expected useful life.*

Comments: *Packaged Unit*

Description of Work: *Provide equipment replacement and installation.*

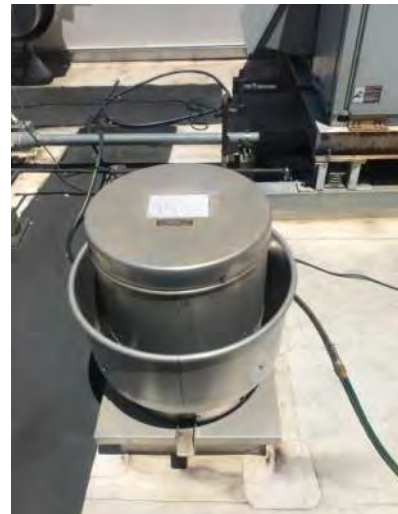
Record ID: 453
System: D3060 - VENTILATION

Item No.: D3060.30.005
Floor/Room: Roof
Priority: 4
Quantity/Unit of Measure: 1/EA
Total Deficiency Cost: \$8,360
Deficiency Description: *Roof exhaust fan is approaching the end of its expected useful life.*

Comments: *Exhaust Fan*

Description of Work: *Provide equipment replacement and installation.*

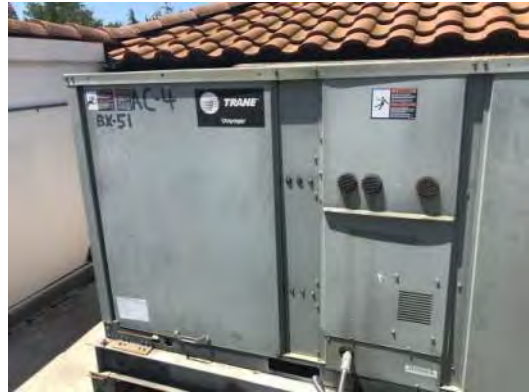
Item No.: D3030.10.019
Floor/Room: Roof
Priority: 2
Quantity/Unit of Measure: 1/EA
Total Deficiency Cost: \$87,030
Deficiency Description: *Packaged AC unit is approaching the end of its expected useful life.*

Comments: *Packaged Unit*

Description of Work: *Provide equipment replacement and installation.*

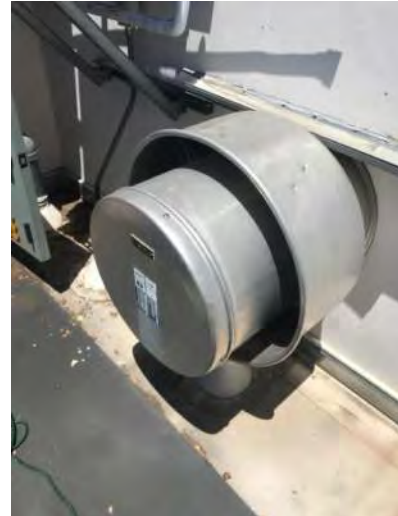
Record ID: 455
System: D3060 - VENTILATION

Item No.: D3060.30.005
Floor/Room: Roof
Priority: 4
Quantity/Unit of Measure: 1/EA
Total Deficiency Cost: \$8,360
Deficiency Description: *Roof exhaust fan is approaching the end of its expected useful life.*

Comments: *Exhaust Fan*

Description of Work: *Provide equipment replacement and installation.*

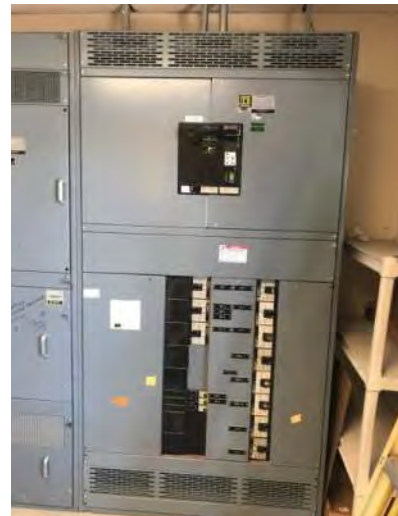
Record ID: 457
System: D5020 - ELECTRICAL SERVICE AND DISTRIBUTION

Item No.: D5020.10.305
Floor/Room: 1
Priority: 3
Quantity/Unit of Measure: 1/EA
Total Deficiency Cost: \$37,430
Deficiency Description: *The 1000A metered main switchboard (3P, 120/208) is approaching the end of its expected useful life.*

Comments: *Metered Switchboard*

Description of Work: *Replace the existing metered main switchboard with a new metered main switchboard.*

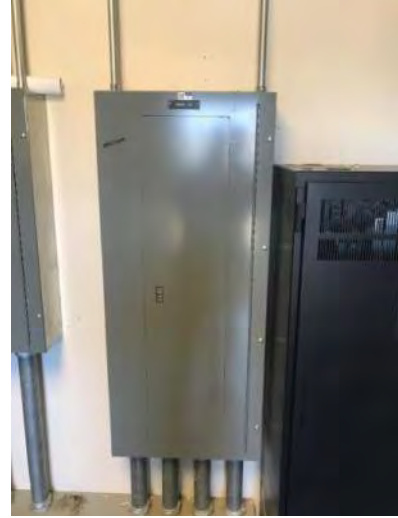
Record ID 461
System D5020 - ELECTRICAL SERVICE AND DISTRIBUTION
Item No. D5020.30.1008
Floor/Room: 1
Priority: 3
Quantity/Unit of Measure: 1/EA
Total Deficiency Cost: \$21,020
Deficiency Description: *The 225A (120/208, 3P) panelboard is past its expected useful life.*
Description of Work: *Replace the existing panelboard with a new panelboard.*
Comments: *Panelboard*

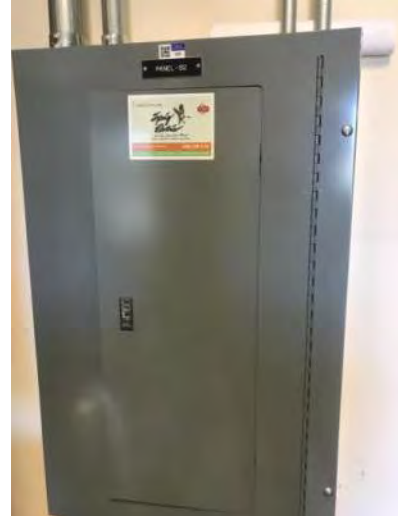
Record ID 462
System D5020 - ELECTRICAL SERVICE AND DISTRIBUTION
Item No. D5020.30.1008
Floor/Room: 1
Priority: 3
Quantity/Unit of Measure: 1/EA
Total Deficiency Cost: \$21,020
Deficiency Description: *The 225A (120/208, 3P) panelboard is past its expected useful life.*
Description of Work: *Replace the existing panelboard with a new panelboard.*
Comments: *Panelboard*

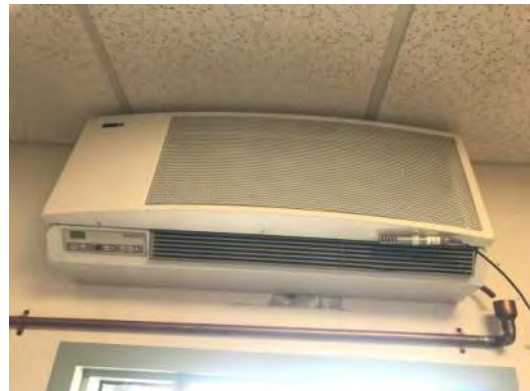
Record ID 464
System D3030 - COOLING SYSTEMS
Item No. D3030.70.043
Floor/Room: 1
Priority: 3
Quantity/Unit of Measure: 1/EA
Total Deficiency Cost: \$30,830
Deficiency Description: *Split system with fan coil and outdoor condensing unit is approaching the end of its expected useful life.*
Description of Work: *Provide equipment replacement and installation.*
Comments: *Mini Split*

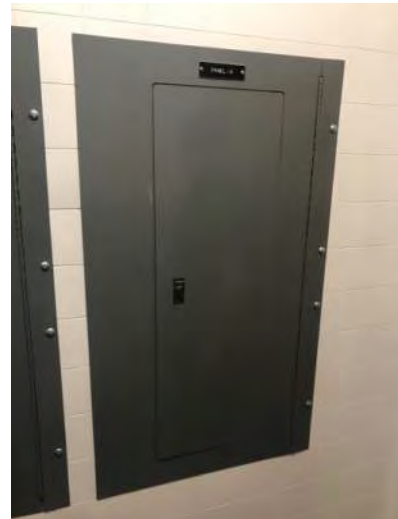
Record ID: 476
System: D5020 - ELECTRICAL SERVICE AND DISTRIBUTION
Item No.: D5020.30.1008
Floor/Room: 1 / Kitchen
Priority: 3
Quantity/Unit of Measure: 1/EA
Total Deficiency Cost: \$21,020
Deficiency Description: *The 225A (120/208, 3P) panelboard is past its expected useful life.*
Description of Work: *Replace the existing panelboard with a new panelboard.*
Comments: *Panelboard*
