City of Cupertino

Facility Condition Assessment

Final Report

December 2, 2022

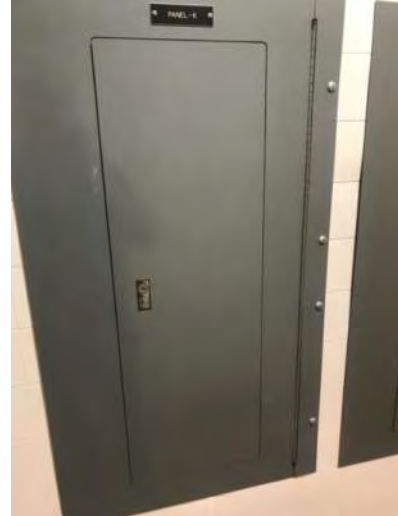
Record ID: 477
System: D5020 - ELECTRICAL SERVICE AND DISTRIBUTION
Item No.: D5020.30.1008
Floor/Room: 1 / Kitchen
Priority: 3
Quantity/Unit of Measure: 1/EA
Total Deficiency Cost: \$21,020
Deficiency Description: *The 225A (120/208, 3P) panelboard is past its expected useful life.*
Description of Work: *Replace the existing panelboard with a new panelboard.*
Comments: *Panelboard*

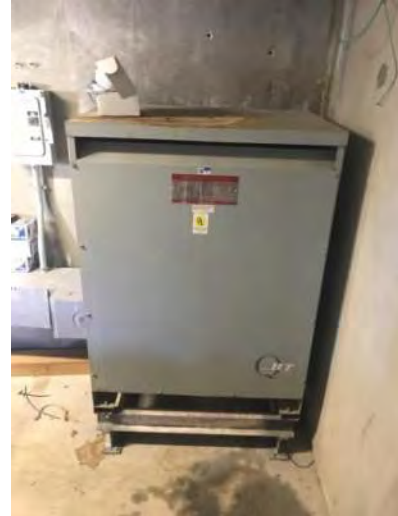
Record ID: 409
System: D5020 - ELECTRICAL SERVICE AND DISTRIBUTION
Item No.: D5020.10.219
Floor/Room: 1
Priority: 3
Quantity/Unit of Measure: 1/EA
Total Deficiency Cost: \$29,270
Deficiency Description: *The 150kVA transformer is past its expected useful life.*

Comments: *Transformer*

Description of Work: *Replace the existing transformer with a new transformer.*

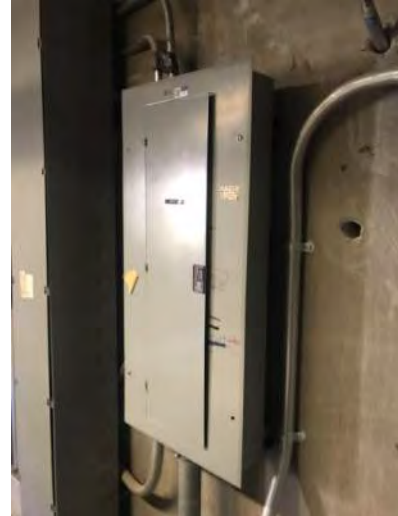
Record ID: 411
System: D5020 - ELECTRICAL SERVICE AND DISTRIBUTION
Item No.: D5020.30.4001
Floor/Room: 1
Priority: 3
Quantity/Unit of Measure: 1/EA
Total Deficiency Cost: \$5,550
Deficiency Description: *The load center is approaching the end of its expected useful life.*

Comments: *Panelboard*

Description of Work: *Replace the existing load center with a new load center.*

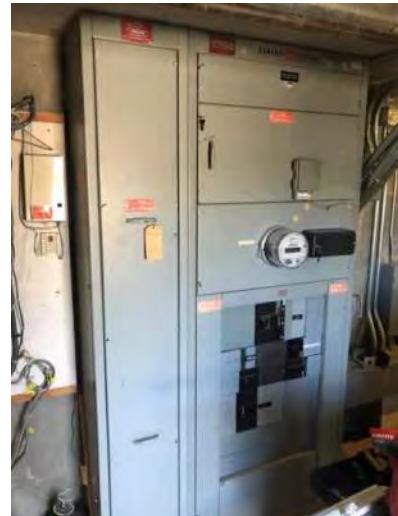
Record ID: 413
System: D5020 - ELECTRICAL SERVICE AND DISTRIBUTION
Item No.: D5020.30.0009
Floor/Room: 1
Priority: 3
Quantity/Unit of Measure: 1/EA
Total Deficiency Cost: \$20,090
Deficiency Description: *The 400A switchboard is past expected useful life.*

Comments: *Switchboard*

Description of Work: *Replace the existing switchboard with a new switchboard.*

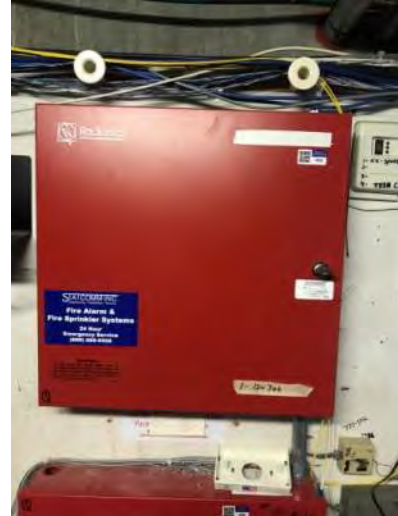
Priority: 1
Quantity/Unit of Measure: 16,750/SF
Total Deficiency Cost: \$334,250

Deficiency Description: *The existing fire alarm system is approaching the end of its useful life and should be replaced.*

Comments: *Fire Alarm Panel*

Description of Work: *Replace the existing fire alarm system with a complete, site-wide, fully addressable fire alarm system.*

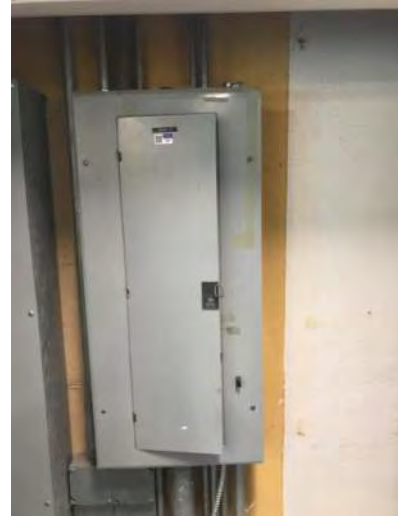
Record ID 421
System D5020 - ELECTRICAL SERVICE AND DISTRIBUTION

Priority: 3
Quantity/Unit of Measure: 1/EA
Total Deficiency Cost: \$5,550
Deficiency Description: *The load center is approaching the end of its expected useful life.*

Comments: *Panelboard*

Description of Work: *Replace the existing load center with a new load center.*

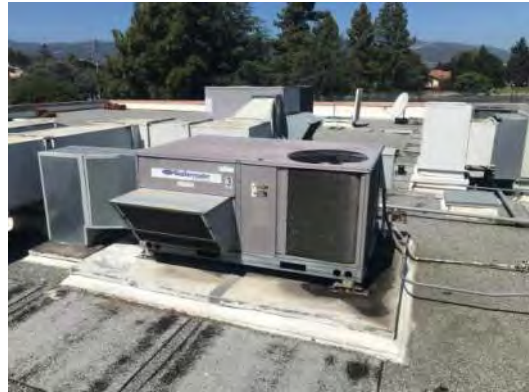
Item No.: D3030.10.018
Floor/Room: Roof
Priority: 2
Quantity/Unit of Measure: 1/EA
Total Deficiency Cost: \$52,230
Deficiency Description: *Packaged AC unit is approaching the end of its expected useful life.*

Comments: *Packaged Unit*

Description of Work: *Provide equipment replacement and installation.*

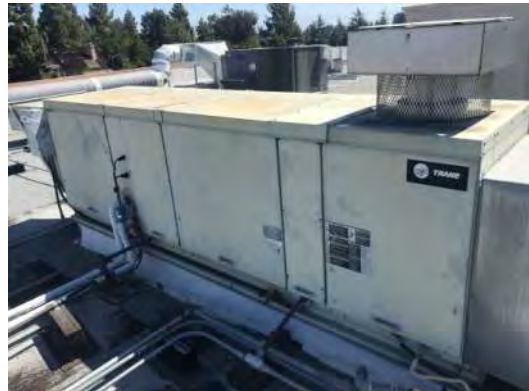
Record ID: 424
System: D3050 - FACILITY HVAC DISTRIBUTION SYSTEMS

Item No.: D3050.50.006
Floor/Room: Roof
Priority: 2
Quantity/Unit of Measure: 1/EA
Total Deficiency Cost: \$78,310
Deficiency Description: *Air handler is approaching the end of its expected useful life.*

Comments: *Air Handler*

Description of Work: *Provide equipment replacement and installation.*

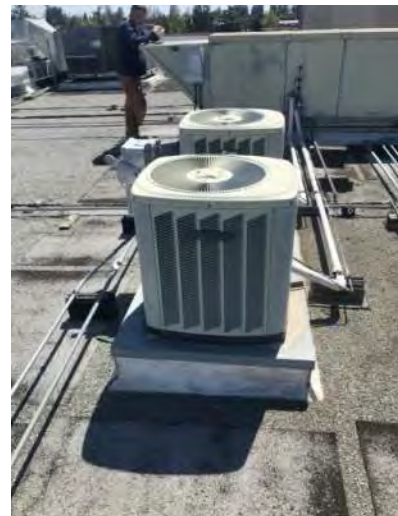
Record ID: 426
System: D3030 - COOLING SYSTEMS

Item No.: D3030.70.043
Floor/Room: Roof
Priority: 3
Quantity/Unit of Measure: 1/EA
Total Deficiency Cost: \$30,830
Deficiency Description: *Split system with fan coil and outdoor condensing unit is approaching the end of its expected useful life.*

Comments: *HVAC - Split System*

Description of Work: *Provide equipment replacement and installation.*

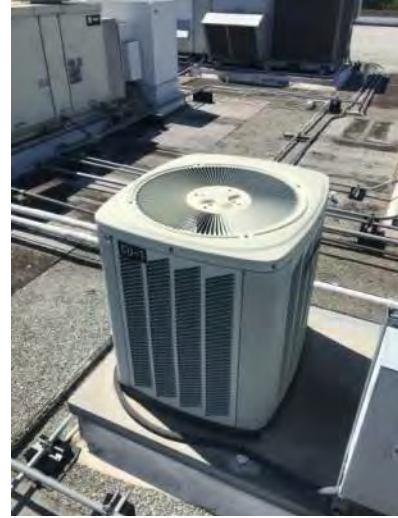
Item No. D3030.70.043
Floor/Room: Roof
Priority: 3
Quantity/Unit of Measure: 1/EA
Total Deficiency Cost: \$30,830
Deficiency Description: *Split system with fan coil and outdoor condensing unit is approaching the end of its expected useful life.*

Comments: *HVAC - Split System*

Description of Work: *Provide equipment replacement and installation.*

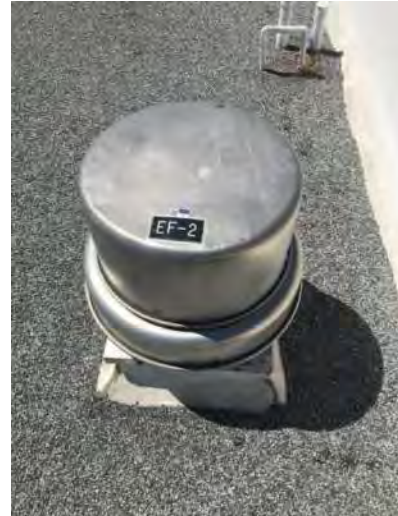
Record ID 428
System D3060 - VENTILATION

Item No. D3060.30.005
Floor/Room: Roof
Priority: 5
Quantity/Unit of Measure: 1/EA
Total Deficiency Cost: \$8,700
Deficiency Description: *Roof exhaust fan is approaching the end of its expected useful life.*

Comments: *Exhaust Fan*

Description of Work: *Provide equipment replacement and installation.*

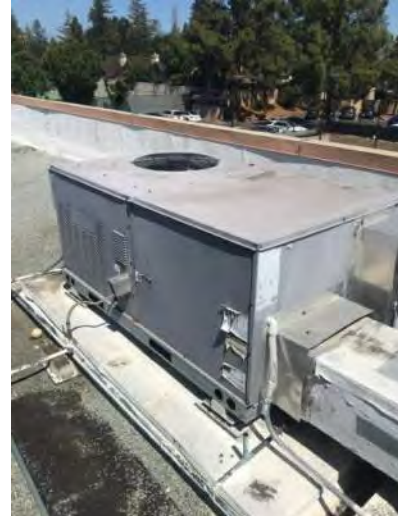
Item No.: D3030.10.018
Floor/Room: Roof
Priority: 2
Quantity/Unit of Measure: 1/EA
Total Deficiency Cost: \$52,230
Deficiency Description: *Packaged AC unit is approaching the end of its expected useful life.*

Comments: *Packaged Unit*

Description of Work: *Provide equipment replacement and installation.*

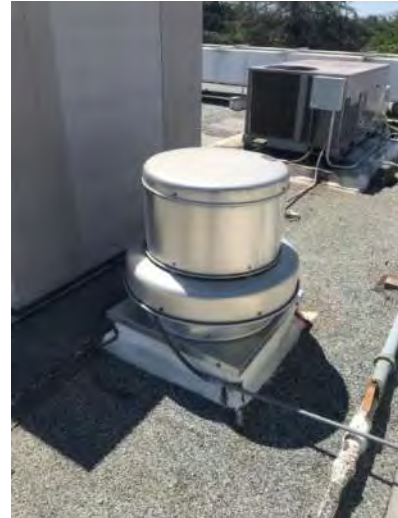
Record ID: 436
System: D3060 - VENTILATION

Item No.: D3060.30.005
Floor/Room: Roof
Priority: 5
Quantity/Unit of Measure: 1/EA
Total Deficiency Cost: \$8,700
Deficiency Description: *Roof exhaust fan is approaching the end of its expected useful life.*

Comments: *Exhaust Fan*

Description of Work: *Provide equipment replacement and installation.*

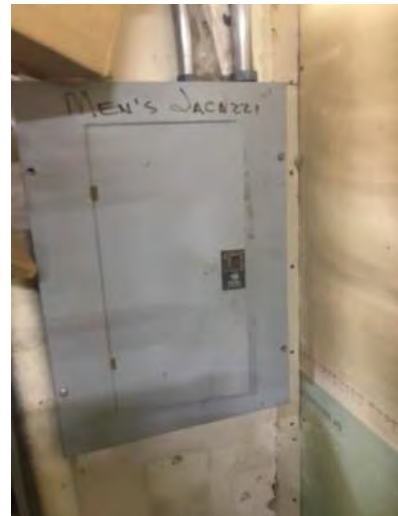
Record ID: 439
System: D5020 - ELECTRICAL SERVICE AND DISTRIBUTION

Item No.: D5020.30.4001
Floor/Room: 1
Priority: 3
Quantity/Unit of Measure: 1/EA
Total Deficiency Cost: \$5,550
Deficiency Description: *The load center is approaching the end of its expected useful life.*

Comments: *Load Center*

Description of Work: *Replace the existing load center with a new load center.*

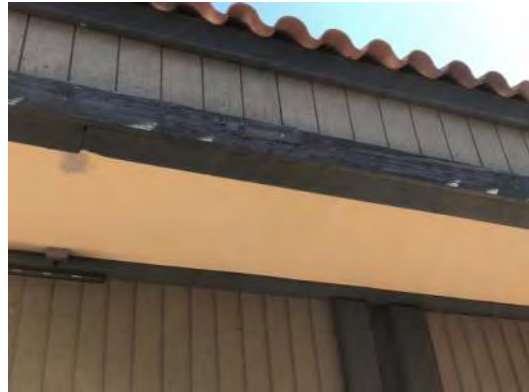
Item No.: B3010.90.009
Floor/Room: / Exterior
Priority: 3
Quantity/Unit of Measure: 460/LF
Total Deficiency Cost: \$46,830
Deficiency Description: *Wood fascia and trim chipped and have peeling paint.*

Description of Work: *Clean, repair, and paint the trim and/or fascia.*

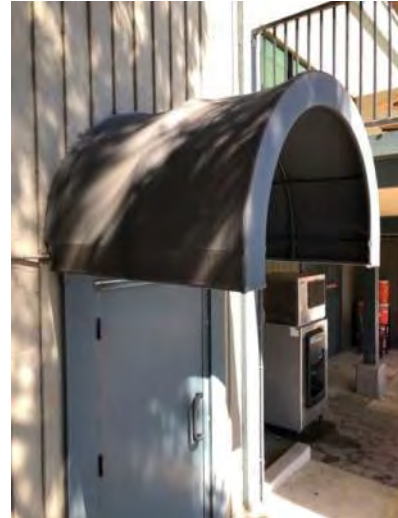
Record ID: 526
System: B2080 - EXTERIOR WALL APPURTENANCES

Item No.: B2080.30.002
Floor/Room: / Exterior
Priority: 3
Quantity/Unit of Measure: 1/EA
Total Deficiency Cost: \$1,850
Deficiency Description: *Awning (fabric) is approaching the end of its useful life.*

Description of Work: *Replace fabric awning.*

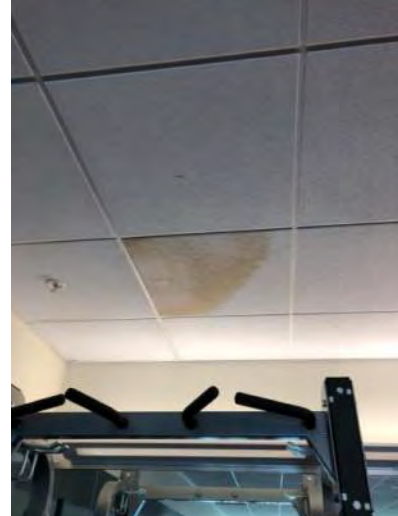
Item No.: C2050.80.001
Floor/Room:
Priority: 3
Quantity/Unit of Measure: 100/SF
Total Deficiency Cost: \$1,740
Deficiency Description: *Lay-in Acoustical Tile is in poor condition.*

Comments: *Spot check tiles that need replacing. Inspect source of water damage.*

Description of Work: *Remove existing lay-in Acoustical Tiles and replace with new lay-in Acoustical Tiles.*

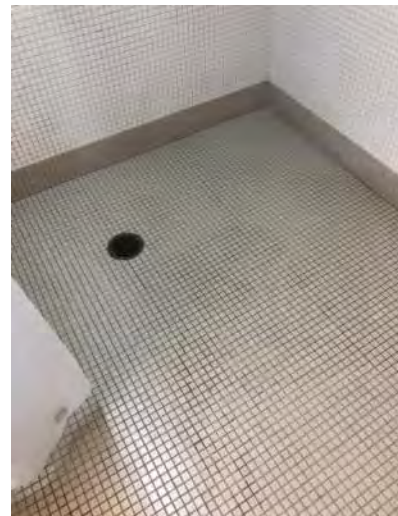
Item No.: C2030.20.003
Floor/Room: Ground / Locker(s)
Priority: 3
Quantity/Unit of Measure: 200/SF
Total Deficiency Cost: \$14,540
Deficiency Description: *Grout is damaged and deteriorating on the tiled floor.*

Description of Work: *Clean and regrout tiles.*

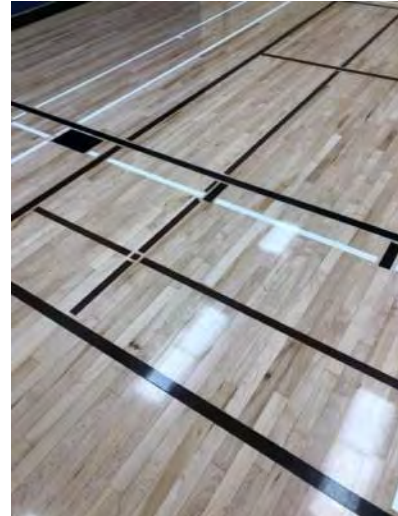
Item No.: C2030.80.001
Floor/Room: 1 / Basketball Court & Racquet Ball Court
Priority: 3
Quantity/Unit of Measure: 4,000/SF
Total Deficiency Cost: \$232,560
Deficiency Description: *Gymnasium floor is approaching the end of its useful life.*

Description of Work: *Replace the existing flooring with a new wood gym floor.*

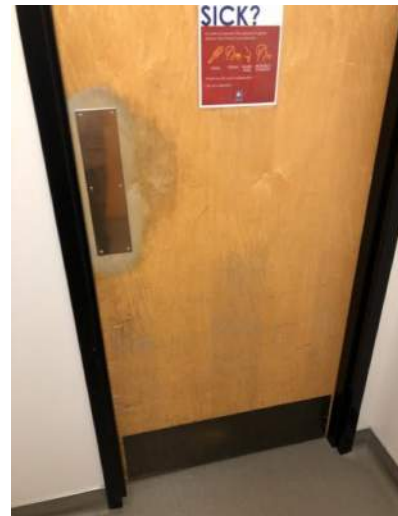
Item No.: C1030.10.008
Floor/Room: / Locker(s)
Priority: 3
Quantity/Unit of Measure: 4/EA
Total Deficiency Cost: \$4,380
Deficiency Description: *Interior wood door is in visual need of refurbishment.*

Description of Work: *Refurbish and restain the wood door.*

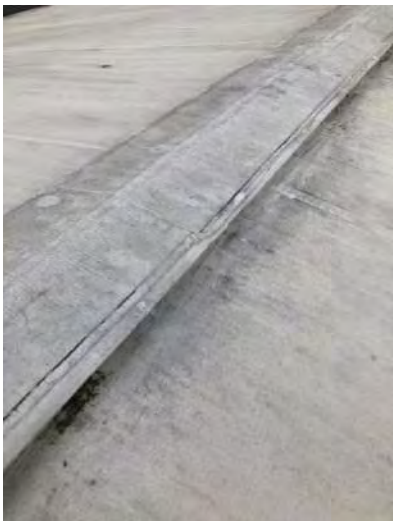
Item No.: B3010.10.002
Floor/Room: Roof / Roof
Priority: 3
Quantity/Unit of Measure: 1,200/SF
Total Deficiency Cost: \$50,170
Deficiency Description: *Metal Roofing is at or approaching end of expected useful service life.*

Description of Work: *Remove and replace metal roofing.*

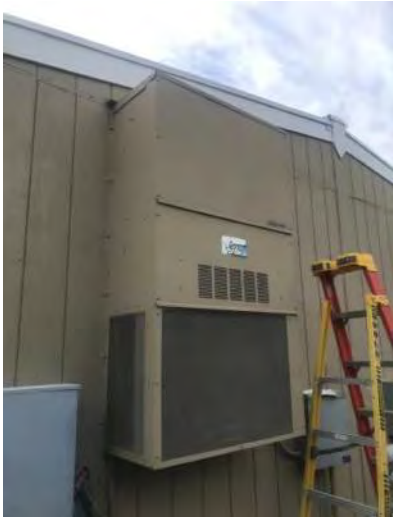
Item No.: D3030.70.030
Floor/Room: 1
Priority: 4
Quantity/Unit of Measure: 1/EA
Total Deficiency Cost: \$37,890
Deficiency Description: *Wall mounted AC unit is approaching the end of its expected useful life.*

Comments: *Wall-Mounted AC*

Description of Work: *Provide equipment replacement and installation.*

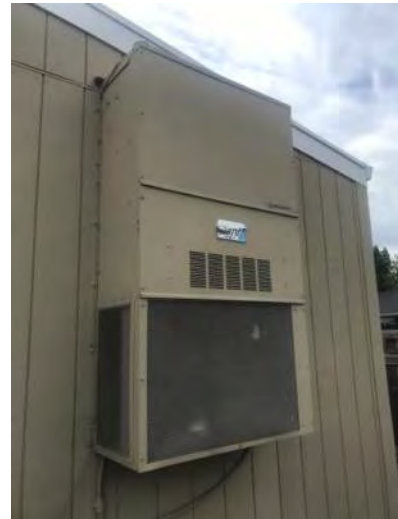
Item No.: D3030.70.030
Floor/Room: 1
Priority: 4
Quantity/Unit of Measure: 1/EA
Total Deficiency Cost: \$37,890
Deficiency Description: *Wall mounted AC unit is approaching the end of its expected useful life.*

Comments: *Wall-Mounted AC*

Description of Work: *Provide equipment replacement and installation.*

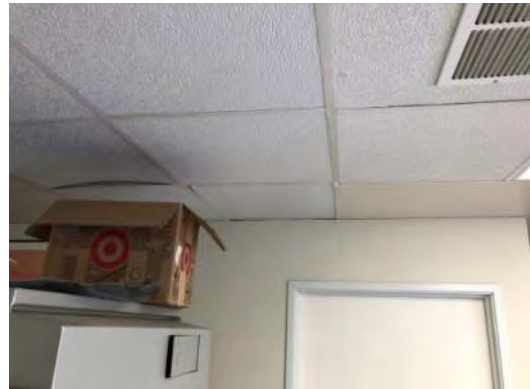
Item No.: C2050.80.001
Floor/Room:
Priority: 3
Quantity/Unit of Measure: 1,100/SF
Total Deficiency Cost: \$18,710
Deficiency Description: *Lay-in Acoustical Tile is in poor condition.*

Description of Work: *Remove existing lay-in Acoustical Tiles and replace with new lay-in Acoustical Tiles.*

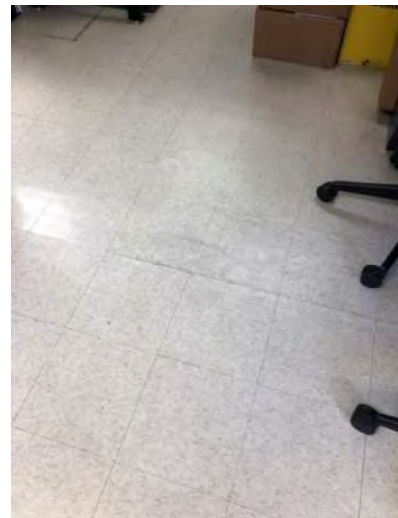
Item No.: C2030.50.001
Floor/Room:
Priority: 4
Quantity/Unit of Measure: 800/SF
Total Deficiency Cost: \$22,740
Deficiency Description: *Vinyl composition tile is approaching the end of its useful life.*

Description of Work: *Remove the existing vinyl composition tile and replace.*

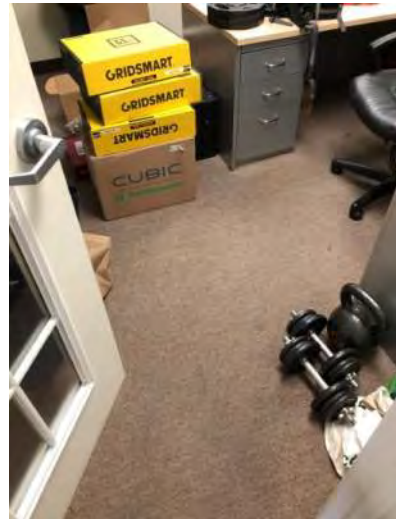
Item No.: C2030.75.002
Floor/Room:
Priority: 5
Quantity/Unit of Measure: 250/SF
Total Deficiency Cost: \$7,890
Deficiency Description: *Rolled carpeting is approaching the end of its useful life.*

Description of Work: *Remove existing rolled carpeting and replace it with new 40 oz. nylon carpet.*

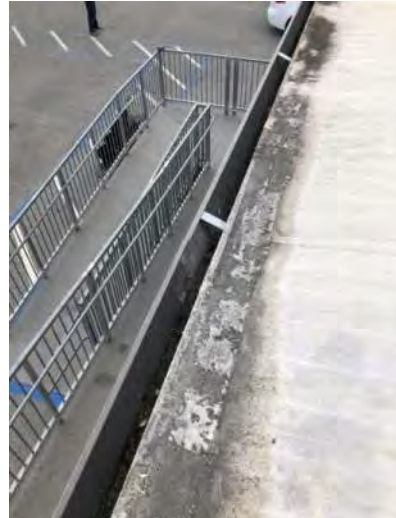
Item No.: B3020.70.001
Floor/Room:
Priority: 3
Quantity/Unit of Measure: 100/LF
Total Deficiency Cost: \$5,480
Deficiency Description: *Rain leaders/gutters are damaged and leak.*

Description of Work: *Repair, replace rain leaders/gutters.*

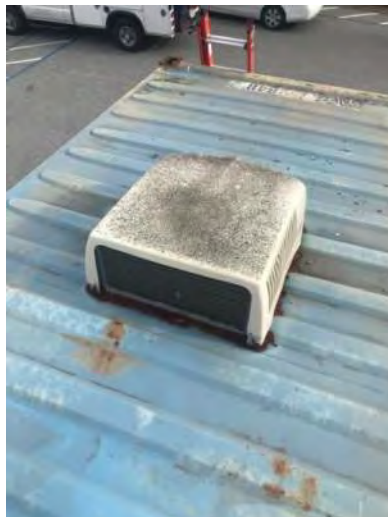
Item No.: D3030.70.032
Floor/Room: 1
Priority: 1
Quantity/Unit of Measure: 1/EA
Total Deficiency Cost: \$6,660
Deficiency Description: *Ceiling mounted AC unit is approaching the end of its expected useful life.*

Comments: *Air Conditioner - Ceiling Mounted*

Description of Work: *Provide equipment replacement and installation.*

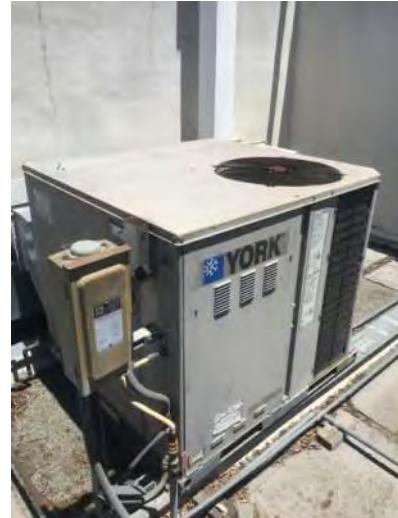
Item No.: D3030.10.018
Floor/Room: 1
Priority: 3
Quantity/Unit of Measure: 1/EA
Total Deficiency Cost: \$54,540
Deficiency Description: *Packaged AC unit is approaching the end of its expected useful life.*

Comments: *Package Unit*

Description of Work: *Provide equipment replacement and installation.*

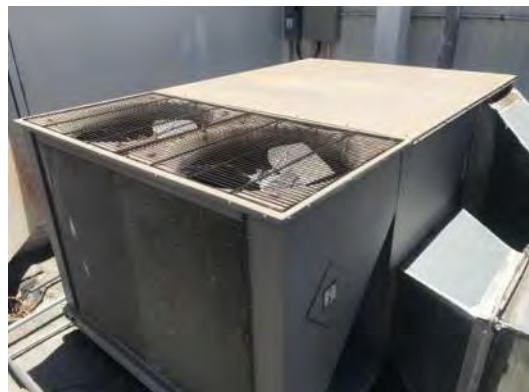
Item No.: D3030.10.018
Floor/Room: 1
Priority: 3
Quantity/Unit of Measure: 1/EA
Total Deficiency Cost: \$54,540
Deficiency Description: *Packaged AC unit is approaching the end of its expected useful life.*

Comments: *Package Unit*

Description of Work: *Provide equipment replacement and installation.*

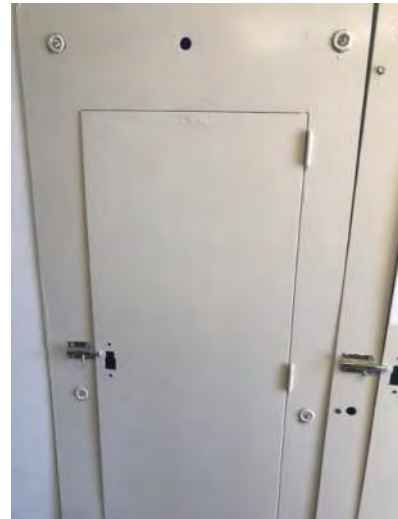
Record ID: 654
System: D5020 - ELECTRICAL SERVICE AND DISTRIBUTION
Item No.: D5020.30.1007
Floor/Room: 1
Priority: 3
Quantity/Unit of Measure: 1/EA
Total Deficiency Cost: \$12,980
Deficiency Description: *The 100A panelboard is approaching the end of its expected useful life.*
Description of Work: *Replace the existing panelboard with a new panelboard.*
Comments: *Panelboard*

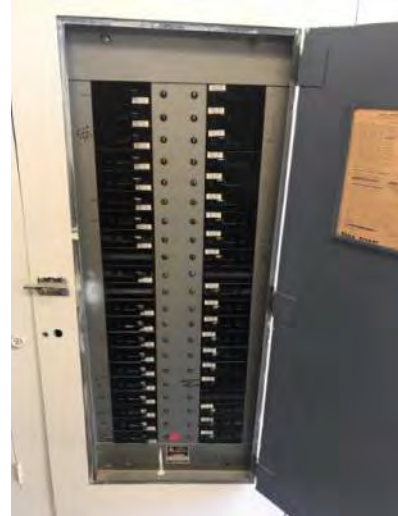
Record ID: 655
System: D5020 - ELECTRICAL SERVICE AND DISTRIBUTION
Item No.: D5020.30.1009
Floor/Room: 1
Priority: 3
Quantity/Unit of Measure: 1/EA
Total Deficiency Cost: \$26,340
Deficiency Description: *The 400A (120/208, 3P) panelboard is approaching the end of its expected useful life.*
Description of Work: *Replace the existing panelboard with a new panelboard.*
Comments: *Panelboard*

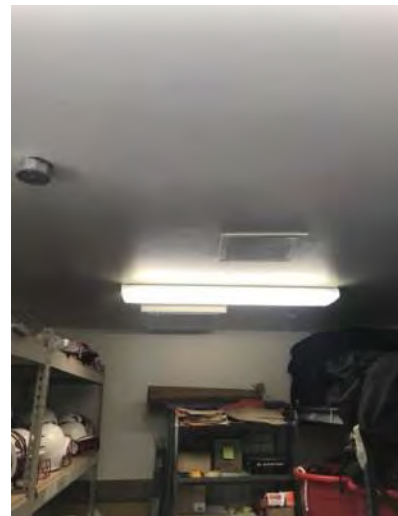
Record ID: 657
System: D5040 - LIGHTING
Item No.: D5040.50.411
Floor/Room: 1
Priority: 3
Quantity/Unit of Measure: 9,386/SF
Total Deficiency Cost: \$607,940
Deficiency Description: *Interior lighting system is past its expected useful life.*
Description of Work: *Provide new interior lighting and control system throughout building per current CEC T24 code.*
Comments:

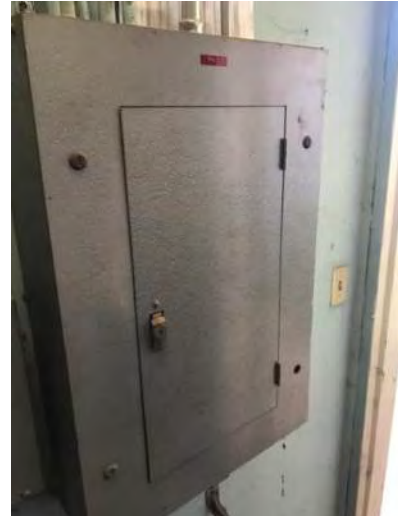
Item No.: D5020.30.1007
Floor/Room: 1
Priority: 3
Quantity/Unit of Measure: 1/EA
Total Deficiency Cost: \$12,980
Deficiency Description: *The 100A panelboard is approaching the end of its expected useful life.*

Comments: *Panelboard*

Description of Work: *Replace the existing panelboard with a new panelboard.*

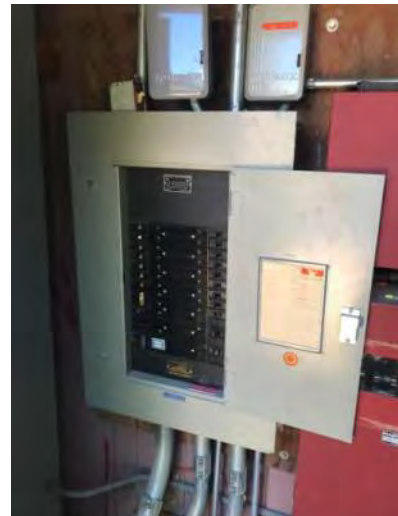
Item No.: D5020.30.1007
Floor/Room: 1
Priority: 3
Quantity/Unit of Measure: 1/EA
Total Deficiency Cost: \$12,980
Deficiency Description: *The 100A panelboard is approaching the end of its expected useful life..*

Comments: *Panelboard*

Description of Work: *Replace the existing panelboard with a new panelboard.*

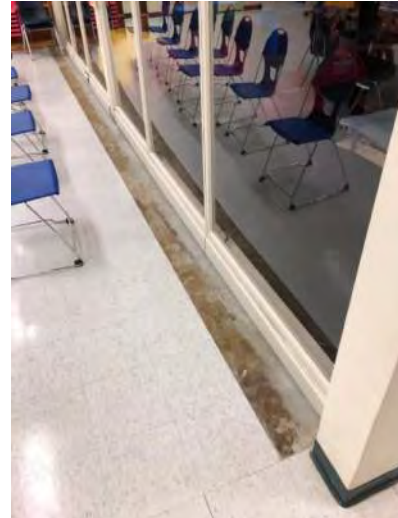
Item No.: C2030.50.001
Floor/Room: 1 / Interior gym
Priority: 3
Quantity/Unit of Measure: 1,200/SF
Total Deficiency Cost: \$32,740
Deficiency Description: *Vinyl composition tile is approaching the end of its useful life.*

Description of Work: *Remove the existing vinyl composition tile and replace.*

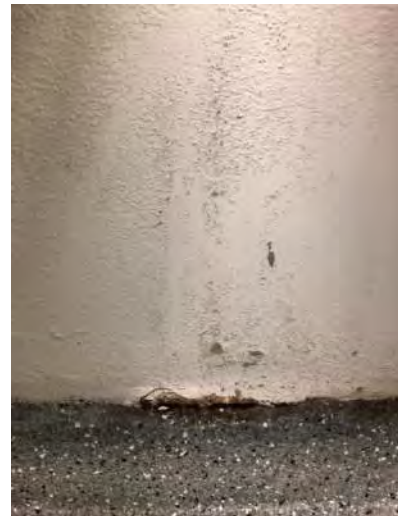
Item No.: C2030.10.002
Floor/Room: 1 / Restroom(s)
Priority: 3
Quantity/Unit of Measure: 300/SF
Total Deficiency Cost: \$16,370
Deficiency Description: *Epoxy is approaching the end of its useful life.*

Description of Work: *Remove the existing epoxy and replace.*

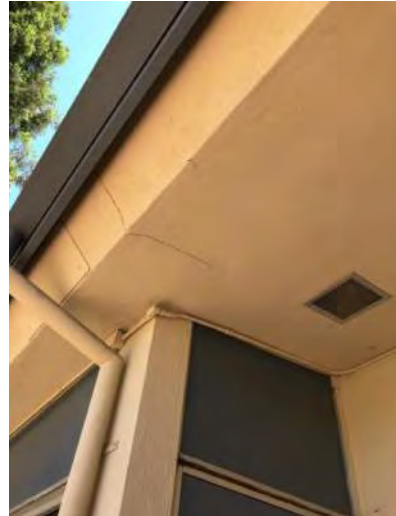
Item No.: B3080.20.002
Floor/Room: 1
Priority: 3
Quantity/Unit of Measure: 6/LF
Total Deficiency Cost: \$190
Deficiency Description: *Stucco soffits is damaged.*

Comments: *Cracking noted in various locations of soffit*

Description of Work: *Repair stucco soffit.*

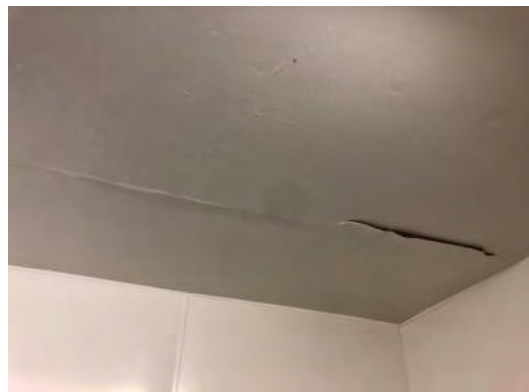
Item No.: C2050.10.001
Floor/Room: / Restroom(s)
Priority: 3
Quantity/Unit of Measure: 300/SF
Total Deficiency Cost: \$7,440
Deficiency Description: *Painted gypsum wallboard ceiling is approaching the end of its useful life.*

Description of Work: *Remove the existing gypsum board ceiling and replace. Tape and paint.*

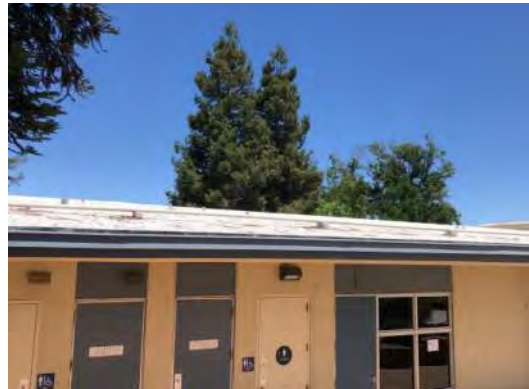
Item No. B3010.50.001
Floor/Room:
Priority: 3
Quantity/Unit of Measure: 11,500/SF
Total Deficiency Cost: \$626,820
Deficiency Description: *Built-up roofing is beyond its expected useful service life and needs replacement.*

Description of Work: *Remove and replace built-up roofing.*

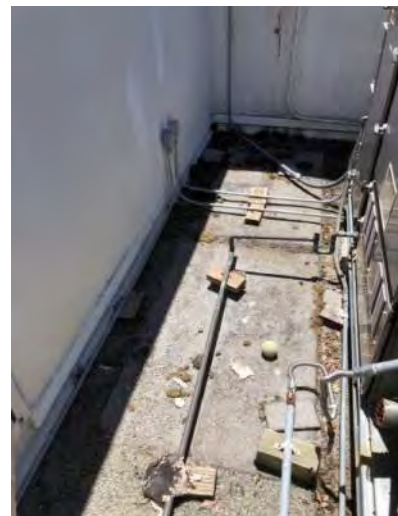
Item No. B3010.50.001
Floor/Room:
Priority: 1
Quantity/Unit of Measure: 500/SF
Total Deficiency Cost: \$24,960
Deficiency Description: *Built-up roofing is beyond its expected useful service life and needs replacement.*

Comments: *Roof Mechanical Unit Area*

Description of Work: *Remove and replace built-up roofing.*

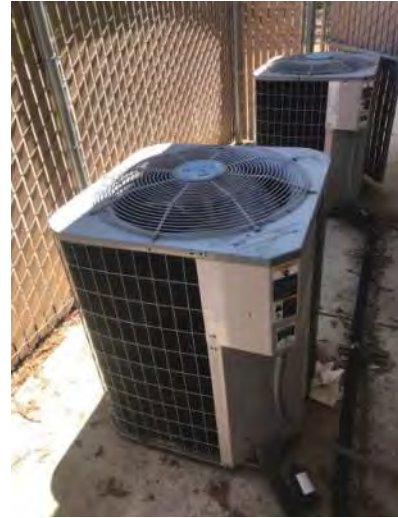
Item No.: D3030.70.047
Floor/Room: 1
Priority: 2
Quantity/Unit of Measure: 1/EA
Total Deficiency Cost: \$36,910
Deficiency Description: *Split system with fan coil and outdoor condensing unit is approaching the end of its expected useful life.*

Comments: *HVAC - Split System*

Description of Work: *Provide equipment replacement and installation.*

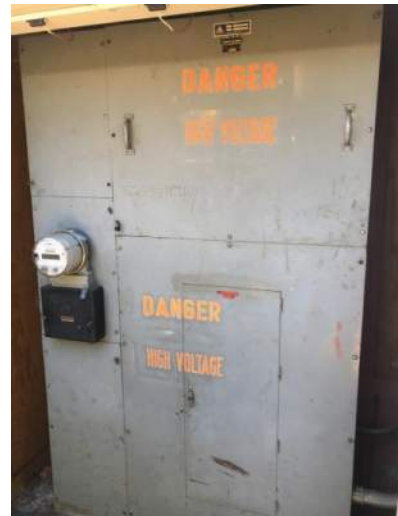
Item No.: D5020.10.304
Floor/Room: 1
Priority: 3
Quantity/Unit of Measure: 1/EA
Total Deficiency Cost: \$24,150
Deficiency Description: *The 800A metered main switchboard is past its expected useful life.*

Comments: *Metered Switchboard*

Description of Work: *Replace the existing metered main switchboard with a new metered main switchboard.*

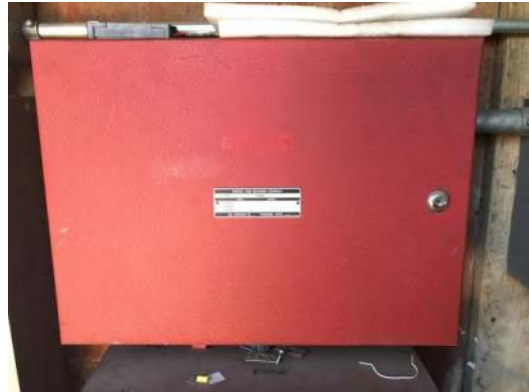
Comments: *Fire Alarm Panel*

Description of Work: *Provide a fully addressable fire alarm control panel with associated initiating and signaling devices.*

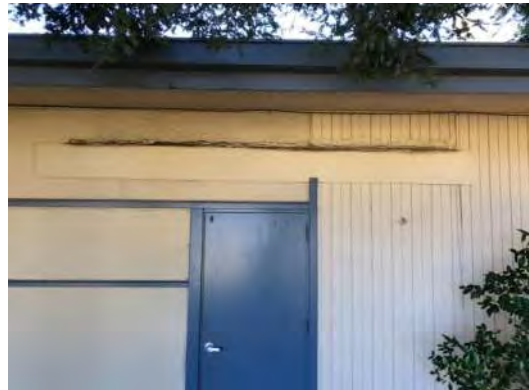
Record ID: 762
System: B2010 - EXTERIOR WALLS

Item No.: B2010.10.009
Floor/Room: Exterior / N/A
Priority: 3
Quantity/Unit of Measure: 20/SF
Total Deficiency Cost: \$1,260
Deficiency Description: *Exterior cement plaster walls are damaged and spalling in several areas.*

Comments: *Possible overhang removed. Patch is poorly done and plaster is peeling/cracking.*

Description of Work: *Clean, patch, and repair the cement plaster wall finish.*

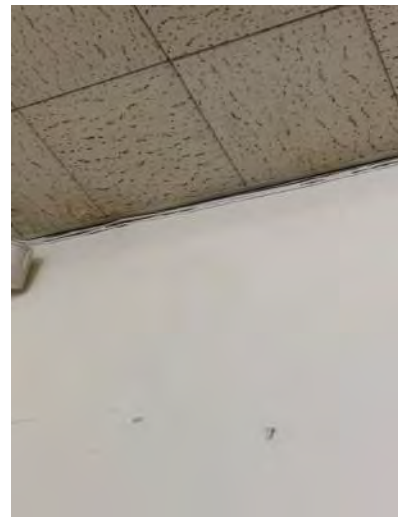
Record ID: 1084
System: C2050 - CEILING FINISHES

Item No.: C2050.80.001
Floor/Room:
Priority: 3
Quantity/Unit of Measure: 2,700/SF
Total Deficiency Cost: \$45,900
Deficiency Description: *Lay-in Acoustical Tile is in poor condition.*

Description of Work: *Remove existing lay-in Acoustical Tiles and replace with new lay-in Acoustical Tiles.*

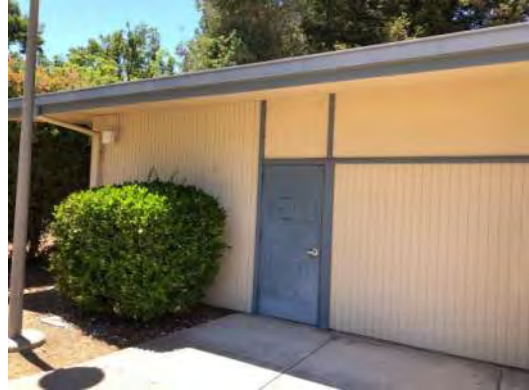
Deficiency Description: *Metal door is damaged or deteriorated.*

Description of Work: *Repair door and repaint.*

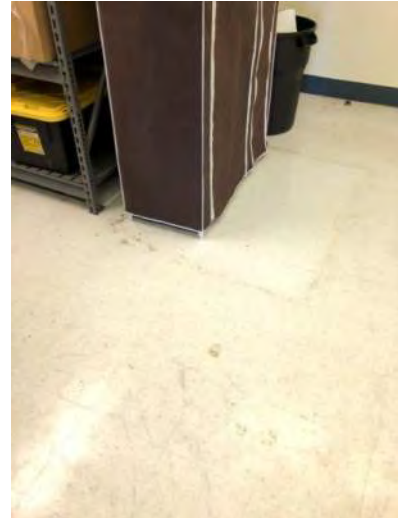
Record ID: 1086
System: C2030 - FLOORING

Deficiency Description: *Vinyl composition tile is approaching the end of its useful life.*

Description of Work: *Remove the existing vinyl composition tile and replace.*

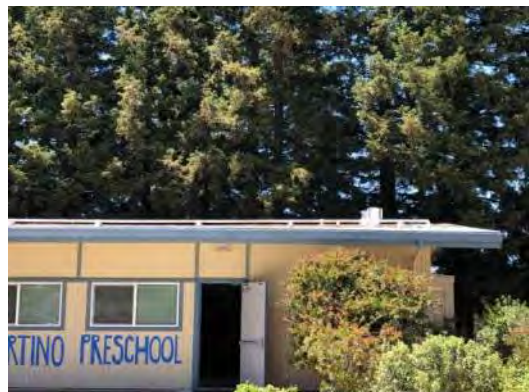
Record ID: 1087
System: B3010 - ROOFING

Deficiency Description: *Built-up roofing is beyond its expected useful service life and needs replacement.*

Description of Work: *Remove and replace built-up roofing.*

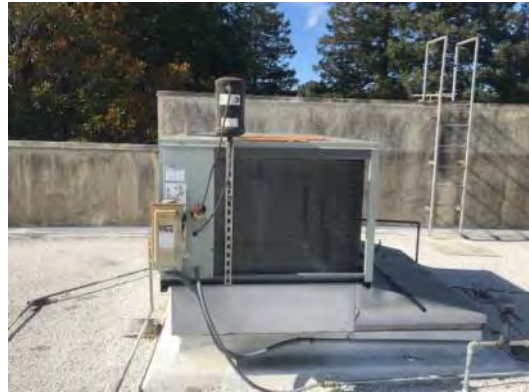
Item No.: D3030.10.018
Floor/Room: Roof
Priority: 2
Quantity/Unit of Measure: 1/EA
Total Deficiency Cost: \$52,230
Deficiency Description: *Packaged AC unit is approaching the end of its expected useful life.*

Comments: *Packaged Unit*

Description of Work: *Provide equipment replacement and installation.*

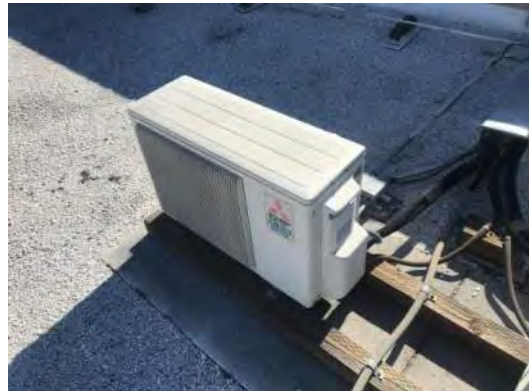
Record ID: 568
System: D3030 - COOLING SYSTEMS

Item No.: D3030.70.041
Floor/Room: Roof
Priority: 4
Quantity/Unit of Measure: 1/EA
Total Deficiency Cost: \$20,120
Deficiency Description: *Split system with wall mounted AC and outdoor condensing unit is approaching the end of its expected useful life.*

Comments: *HVAC - Split System*

Description of Work: *Provide equipment replacement and installation.*

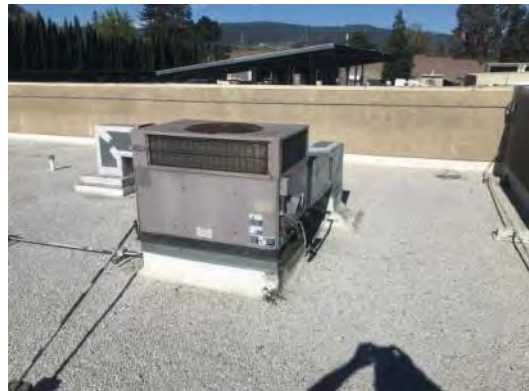
Record ID: 569
System: D3030 - COOLING SYSTEMS

Item No.: D3030.10.018
Floor/Room: Roof
Priority: 2
Quantity/Unit of Measure: 1/EA
Total Deficiency Cost: \$52,230
Deficiency Description: *Packaged AC unit is approaching the end of its expected useful life.*

Comments: *Packaged Unit*

Description of Work: *Provide equipment replacement and installation.*

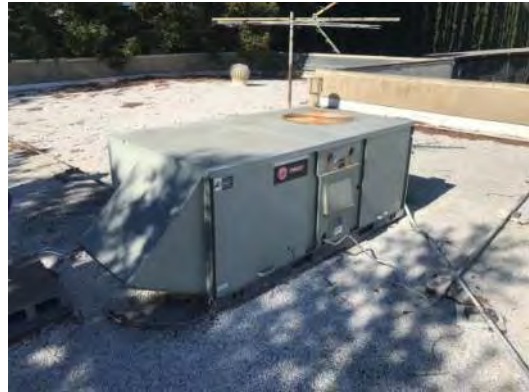
Item No.: D3030.10.017
Floor/Room: Roof
Priority: 2
Quantity/Unit of Measure: 1/EA
Total Deficiency Cost: \$17,430
Deficiency Description: *Packaged AC unit is approaching the end of its expected useful life.*

Comments: *Packaged Unit*

Description of Work: *Provide equipment replacement and installation.*

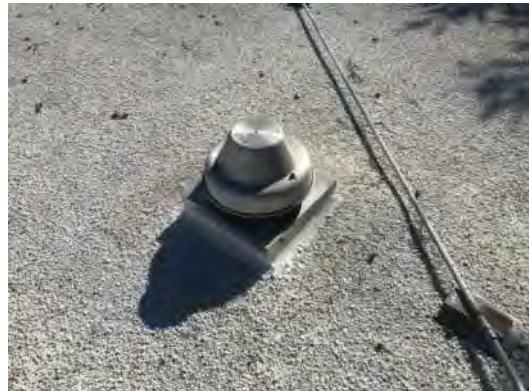
Record ID: 571
System: D3060 - VENTILATION

Item No.: D3060.30.007
Floor/Room: Roof
Priority: 4
Quantity/Unit of Measure: 1/EA
Total Deficiency Cost: \$7,580
Deficiency Description: *Ventilator is approaching the end of its expected useful life.*

Comments: *Exhaust Fan*

Description of Work: *Provide equipment replacement and installation.*

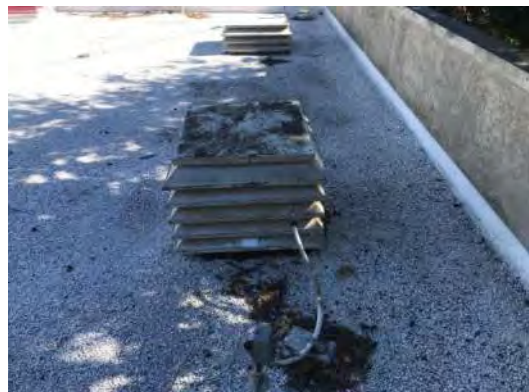
Record ID: 572
System: D3060 - VENTILATION

Item No.: D3060.30.007
Floor/Room: Roof
Priority: 4
Quantity/Unit of Measure: 1/EA
Total Deficiency Cost: \$7,580
Deficiency Description: *Ventilator is approaching the end of its expected useful life.*

Comments: *Exhaust Fan*

Description of Work: *Provide equipment replacement and installation.*

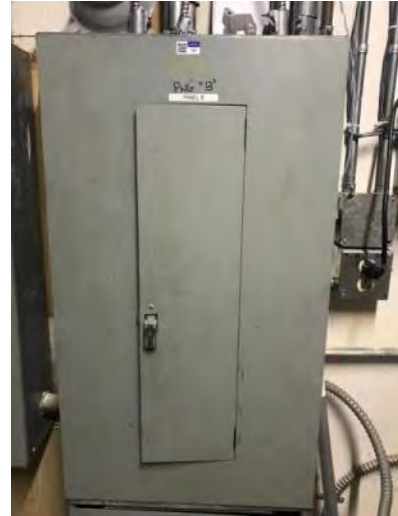
Record ID: 583
System: D5020 - ELECTRICAL SERVICE AND DISTRIBUTION

Item No.: D5020.30.1008
Floor/Room: 1
Priority: 3
Quantity/Unit of Measure: 1/EA
Total Deficiency Cost: \$21,020
Deficiency Description: *The 225A (120/208, 3P) panelboard is approaching the end of its expected useful life.*

Comments: *Panelboard*

Description of Work: *Replace the existing panelboard with a new panelboard.*

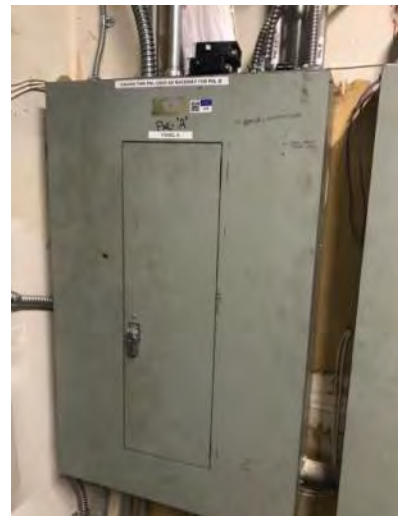
Record ID: 585
System: D5020 - ELECTRICAL SERVICE AND DISTRIBUTION

Item No.: D5020.30.1007
Floor/Room: 1
Priority: 3
Quantity/Unit of Measure: 1/EA
Total Deficiency Cost: \$12,980
Deficiency Description: *The 100A (120/208, 3P) panelboard is approaching the end of its expected useful life.*

Comments: *Panelboard*

Description of Work: *Replace the existing panelboard with a new panelboard.*

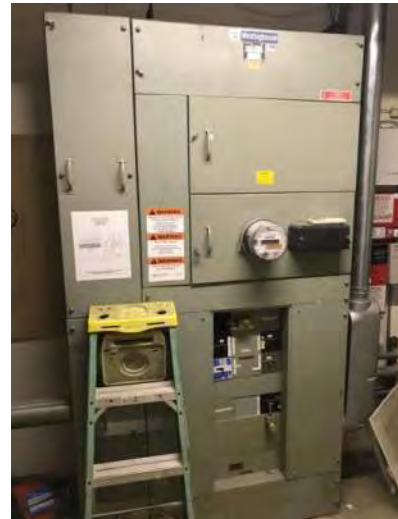
Record ID: 586
 System: D5020 - ELECTRICAL SERVICE AND DISTRIBUTION
 Item No.: D5020.10.302
 Floor/Room: 1
 Priority: 3
 Quantity/Unit of Measure: 1/EA
 Total Deficiency Cost: \$20,090
 Deficiency Description: *The 400A metered main switchboard (3P, 120/208) is approaching the end of its expected useful life.*
 Description of Work: *Replace the existing metered main switchboard with a new metered main switchboard.*
 Comments: *Metered Switchboard*

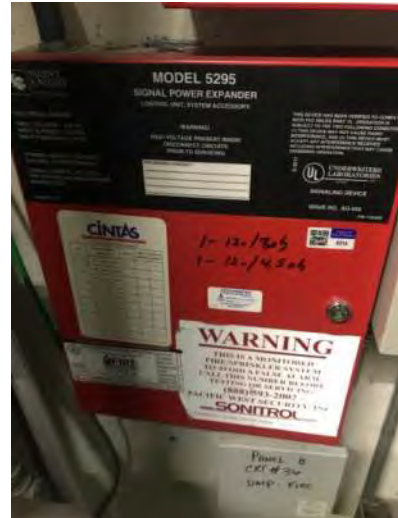
Record ID: 587
 System: D7050 - DETECTION AND ALARM
 Item No.: D7050.10.025
 Floor/Room: 1
 Priority: 1
 Quantity/Unit of Measure: 7,100/SF
 Total Deficiency Cost: \$141,700
 Deficiency Description: *The existing fire alarm system is past its useful life and should be replaced.*
 Description of Work: *Replace the existing fire alarm system with a complete, site-wide, fully addressable fire alarm system.*
 Comments: *Fire Alarm Panel*

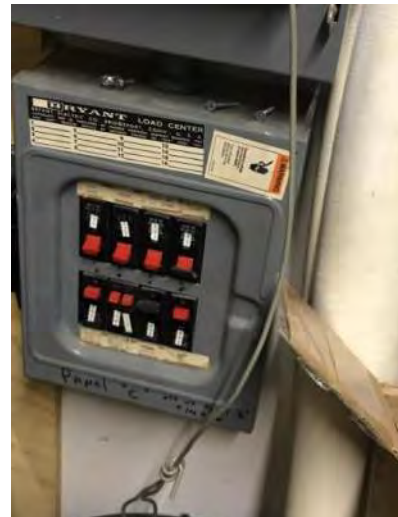
Record ID: 588
 System: D5020 - ELECTRICAL SERVICE AND DISTRIBUTION
 Item No.: D5020.30.4001
 Floor/Room: 1
 Priority: 3
 Quantity/Unit of Measure: 1/EA
 Total Deficiency Cost: \$5,550
 Deficiency Description: *The load center is approaching the end of its expected useful life.*
 Description of Work: *Replace the existing load center with a new load center.*
 Comments: *Load Center*

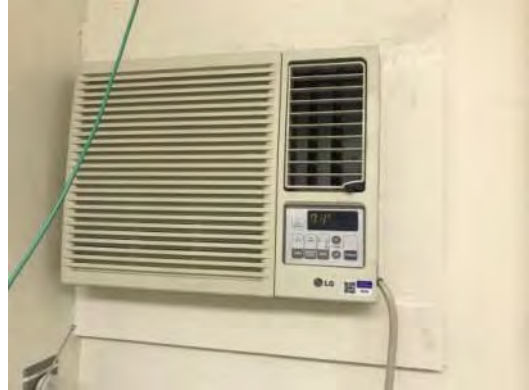
Comments: *Air Conditioner - Wall Mounted*

Description of Work: *Provide equipment replacement and installation.*

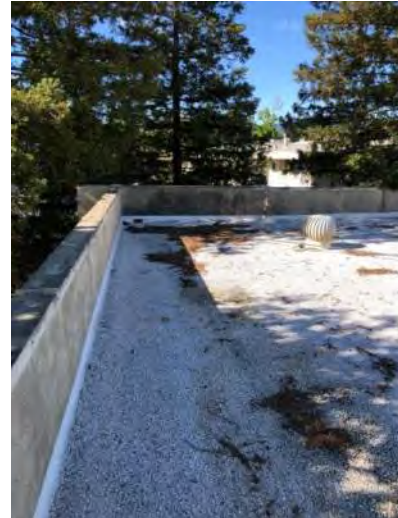
Record ID: 697
System: B3010 - ROOFING

Item No.: B3010.50.001
Floor/Room: Roof
Priority: 3
Quantity/Unit of Measure: 6,600/SF
Total Deficiency Cost: \$359,760
Deficiency Description: *Built-up roofing is beyond its expected useful service life and needs replacement.*

Comments: *Evidence of ponding, not draining properly. Leaves blocking roof drain.*

Description of Work: *Remove and replace built-up roofing.*

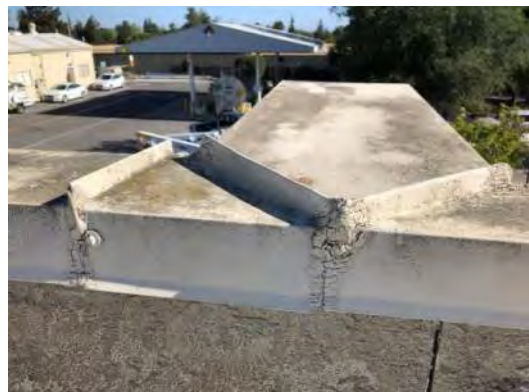
Record ID: 698
System: B2010 - EXTERIOR WALLS

Item No.: B2010.50.001
Floor/Room: Roof
Priority: 3
Quantity/Unit of Measure: 500/LF
Total Deficiency Cost: \$36,350
Deficiency Description: *The top of the parapet wall is not protected.*

Comments: *Existing parapet metal cap is beyond its useful life.*

Description of Work: *Provide a sheet metal cap.*

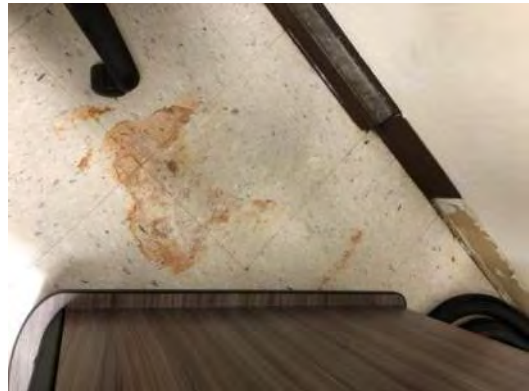
Record ID: 700
System: C2030 - FLOORING

Item No.: C2030.50.001
Floor/Room: 1 / Break Room
Priority: 3
Quantity/Unit of Measure: 700/SF
Total Deficiency Cost: \$19,110
Deficiency Description: *Vinyl composition tile is approaching the end of its useful life.*

Description of Work: *Remove the existing vinyl composition tile and replace.*

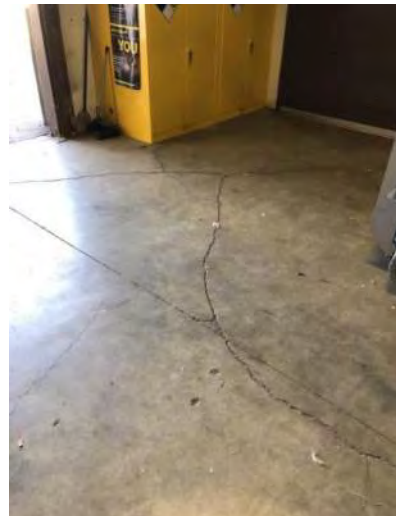
Record ID: 701
System: A4010 - STANDARD SLABS-ON-GRADE

Item No.: A4010.10.001
Floor/Room: 1 / Warehouse
Priority: 3
Quantity/Unit of Measure: 30/LF
Total Deficiency Cost: \$780
Deficiency Description: *Excessive cracks were detected in the floor slab-on-grade.*

Description of Work: *Fill the slab-on-grade cracks with caulking.*

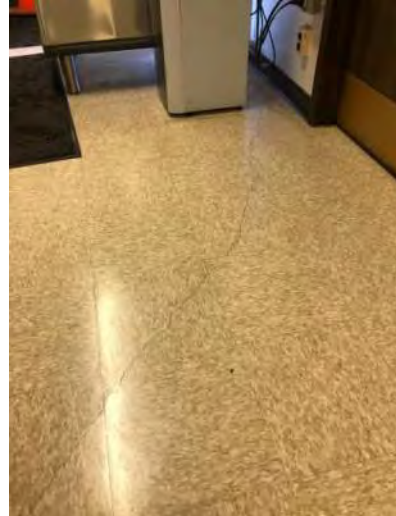
Comments: *Cracking in Tile suggests substructure shifting*

Description of Work: *Remove the existing vinyl composition tile and replace.*

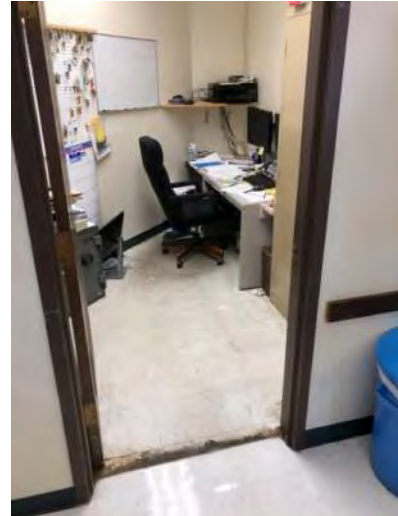
Record ID: 708
System: C2030 - FLOORING
Item No.: C2030.50.001
Floor/Room: 1 / Back Office/Break Room
Priority: 3
Quantity/Unit of Measure: 500/SF
Total Deficiency Cost: \$13,650
Deficiency Description: *Vinyl composition tile is approaching the end of its useful life.*

Description of Work: *Remove the existing vinyl composition tile and replace.*

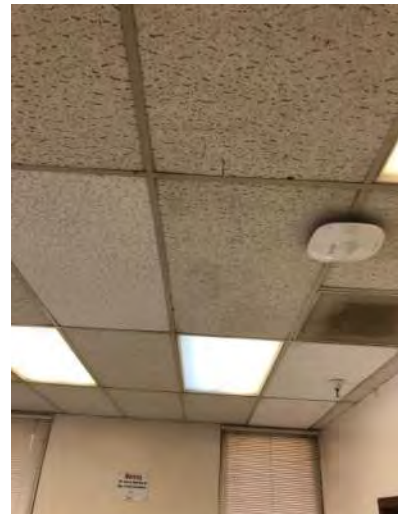
Record ID: 710
System: C2050 - CEILING FINISHES
Item No.: C2050.80.001
Floor/Room:
Priority: 3
Quantity/Unit of Measure: 4,000/SF
Total Deficiency Cost: \$67,960
Deficiency Description: *Lay-in Acoustical Tile is in poor condition.*

Description of Work: *Remove existing lay-in Acoustical Tiles and replace with new lay-in Acoustical Tiles.*

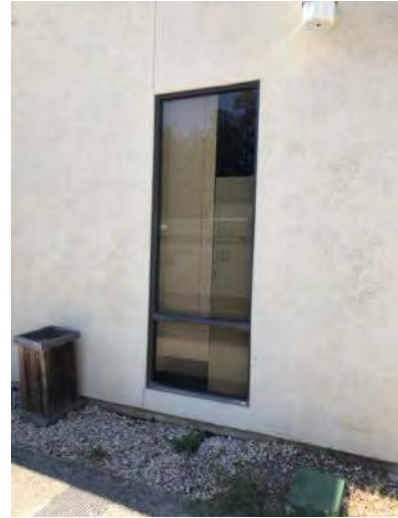
Record ID: 712
System: B2020 - EXTERIOR WINDOWS

Item No.: B2020.20.003
Floor/Room:
Priority: 3
Quantity/Unit of Measure: 400/SF
Total Deficiency Cost: \$87,220
Deficiency Description: *Metal window is approaching the end of its useful life.*

Description of Work: *Replace metal window.*

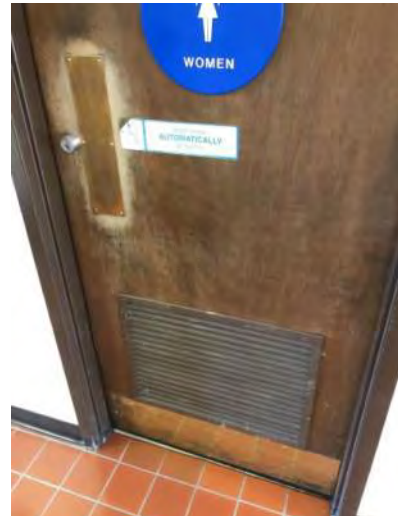
Record ID: 1117
System: C1030 - INTERIOR DOORS

Item No.: C1030.10.008
Floor/Room:
Priority: 3
Quantity/Unit of Measure: 14/EA
Total Deficiency Cost: \$15,290
Deficiency Description: *Interior wood door is in visual need of refurbishment.*

Description of Work: *Refurbish and restain the wood door.*

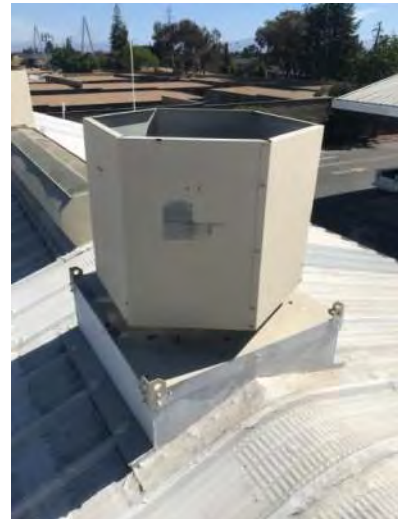
Comments: *Exhaust Fan*

Description of Work: *Provide equipment replacement and installation.*

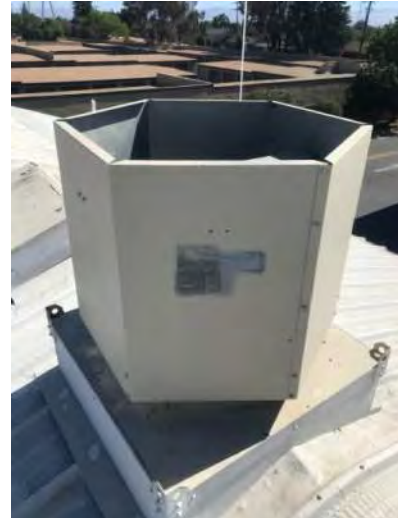
Record ID: 607
System: D3060 - VENTILATION

Item No.: D3060.30.005
Floor/Room: Roof
Priority: 5
Quantity/Unit of Measure: 1/EA
Total Deficiency Cost: \$8,700
Deficiency Description: *Roof exhaust fan is approaching the end of its expected useful life.*

Comments: *Exhaust Fan*

Description of Work: *Provide equipment replacement and installation.*

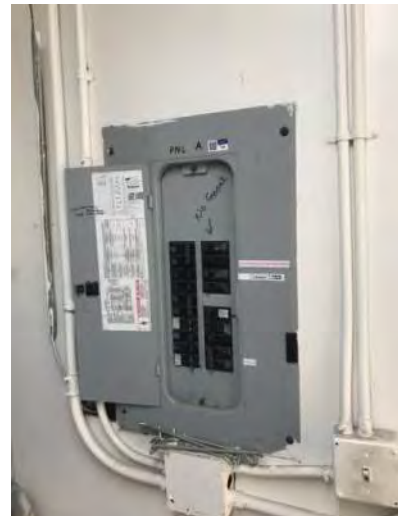
Record ID: 609
System: D5020 - ELECTRICAL SERVICE AND DISTRIBUTION

Item No.: D5020.30.4001
Floor/Room: 1
Priority: 3
Quantity/Unit of Measure: 1/EA
Total Deficiency Cost: \$5,550
Deficiency Description: *The load center is past its expected useful life.*

Comments: *Load Center*

Description of Work: *Replace the existing load center with a new load center.*

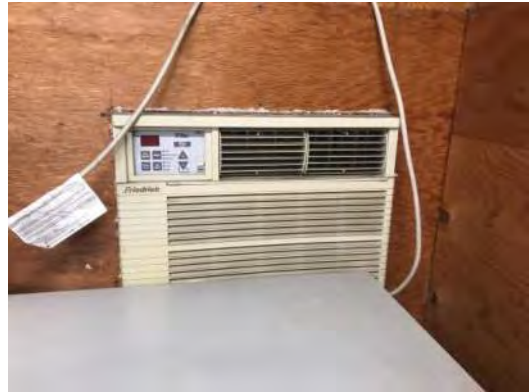
Comments: *Air Conditioner - Wall Mounted*

Description of Work: *Provide equipment replacement and installation.*

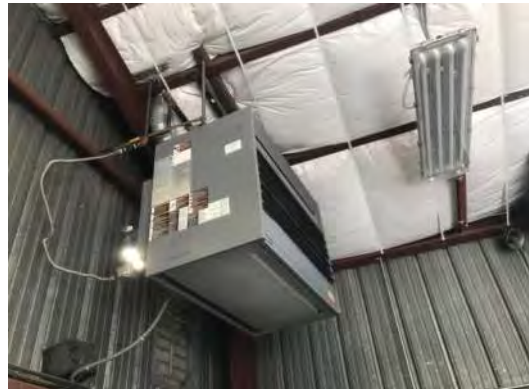
Record ID: 614
System: D3020 - HEATING SYSTEMS

Item No.: D3020.70.003
Floor/Room: 1
Priority: 5
Quantity/Unit of Measure: 1/EA
Total Deficiency Cost: \$14,620
Deficiency Description: *Unit heater is approaching the end of its expected useful life.*

Comments: *Unit Heater*

Description of Work: *Provide equipment replacement and installation.*

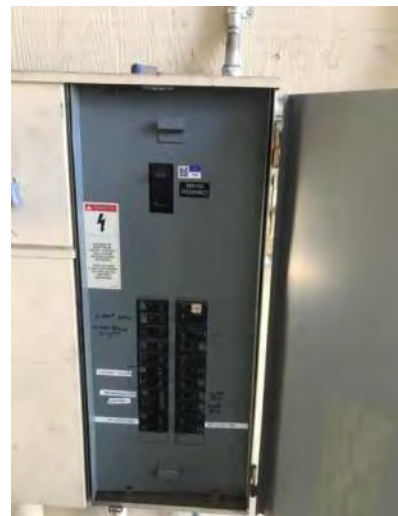
Record ID: 615
System: D5020 - ELECTRICAL SERVICE AND DISTRIBUTION

Item No.: D5020.10.007
Floor/Room: 1
Priority: 3
Quantity/Unit of Measure: 1/EA
Total Deficiency Cost: \$9,320
Deficiency Description: *The all-in-one combination service entrance pedestal is approaching the end of its expected useful life.*

Comments: *Panelboard*

Description of Work: *Replace the existing all-in-one combination service entrance device with a new all-in-one combination service entrance device.*
