City of Cupertino

Facility Condition Assessment

Final Report

December 2, 2022

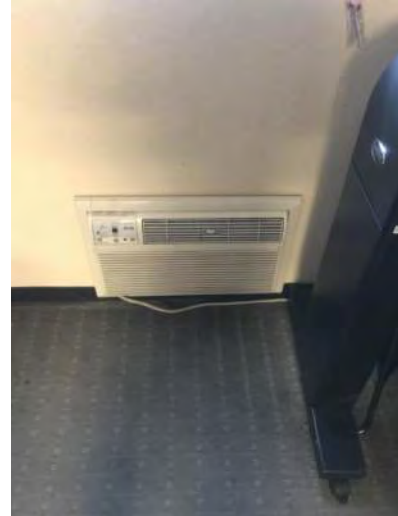
Item No.: D3030.70.032
Floor/Room: 1 / Sigh Shop
Priority: 3
Quantity/Unit of Measure: 1/EA
Total Deficiency Cost: \$7,270
Deficiency Description: *Wall mounted AC unit is approaching the end of its expected useful life.*

Comments: *Air Conditioner - Wall Mounted*

Description of Work: *Provide equipment replacement and installation.*

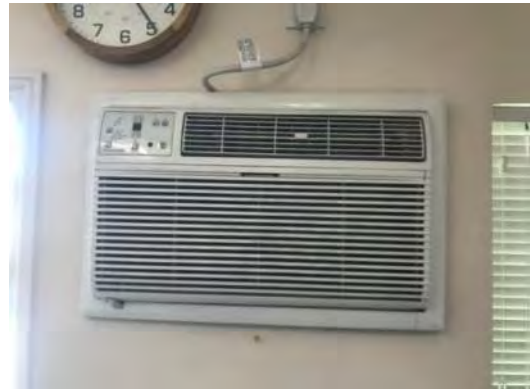
Record ID: 619
System: D3030 - COOLING SYSTEMS

Item No.: D3030.70.032
Floor/Room: 1 / Facilities
Priority: 4
Quantity/Unit of Measure: 1/EA
Total Deficiency Cost: \$7,580
Deficiency Description: *Wall mounted AC unit is approaching the end of its expected useful life.*

Comments: *Air Conditioner - Wall Mounted*

Description of Work: *Provide equipment replacement and installation.*

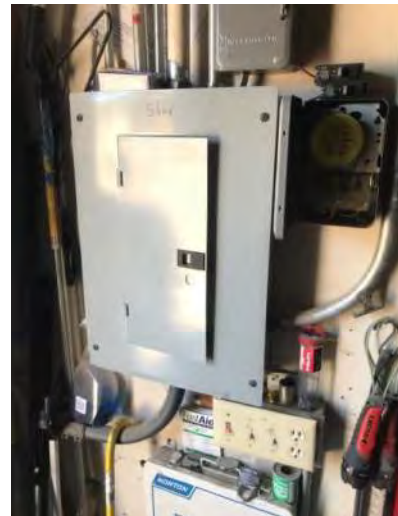
Record ID: 620
System: D5020 - ELECTRICAL SERVICE AND DISTRIBUTION

Item No.: D5020.30.4001
Floor/Room: 1 / Wood Shop
Priority: 3
Quantity/Unit of Measure: 1/EA
Total Deficiency Cost: \$5,550
Deficiency Description: *The load center is past its expected useful life.*

Comments: *Load Center*

Description of Work: *Replace the existing load center with a new load center.*

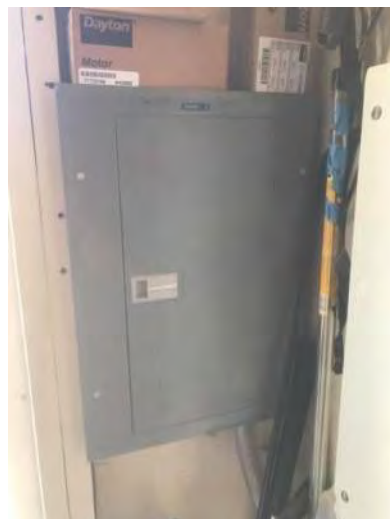
Record ID: 621
System: D5020 - ELECTRICAL SERVICE AND DISTRIBUTION
Item No.: D5020.30.4001
Floor/Room: 1 / Wood Shop
Priority: 3
Quantity/Unit of Measure: 1/EA
Total Deficiency Cost: \$5,550
Deficiency Description: *The load center is past its expected useful life.*
Description of Work: *Replace the existing load center with a new load center.*
Comments: *Panelboard*

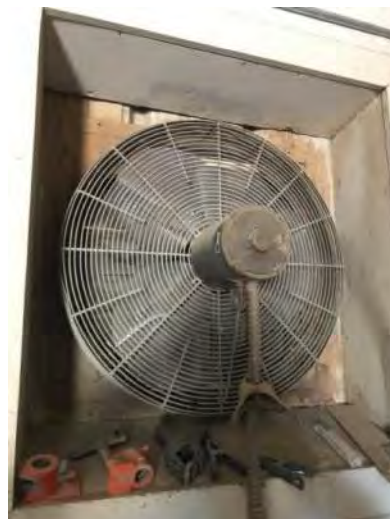
Record ID: 622
System: D3060 - VENTILATION
Item No.: D3060.30.007
Floor/Room: 1 / Wood Shop
Priority: 4
Quantity/Unit of Measure: 1/EA
Total Deficiency Cost: \$7,580
Deficiency Description: *Ventilator is approaching the end of its expected useful life.*
Description of Work: *Provide equipment replacement and installation.*
Comments: *Ventilator*

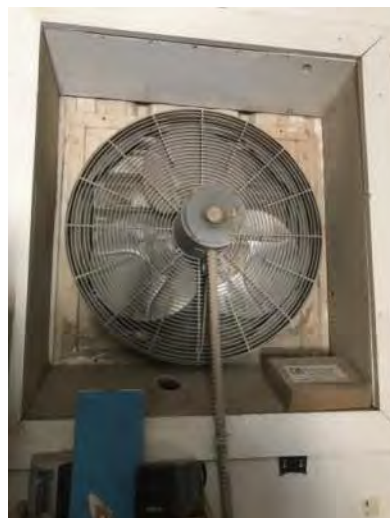
Record ID: 623
System: D3060 - VENTILATION
Item No.: D3060.30.007
Floor/Room: 1 / Wood Shop
Priority: 4
Quantity/Unit of Measure: 1/EA
Total Deficiency Cost: \$7,580
Deficiency Description: *Ventilator is approaching the end of its expected useful life.*
Description of Work: *Provide equipment replacement and installation.*
Comments: *Ventilator*

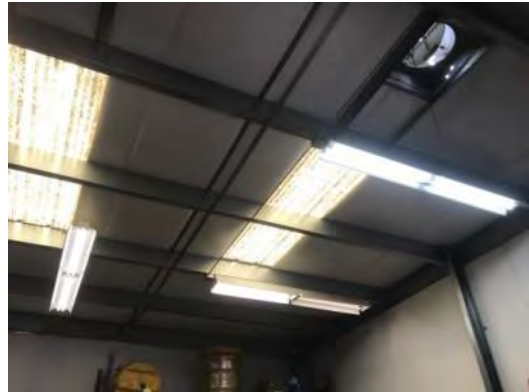
Item No.: D5040.50.411
Floor/Room: 1
Priority: 3
Quantity/Unit of Measure: 8,250/SF
Total Deficiency Cost: \$534,370
Deficiency Description: *Interior lighting system is at or is approaching end of its expected useful life.*

Description of Work: *Provide new interior lighting and control system throughout building per current CEC T24 code.*

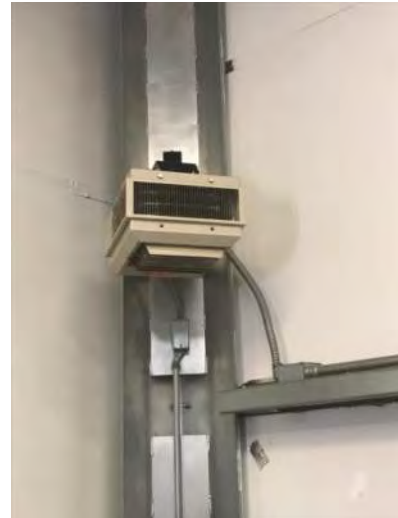
Record ID: 626
System: D3020 - HEATING SYSTEMS

Item No.: D3020.70.003
Floor/Room: 1
Priority: 5
Quantity/Unit of Measure: 1/EA
Total Deficiency Cost: \$14,620
Deficiency Description: *Unit heater is approaching the end of its expected useful life.*

Comments: *Unit Heater*

Description of Work: *Provide equipment replacement and installation.*

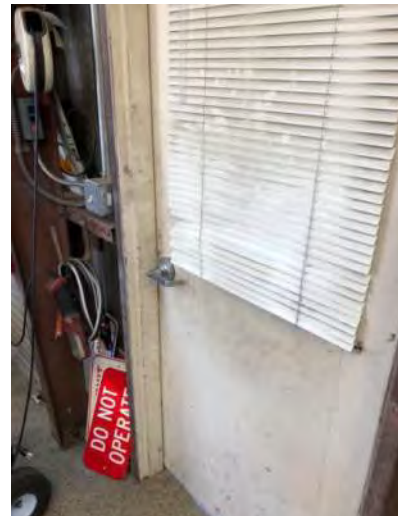
Record ID: 713
System: B2050 - EXTERIOR DOORS AND GRILLES

Item No.: B2050.10.006
Floor/Room: 1 / Maintenance Bldg
Priority: 3
Quantity/Unit of Measure: 1/EA
Total Deficiency Cost: \$7,990
Deficiency Description: *Exterior aluminum entrance door, frame and hardware is approaching the end of its useful life.*

Description of Work: *Replace aluminum door, frame, and hardware.*

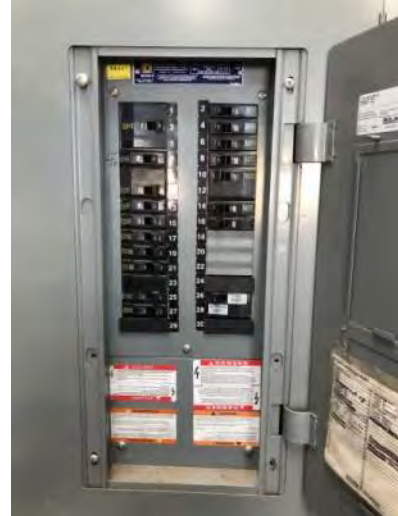
Record ID: 715
System: D5020 - ELECTRICAL SERVICE AND DISTRIBUTION
Item No.: D5020.30.1007
Floor/Room: 1
Priority: 3
Quantity/Unit of Measure: 1/EA
Total Deficiency Cost: \$12,980
Deficiency Description: *The 100A (120/208, 3P) panelboard is approaching the end of its expected useful life.*
Description of Work: *Replace the existing panelboard with a new panelboard.*
Comments: *Panelboard*

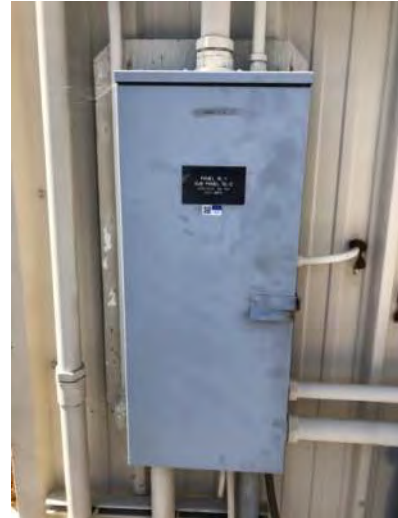
Record ID: 719
System: D5020 - ELECTRICAL SERVICE AND DISTRIBUTION
Item No.: D5020.30.4001
Floor/Room: 1
Priority: 3
Quantity/Unit of Measure: 1/EA
Total Deficiency Cost: \$5,550
Deficiency Description: *The load center is past its expected useful life.*
Description of Work: *Replace the existing load center with a new load center.*
Comments: *Panelboard*

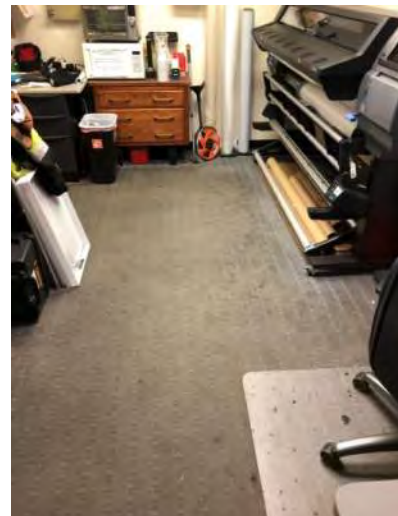
Record ID: 722
System: C2030 - FLOORING
Item No.: C2030.75.002
Floor/Room: 1 / Street dept
Priority: 3
Quantity/Unit of Measure: 400/SF
Total Deficiency Cost: \$11,650
Deficiency Description: *Rolled carpeting is approaching the end of its useful life.*
Description of Work: *Remove existing rolled carpeting and replace it with new 40 oz. nylon carpet.*
Comments:

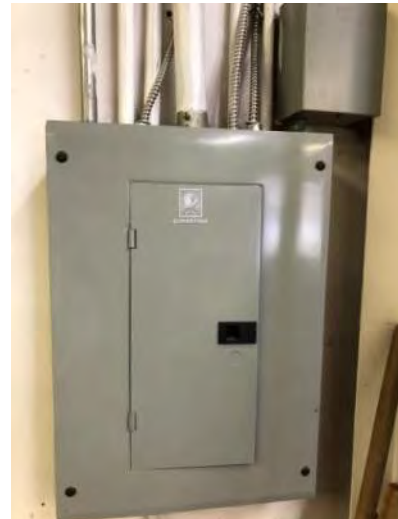
Record ID: 724
System: D5020 - ELECTRICAL SERVICE AND DISTRIBUTION
Item No.: D5020.30.4001
Floor/Room: 1 / Street dept
Priority: 3
Quantity/Unit of Measure: 1/EA
Total Deficiency Cost: \$5,550
Deficiency Description: *The load center is past its expected useful life.*

Comments: *Load Center*

Description of Work: *Replace the existing load center with a new load center.*

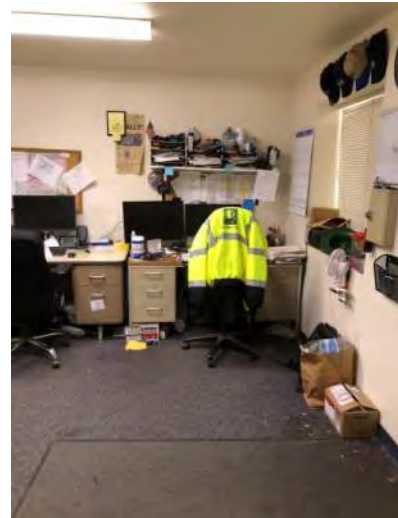
Record ID: 725
System: C2030 - FLOORING
Item No.: C2030.75.002
Floor/Room: 1 / Facilities
Priority: 3
Quantity/Unit of Measure: 1,200/SF
Total Deficiency Cost: \$34,910
Deficiency Description: *Rolled carpeting is approaching the end of its useful life.*

Description of Work: *Remove existing rolled carpeting and replace it with new 40 oz. nylon carpet.*

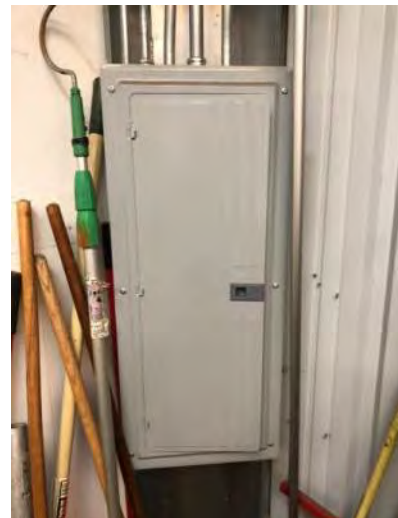
Record ID: 728
System: D5020 - ELECTRICAL SERVICE AND DISTRIBUTION
Item No.: D5020.30.4001
Floor/Room: 1 / Hazmat storage
Priority: 3
Quantity/Unit of Measure: 1/EA
Total Deficiency Cost: \$5,550
Deficiency Description: *The load center is past its expected useful life.*

Comments: *Panelboard*

Description of Work: *Replace the existing load center with a new load center.*

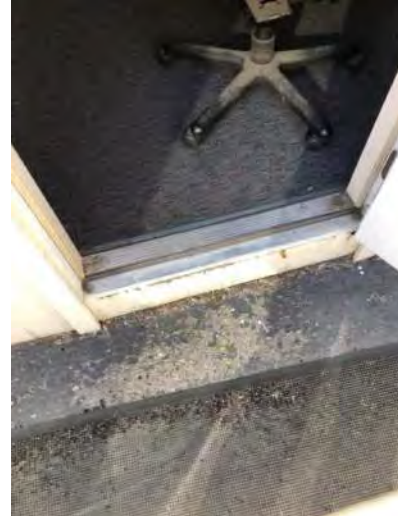
Priority: 3
Quantity/Unit of Measure: 1/EA
Total Deficiency Cost: \$570

Deficiency Description: *The existing threshold is approaching the end of its useful life.*

Description of Work: *Replace the associated threshold.*

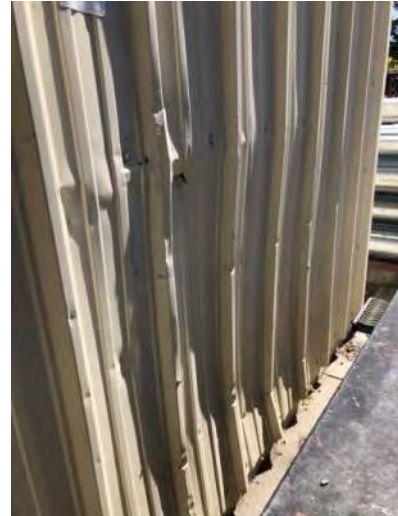
Record ID: 1116
System: B2010 - EXTERIOR WALLS

Item No.: B2010.10.012
Floor/Room: 1 / Street Dept

Priority: 3
Quantity/Unit of Measure: 100/SF
Total Deficiency Cost: \$5,850

Deficiency Description: *Metal siding panels damaged in several locations.*

Description of Work: *Replace damaged panels.*

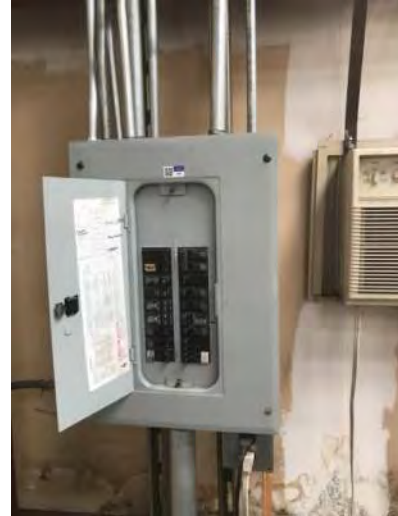
Record ID: 628
System: D5020 - ELECTRICAL SERVICE AND DISTRIBUTION
Item No.: D5020.30.4001
Floor/Room: 1
Priority: 3
Quantity/Unit of Measure: 1/EA
Total Deficiency Cost: \$5,550
Deficiency Description: *The load center is past its expected useful life.*

Comments: *Load Center*

Description of Work: *Replace the existing load center with a new load center.*

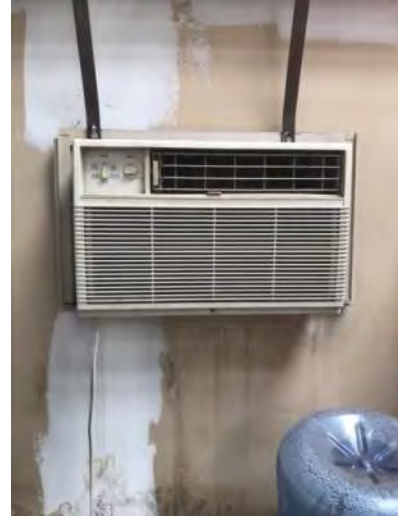
Record ID: 629
System: D3030 - COOLING SYSTEMS
Item No.: D3030.70.032
Floor/Room: 1
Priority: 3
Quantity/Unit of Measure: 1/EA
Total Deficiency Cost: \$7,270
Deficiency Description: *Wall mounted AC unit is approaching the end of its expected useful life.*

Comments: *Air Conditioner - Wall Mounted*

Description of Work: *Provide equipment replacement and installation.*

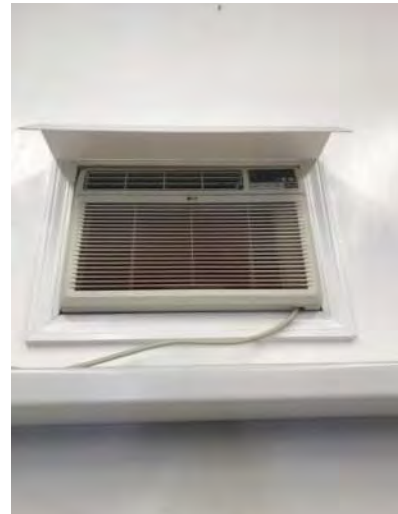
Record ID: 631
System: D3030 - COOLING SYSTEMS
Item No.: D3030.70.032
Floor/Room: 1 / Street Lights
Priority: 5
Quantity/Unit of Measure: 1/EA
Total Deficiency Cost: \$7,890
Deficiency Description: *Wall mounted AC unit is approaching the end of its expected useful life.*

Comments: *Air Conditioner - Wall Mounted*

Description of Work: *Provide equipment replacement and installation.*

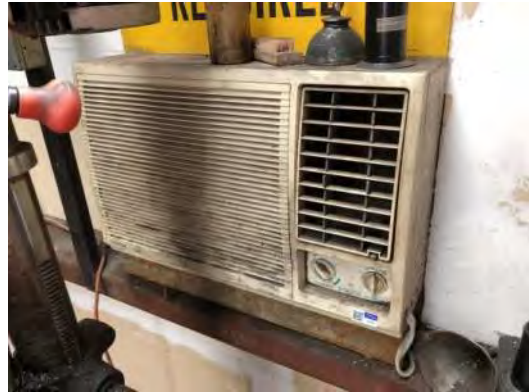
Item No.: D3030.70.032
Floor/Room: 1
Priority: 5
Quantity/Unit of Measure: 1/EA
Total Deficiency Cost: \$7,890
Deficiency Description: *Wall mounted AC unit is approaching the end of its expected useful life.*

Comments: *Air Conditioner - Wall Mounted*

Description of Work: *Provide equipment replacement and installation.*

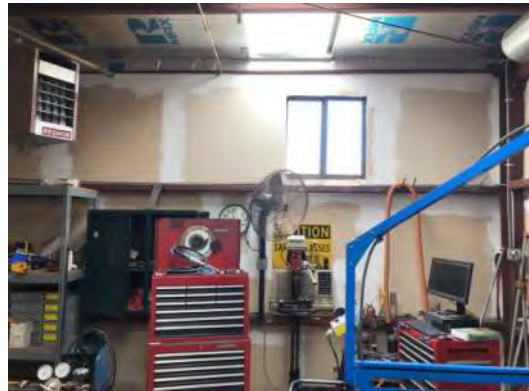
Record ID: 730
System: C2010 - WALL FINISHES

Item No.: C2010.30.004
Floor/Room: 1
Priority: 3
Quantity/Unit of Measure: 1,000/SF
Total Deficiency Cost: \$6,850
Deficiency Description: *Interior wall paint is in need of refresh.*

Description of Work: *Paint interior walls with 2 coat finish (includes surface prep and primer).*

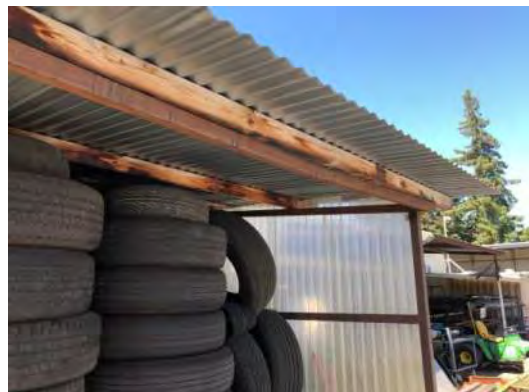
Record ID: 731
System: B2080 - EXTERIOR WALL APPURTENANCES

Item No.: B2080.30.003
Floor/Room: 1
Priority: 3
Quantity/Unit of Measure: 700/SF
Total Deficiency Cost: \$25,470
Deficiency Description: *Awning (metal) is approaching the end of its useful life.*

Description of Work: *Replace metal awning.*

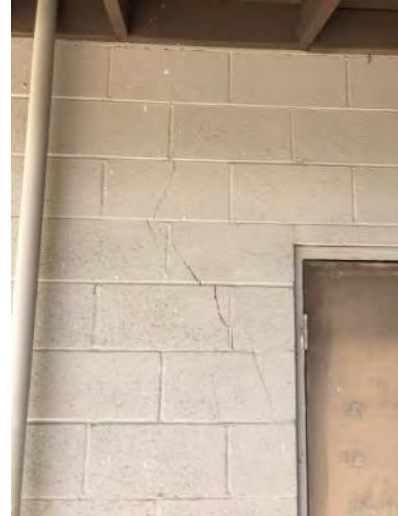
The exterior consists of CMU, asphalt shingling, coiling windows & doors, and HM doors. At select locations cracking was noted in the CMU walls and should be caulked and repainted. HM door frames are damaged, not weather proofed properly, and should be replaced. Rusting was noted at the coiling window and door frames. Overall, the exterior is in fair condition.

Comments: *Cracking in CMU exterior wall noted. Use epoxy filler and repaint.*

Description of Work: *Clean and repaint CMU walls.*

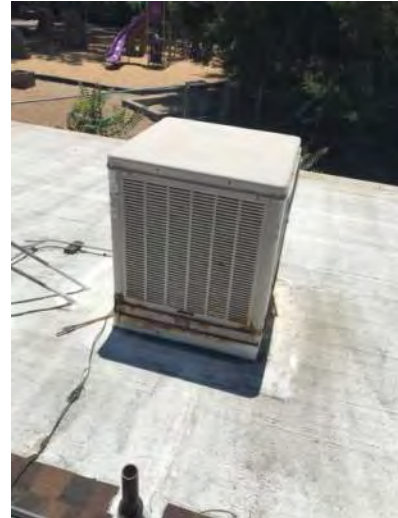
Record ID: 1005
System: D3030 - COOLING SYSTEMS

Item No.: D3030.30.001
Floor/Room: Roof / N/A
Priority: 5
Quantity/Unit of Measure: 1/EA
Total Deficiency Cost: \$73,090
Deficiency Description: *Evaporative cooler is approaching the end of its expected useful life.*

Comments: *Evaporative Cooler*

Description of Work: *Provide equipment replacement and installation.*

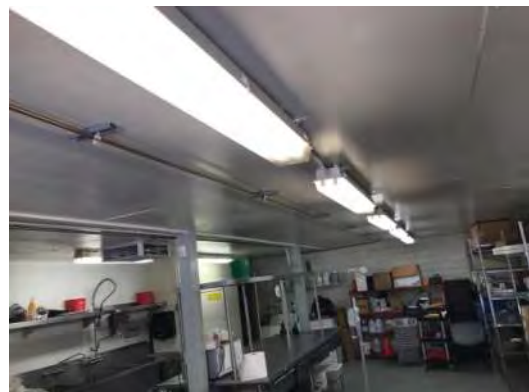
Record ID: 1006
System: D5040 - LIGHTING

Item No.: D5040.50.411
Floor/Room: 1 / All
Priority: 3
Quantity/Unit of Measure: 2,100/SF
Total Deficiency Cost: \$136,050
Deficiency Description: *Interior lighting system is at or is approaching end of its expected useful life.*

Description of Work: *Provide new interior lighting and control system throughout building per current CEC T24 code.*

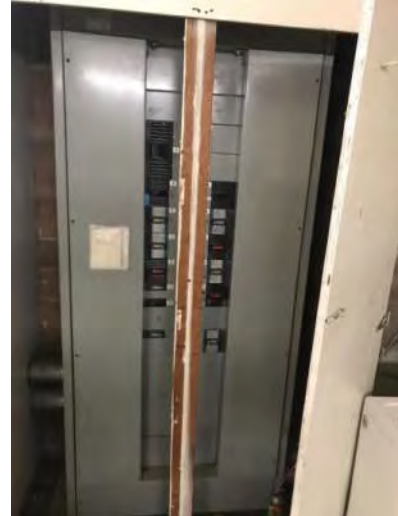
Comments: *Switchboard*

Description of Work: *Replace the existing switchboard with a new switchboard.*

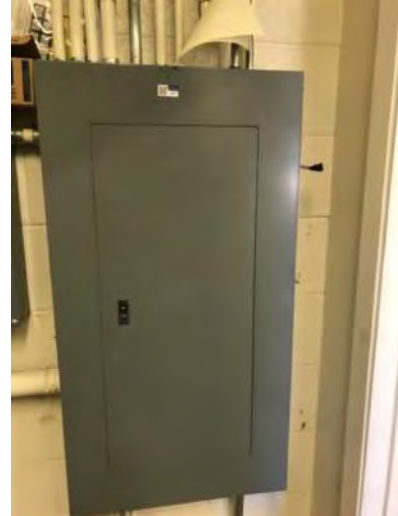
Record ID: 1011
System: D5020 - ELECTRICAL SERVICE AND DISTRIBUTION
Item No.: D5020.30.1002
Floor/Room: 1 / Electrical Room
Priority: 3
Quantity/Unit of Measure: 1/EA
Total Deficiency Cost: \$20,700
Deficiency Description: *The 225A (120/240V, 3P) panelboard is approaching the end of its expected useful life.*

Comments: *Panelboard*

Description of Work: *Replace the existing panelboard with a new panelboard.*

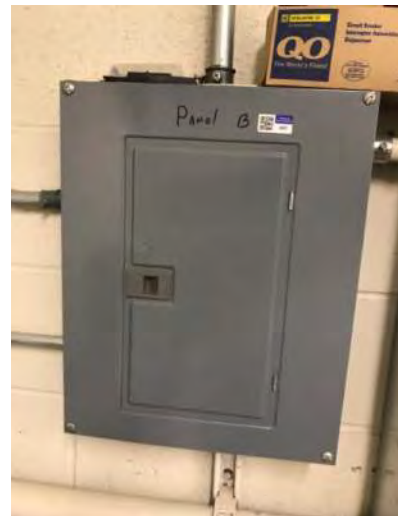
Record ID: 1012
System: D5020 - ELECTRICAL SERVICE AND DISTRIBUTION
Item No.: D5020.30.4002
Floor/Room: 1 / Electrical Room
Priority: 3
Quantity/Unit of Measure: 1/EA
Total Deficiency Cost: \$6,910
Deficiency Description: *The load center is approaching the end of its expected useful life.*

Comments: *Load Center*

Description of Work: *Replace the existing load center with a new load center.*

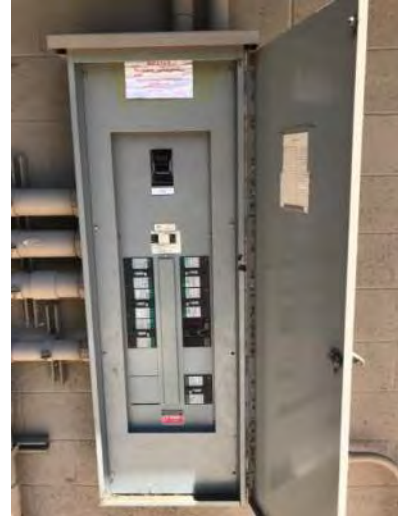
Record ID: 1017
System: D5020 - ELECTRICAL SERVICE AND DISTRIBUTION
Item No.: D5020.30.1009
Floor/Room: 1 / Exterior
Priority: 3
Quantity/Unit of Measure: 1/EA
Total Deficiency Cost: \$26,340
Deficiency Description: *The 400A (120/208, 3P) panelboard is approaching the end of its expected useful life.*
Description of Work: *Replace the existing panelboard with a new panelboard.*
Comments: *Panelboard*

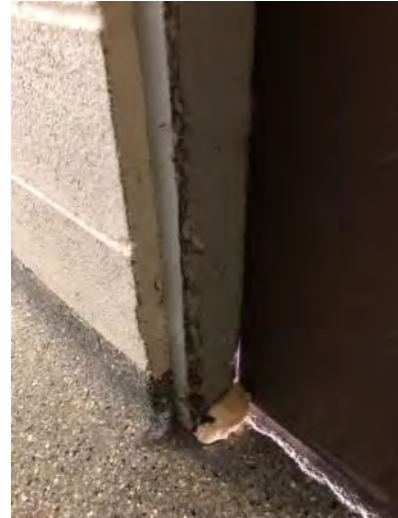
Record ID: 1024
System: B2050 - EXTERIOR DOORS AND GRILLES
Item No.: B2050.90.001
Floor/Room: 1 / Corridor
Priority: 3
Quantity/Unit of Measure: 1/EA
Total Deficiency Cost: \$6,570
Deficiency Description: *Existing door frames are deteriorated.*
Description of Work: *Replace door frame, reinstall the door and its associated hardware.*
Comments: *Remove spray foam and install proper weather stripping and door sweeps.*

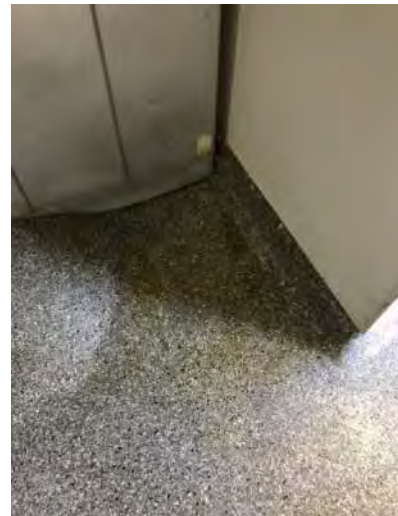
Record ID: 1025
System: C2030 - FLOORING
Item No.: C2030.10.002
Floor/Room: 1 / General
Priority: 4
Quantity/Unit of Measure: 1,700/SF
Total Deficiency Cost: \$96,610
Deficiency Description: *Epoxy is approaching the end of its useful life.*
Description of Work: *Remove the existing epoxy and replace.*
Comments:

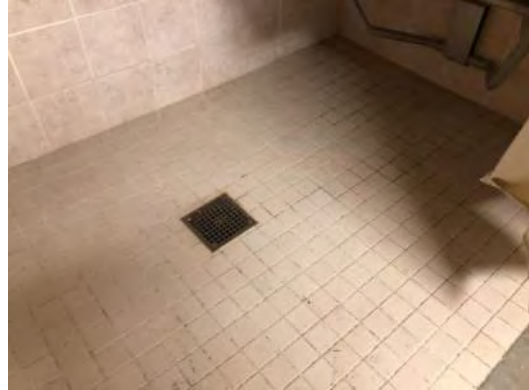
Item No.: C2030.20.001
Floor/Room: 1 / Shower
Priority: 3
Quantity/Unit of Measure: 1/SF
Total Deficiency Cost: \$90
Deficiency Description: *Ceramic tile floor is approaching the end of its useful life.*

Comments: *Clean and regrout existing tile. Replace any damaged or broken tiles.*

Description of Work: *Remove the existing ceramic tile flooring and replace.*

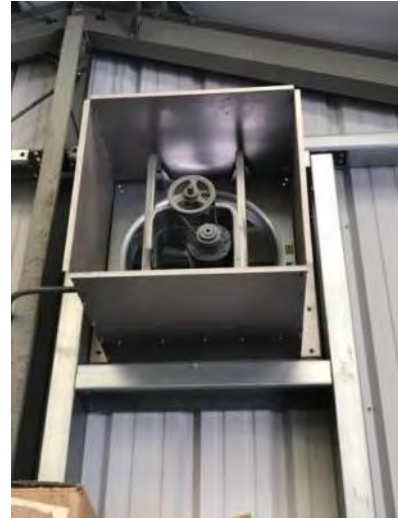
Item No.: D3060.30.007
Floor/Room: 1
Priority: 3
Quantity/Unit of Measure: 1/EA
Total Deficiency Cost: \$7,270
Deficiency Description: *Ventilator is approaching the end of its expected useful life.*

Comments: *Ventilator*

Description of Work: *Provide equipment replacement and installation.*

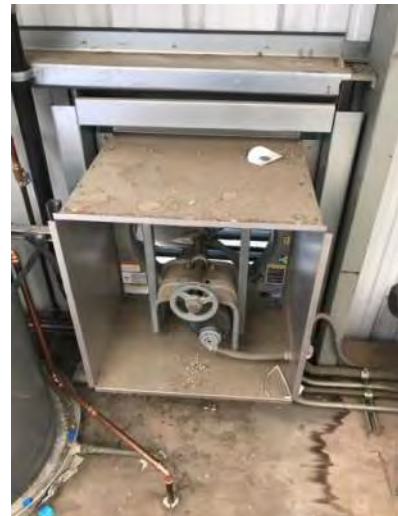
Item No.: D3060.30.007
Floor/Room: 2 / Mezzanine
Priority: 3
Quantity/Unit of Measure: 1/EA
Total Deficiency Cost: \$7,270
Deficiency Description: *Ventilator is approaching the end of its expected useful life.*

Comments: *Ventilator*

Description of Work: *Provide equipment replacement and installation.*

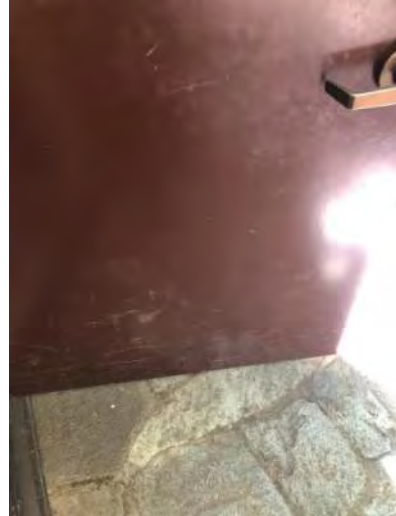
Item No.: B2050.20.002
Floor/Room: 1 / Interior
Priority: 5
Quantity/Unit of Measure: 1/EA
Total Deficiency Cost: \$4,750
Deficiency Description: *Metal door is damaged or deteriorated.*

Description of Work: *Repair door and repaint.*

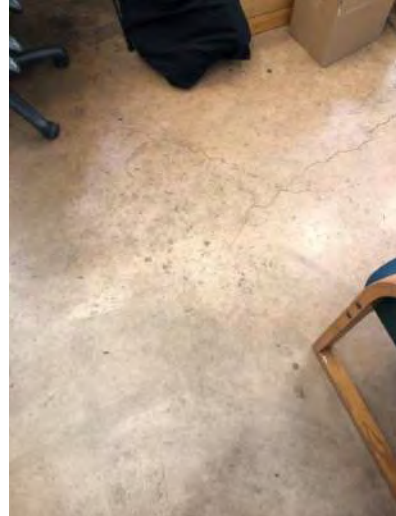
Item No.: C2030.10.001
Floor/Room: 1 / Interior
Priority: 5
Quantity/Unit of Measure: 160/SF
Total Deficiency Cost: \$3,180
Deficiency Description: *Sealed concrete floor is approaching the end of its useful life.*

Description of Work: *Repair and refinish the concrete floor.*

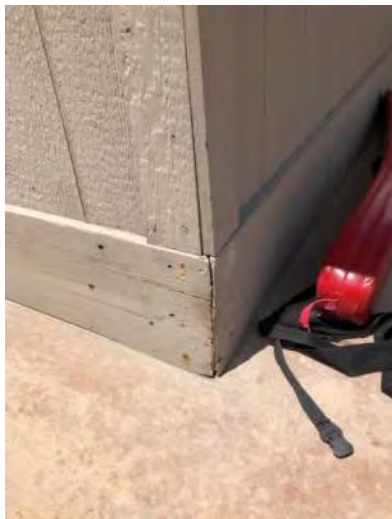
Item No.: B2010.10.006
Floor/Room: 1 / Exterior
Priority: 5
Quantity/Unit of Measure: 30/LF
Total Deficiency Cost: \$1,220
Deficiency Description: *Trim is worn and should be replaced.*

Description of Work: *Replace trim and finish to match. Replace at the same time as siding.*

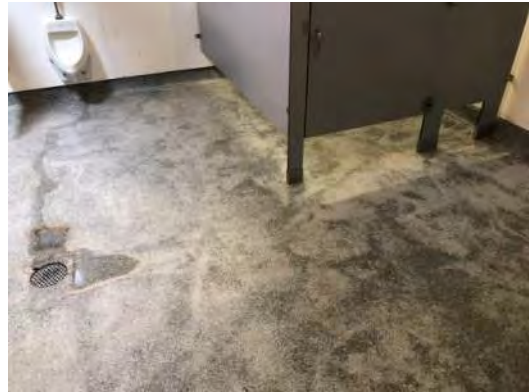
Item No.: C2030.10.002
Floor/Room: 1 / Dressing Room(s)
Priority: 3
Quantity/Unit of Measure: 900/SF
Total Deficiency Cost: \$49,080
Deficiency Description: *Epoxy is approaching the end of its useful life.*

Description of Work: *Remove the existing epoxy and replace.*

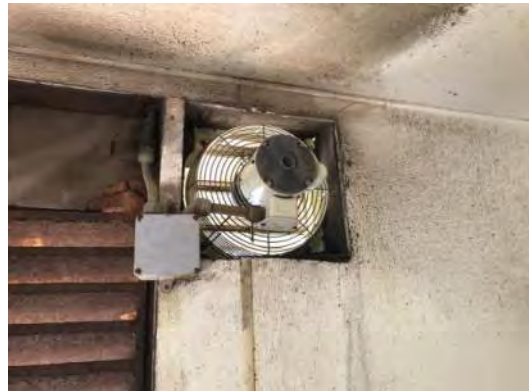
Item No.: D3060.30.030
Floor/Room: 1
Priority: 1
Quantity/Unit of Measure: 1/EA
Total Deficiency Cost: \$11,730
Deficiency Description: *Sidewall propeller fan is approaching the end of its expected useful life.*

Ventilator

Description of Work: *Provide equipment replacement and installation.*

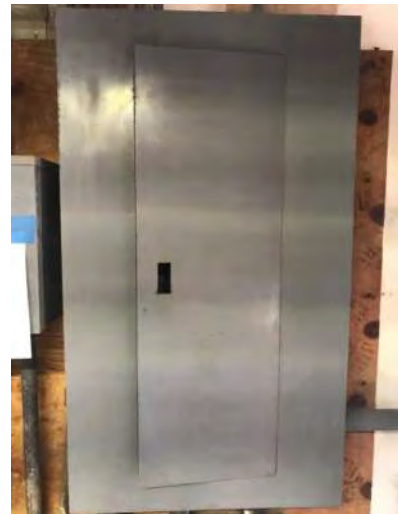
Item No.: D5020.30.1021
Floor/Room: 1 / Pump Room
Priority: 3
Quantity/Unit of Measure: 1/EA
Total Deficiency Cost: \$27,910
Deficiency Description: *The 225A (40 ckts, 120/240, 1P) panelboard is approaching the end of its expected useful life.*

Panelboard

Description of Work: *Replace the existing panelboard with a new panelboard.*

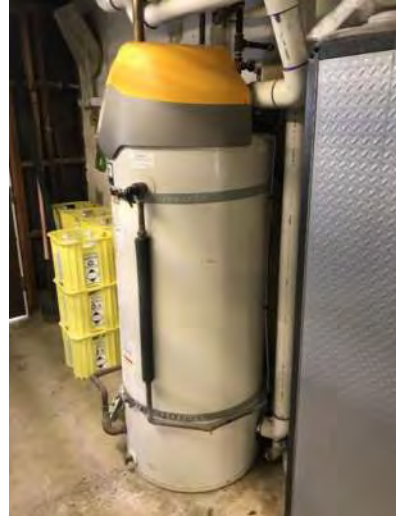
Item No.: D2010.20.003
Floor/Room: 1 / Pump Room
Priority: 4
Quantity/Unit of Measure: 1/EA
Total Deficiency Cost: \$29,290
Deficiency Description: *Gas fired water heater is approaching the end of its expected useful life.*

Comments: *Water Heater*

Description of Work: *Provide equipment replacement and installation.*

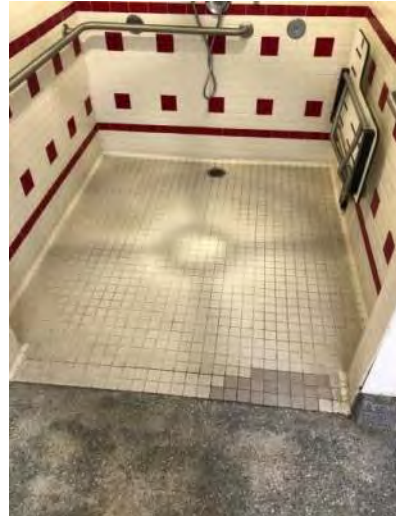
Item No.: C2030.20.003
Floor/Room: 1 / Dressing Room(s)
Priority: 3
Quantity/Unit of Measure: 80/SF
Total Deficiency Cost: \$5,850
Deficiency Description: *Grout is damaged and deteriorating on the tiled floor.*

Comments: *Replace any broken tiles.*

Description of Work: *Clean and regrout tiles.*

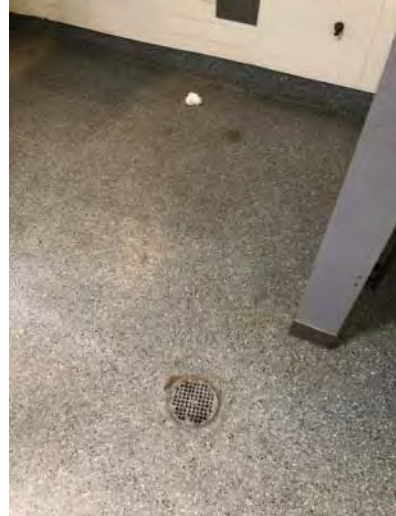
Item No.: C2030.10.002
Floor/Room: 1 / Restroom(s)
Priority: 3
Quantity/Unit of Measure: 480/SF
Total Deficiency Cost: \$26,190
Deficiency Description: *Epoxy is approaching the end of its useful life.*

Description of Work: *Remove the existing epoxy and replace.*

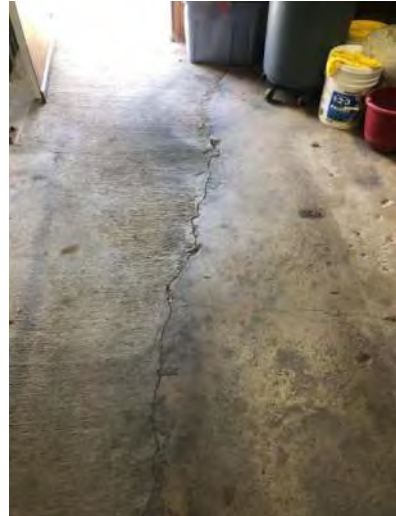
Item No.: A4010.10.002
Floor/Room: 1 / Pump Room
Priority: 3
Quantity/Unit of Measure: 380/SF
Total Deficiency Cost: \$9,690
Deficiency Description: *The concrete pad has major cracks and divots that present tripping hazards.*

Description of Work: *Repair the concrete pad to eliminate tripping hazards.*

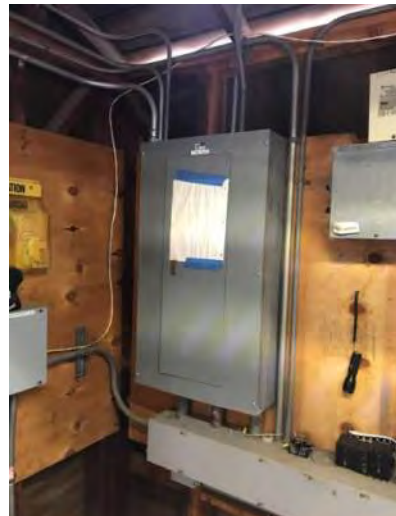
Item No.: D5020.30.1008
Floor/Room: 1
Priority: 3
Quantity/Unit of Measure: 1/EA
Total Deficiency Cost: \$21,020
Deficiency Description: *The 225A (42 ckts, 120/208, 3P) panelboard is approaching the end of its expected useful life.*

Panelboard

Description of Work: *Replace the existing panelboard with a new panelboard.*

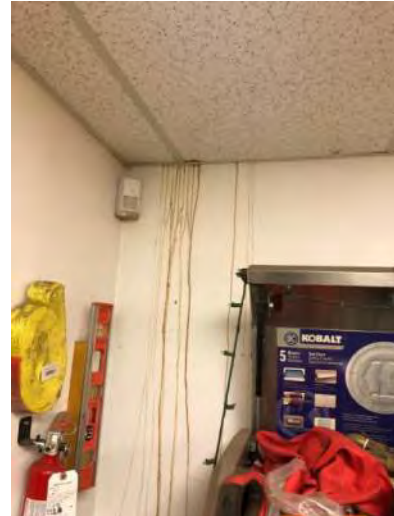
Item No.: D2030.30.005
Floor/Room: 1 / Garage
Priority: 3
Quantity/Unit of Measure: 1/EA
Total Deficiency Cost: \$12,740
Deficiency Description: *Evidence of leaks at roof drains & overflow drains with damage to soffit around downspout penetration.*

Comments: *Water damage noted on interior walls. Suspected source is drain outlet from high to low roof.*

Description of Work: *Replace roof & overflow drains & accessories including downspout through soffit.*

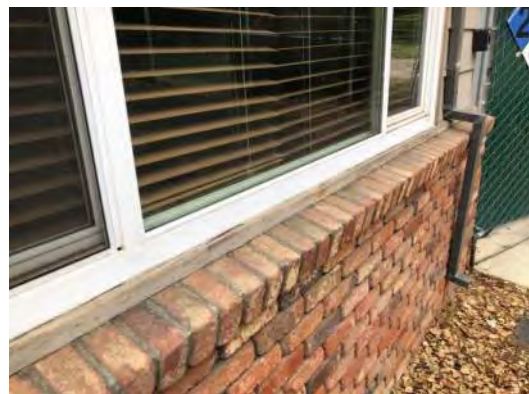
Item No.: B2010.10.006
Floor/Room: 1 / Exterior
Priority: 3
Quantity/Unit of Measure: 1/LF
Total Deficiency Cost: \$60
Deficiency Description: *Trim is worn and should be replaced.*

Description of Work: *Replace trim and finish to match. Replace at the same time as siding.*

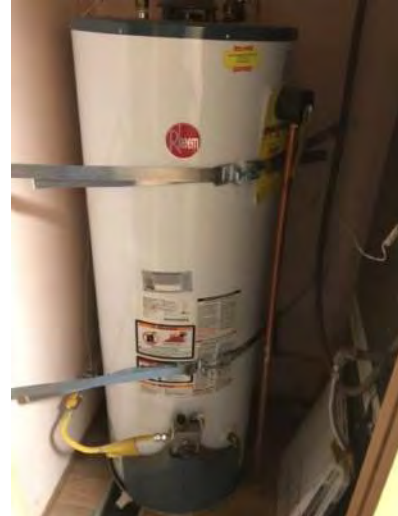
Comments: *Water Heater*

Description of Work: *Provide equipment replacement and installation.*

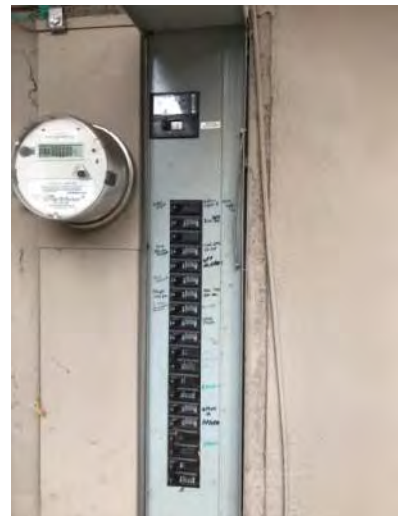
Comments: *Panelboard*

Description of Work: *Replace the existing all-in-one combination service entrance device with a new all-in-one combination service entrance device.*

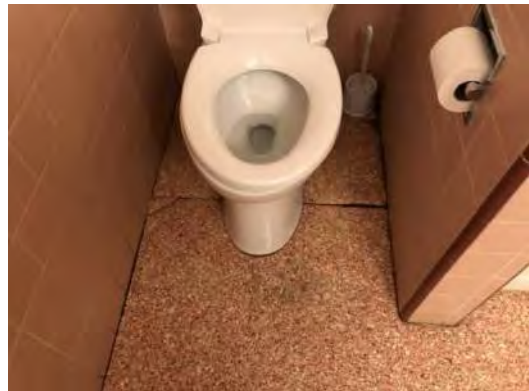
Item No. C2030.50.002
Floor/Room: 1 / Staff Restroom
Priority: 3
Quantity/Unit of Measure: 55/SF
Total Deficiency Cost: \$2,550
Deficiency Description: *Sheet vinyl is approaching the end of its useful life.*

Description of Work: *Remove the existing sheet vinyl and replace.*

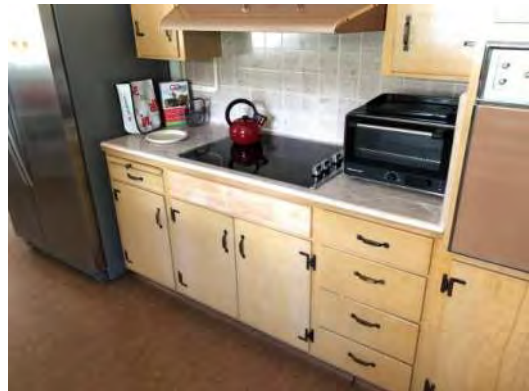
Item No. E2010.30.004
Floor/Room: 1 / Kitchen
Priority: 3
Quantity/Unit of Measure: 60/LF
Total Deficiency Cost: \$98,150
Deficiency Description: *The existing casework is at or is approaching the end of its useful life.*

Description of Work: *Replace original wood cabinets and countertops.*

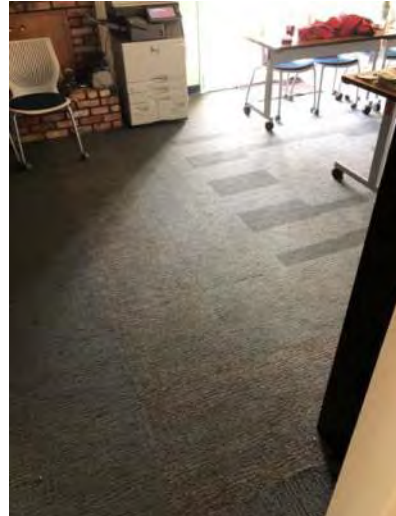
Item No.: C2030.75.001
Floor/Room: 1 / Conference Room
Priority: 4
Quantity/Unit of Measure: 640/SF
Total Deficiency Cost: \$19,410
Deficiency Description: *Carpet tile is missing or damaged.*

Description of Work: *Replace carpet tile.*

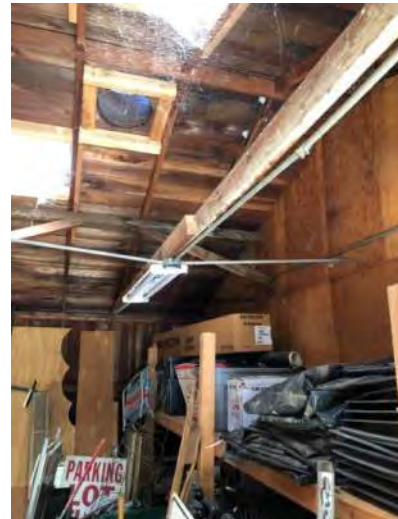
Comments: *Noticeable deterioration, water damage, and impromptu repairs.*

Description of Work: *Remove and replace wood roof framing and decking.*

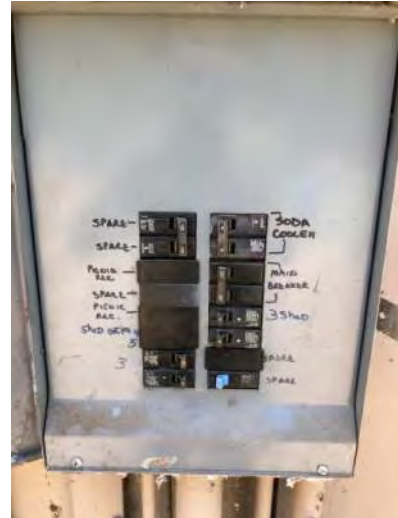
Item No.: D5020.30.4001
 Floor/Room: 1
 Priority: 3
 Quantity/Unit of Measure: 1/EA
 Total Deficiency Cost: \$5,550
 Deficiency Description: *The load center is past its expected useful life.*

Comments: *Load Center*

Description of Work: *Replace the existing load center with a new load center.*

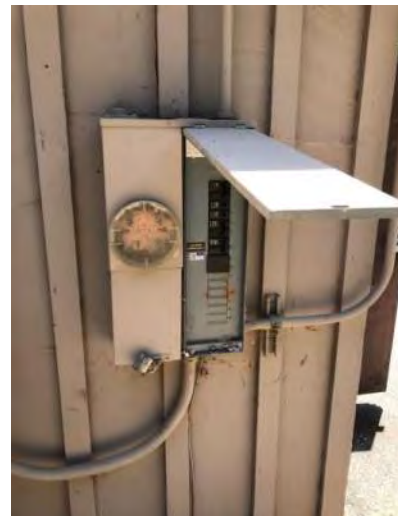
Item No.: D5020.10.007
 Floor/Room: 1
 Priority: 3
 Quantity/Unit of Measure: 1/EA
 Total Deficiency Cost: \$9,320
 Deficiency Description: *The all-in-one combination service entrance pedestal is past its expected useful life.*

Comments: *Service Entrance*

Description of Work: *Replace the existing all-in-one combination service entrance device with a new all-in-one combination service entrance device.*

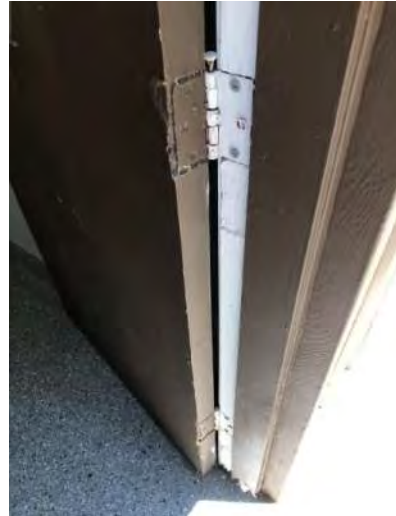
Item No.: B2050.10.005
Floor/Room: 1 / Men's
Priority: 3
Quantity/Unit of Measure: 2/EA
Total Deficiency Cost: \$10,940
Deficiency Description: *Exterior wood entrance door, frame and hardware is approaching the end of its useful life.*

Description of Work: *Replace wood door, frame, and hardware.*

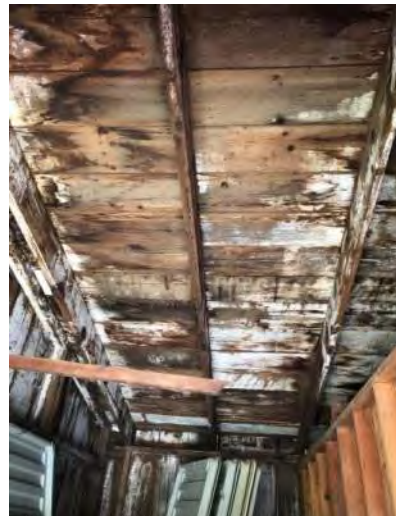
Item No.: B1020.10.001
Floor/Room: 1 / Storage
Priority: 3
Quantity/Unit of Measure: 360/SF
Total Deficiency Cost: \$26,190
Deficiency Description: *Wood roof framing and decking are in poor condition.*

Description of Work: *Remove and replace wood roof framing and decking.*

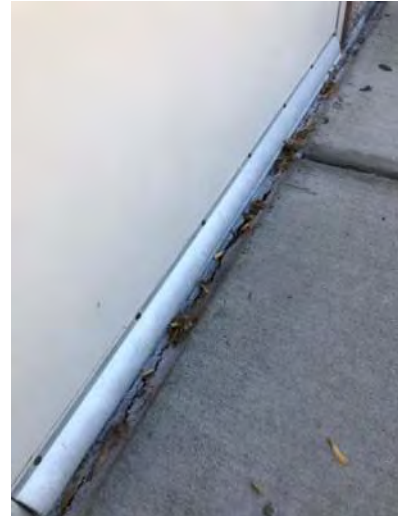
Item No.: G2030.10.008
Floor/Room: 1 / Exterior
Priority: 3
Quantity/Unit of Measure: 300/LF
Total Deficiency Cost: \$3,300
Deficiency Description: *Caulking is missing / damaged.*

Comments: *Caulking between concrete pavement and foundation is cracked and beyond useful life.*

Description of Work: *Replace caulking.*

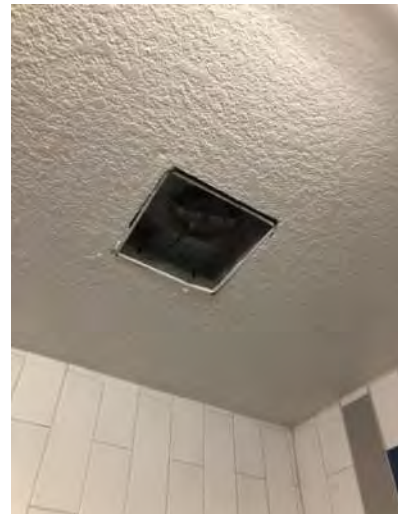
Item No.: D3060.30.002
Floor/Room: 1 / Restroom
Priority: 3
Quantity/Unit of Measure: 1/EA
Total Deficiency Cost: \$2,550
Deficiency Description: *Ceiling exhaust fan is approaching the end of its expected useful life.*

Comments: *Cover grille missing.*

Description of Work: *Provide equipment replacement and installation.*

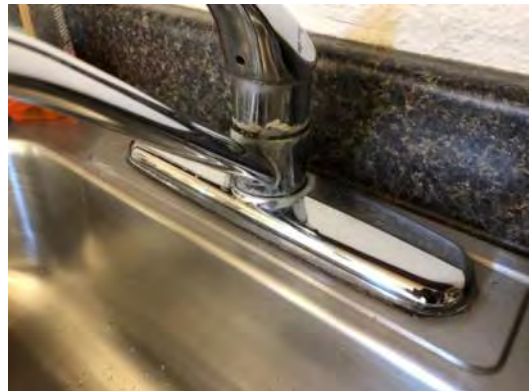
Item No.: D2010.60.022
Floor/Room: 1 / Community Room
Priority: 4
Quantity/Unit of Measure: 1/EA
Total Deficiency Cost: \$2,660
Deficiency Description: *Swing faucet is approaching the end of its expected useful life.*

Description of Work: *Provide equipment replacement and installation.*

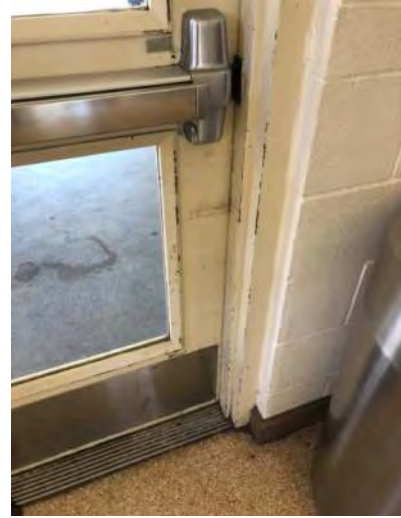
Deficiency Description: *Exterior doors, frames and hardware are approaching the end of their useful life.*

Description of Work: *Replace the exterior doors, frames and hardware.*

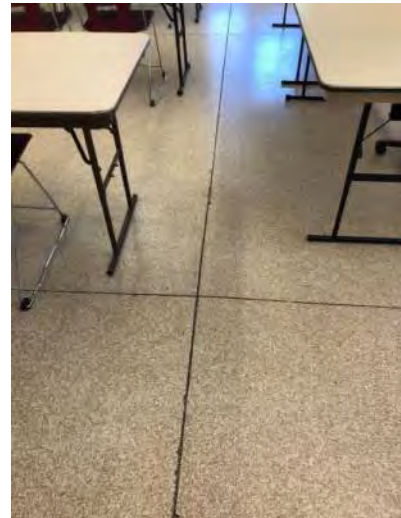
Record ID: 36
System: C2030 - FLOORING

Deficiency Description: *Sheet vinyl is approaching the end of its useful life.*

Description of Work: *Remove the existing sheet vinyl and replace.*

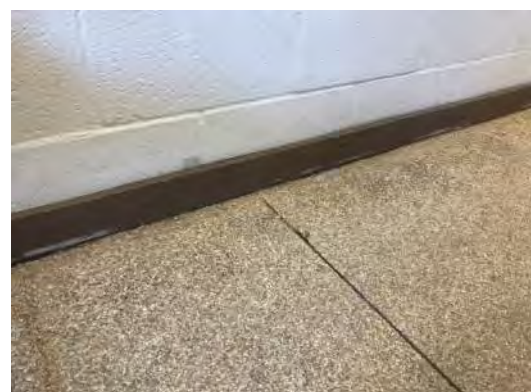
Record ID: 37
System: C2030 - FLOORING

Deficiency Description: *Wood wall base is approaching the end of its useful life.*

Description of Work: *Replace the wood wall base.*

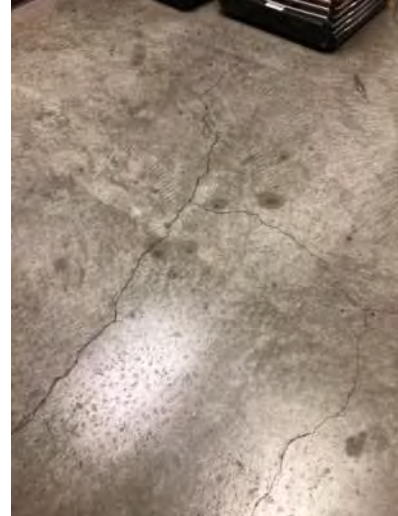
Item No.: C2030.10.001
Floor/Room: 1 / Community Room
Priority: 4
Quantity/Unit of Measure: 250/SF
Total Deficiency Cost: \$4,770
Deficiency Description: *Sealed concrete floor is approaching the end of its useful life.*

Description of Work: *Repair and refinish the concrete floor.*

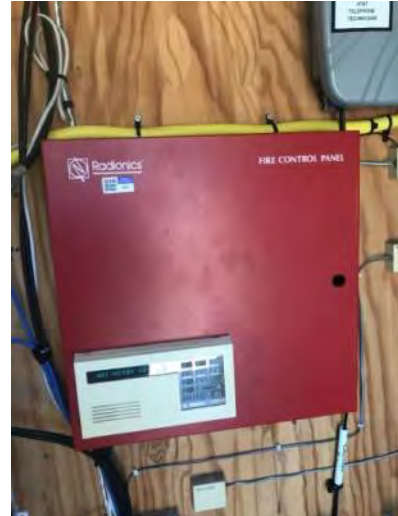
Record ID: 99
System: D7050 - DETECTION AND ALARM

Item No.: D7050.10.025
Floor/Room: 1
Priority: 1
Quantity/Unit of Measure: 1,750/SF
Total Deficiency Cost: \$34,940
Deficiency Description: *The existing fire alarm system is approaching the end of its useful life and should be replaced.*

Comments: *Fire Alarm Panel*

Description of Work: *Replace the existing fire alarm system with a complete, site-wide, fully addressable fire alarm system.*

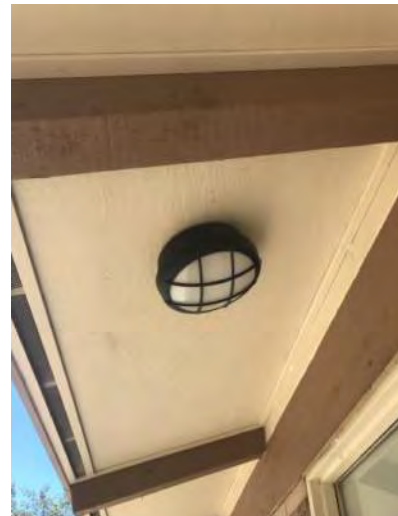
Record ID: 107
System: D5040 - LIGHTING

Item No.: D5040.50.302
Floor/Room: 1
Priority: 3
Quantity/Unit of Measure: 10/EA
Total Deficiency Cost: \$25,720
Deficiency Description: *The exterior fixture is past its expected useful life.*

Description of Work: *Replace the existing wall mounted lighting fixture with an LED lighting fixture.*

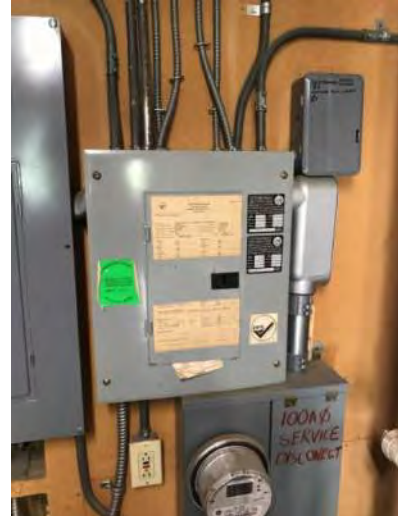
Record ID: 222
System: D5020 - ELECTRICAL SERVICE AND DISTRIBUTION
Item No.: D5020.30.4001
Floor/Room: 1
Priority: 3
Quantity/Unit of Measure: 1/EA
Total Deficiency Cost: \$5,550
Deficiency Description: *The load center is past its expected useful life.*

Comments: *Load Center*

Description of Work: *Replace the existing load center with a new load center.*

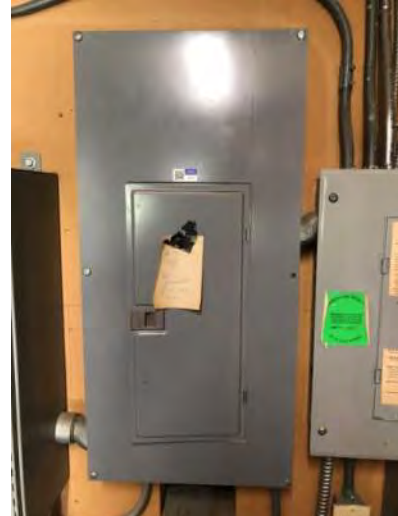
Record ID: 223
System: D5020 - ELECTRICAL SERVICE AND DISTRIBUTION
Item No.: D5020.30.4001
Floor/Room: 1
Priority: 3
Quantity/Unit of Measure: 1/EA
Total Deficiency Cost: \$5,550
Deficiency Description: *The load center is past its expected useful life.*

Comments: *Load Center*

Description of Work: *Replace the existing load center with a new load center.*

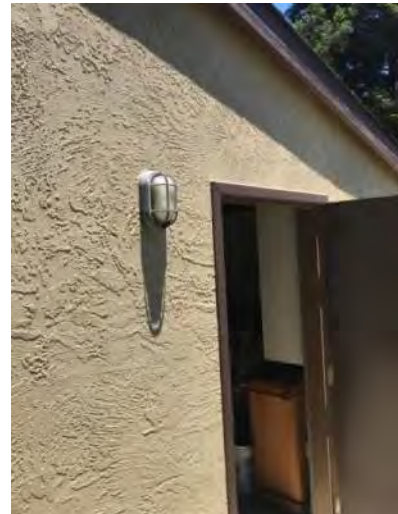
Record ID: 225
System: D5040 - LIGHTING
Item No.: D5040.50.302
Floor/Room: 1
Priority: 3
Quantity/Unit of Measure: 3/EA
Total Deficiency Cost: \$7,730
Deficiency Description: *The exterior wall mounted fixture is past its expected useful life.*

Description of Work: *Replace the existing wall mounted lighting fixture with an LED lighting fixture.*

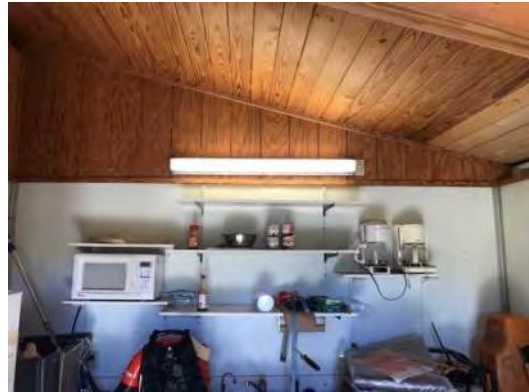
Item No.: D5040.50.406
Floor/Room: 1
Priority: 3
Quantity/Unit of Measure: 3/EA
Total Deficiency Cost: \$4,100
Deficiency Description: *The light fixtures are past their expected useful life.*

Description of Work: *Replace existing fixtures with LED fixtures.*

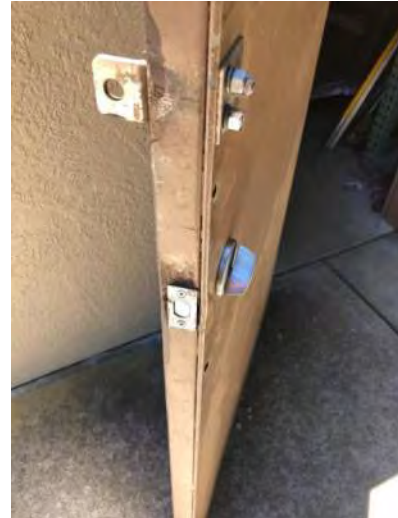
Record ID: 292
System: B2050 - EXTERIOR DOORS AND GRILLES

Item No.: B2050.20.003
Floor/Room: 1 / Storage
Priority: 3
Quantity/Unit of Measure: 1/EA
Total Deficiency Cost: \$12,740
Deficiency Description: *Exterior doors, frames and hardware are approaching the end of their useful life.*

Description of Work: *Replace the exterior doors, frames and hardware.*

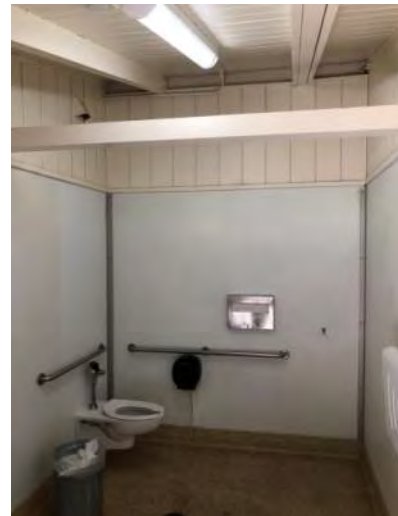
Record ID: 294
System: C2010 - WALL FINISHES

Item No.: C2010.20.003
Floor/Room: 1 / Restroom(s)
Priority: 3
Quantity/Unit of Measure: 600/SF
Total Deficiency Cost: \$13,110
Deficiency Description: *Fiberglass reinforced paneling is at or approaching the end of its useful life.*

Description of Work: *Install and replace the fiberglass reinforced paneling.*

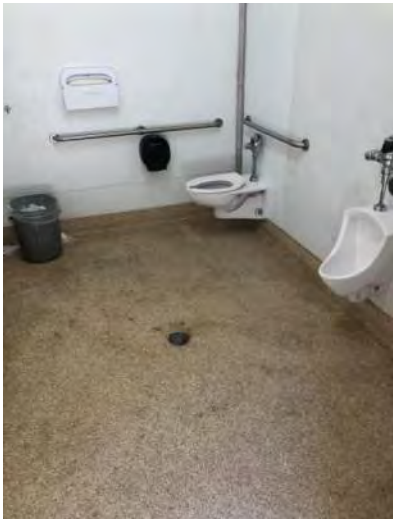
Record ID: 1042
System: C2030 - FLOORING

Item No.: C2030.10.002
Floor/Room: 1 / Restroom(s)
Priority: 3
Quantity/Unit of Measure: 300/SF
Total Deficiency Cost: \$16,370
Deficiency Description: *Epoxy is approaching the end of its useful life.*

Description of Work: *Remove the existing epoxy and replace.*

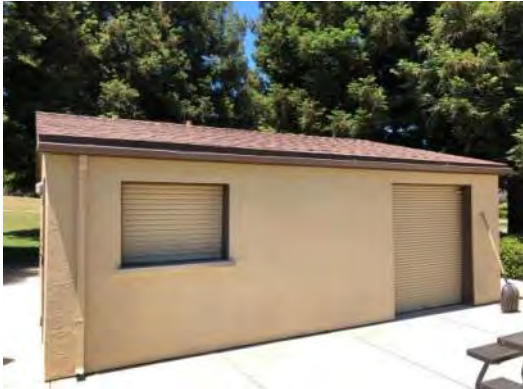
Record ID: 1043
System: B3020 - ROOF APPURTENANCES

Item No.: B3020.70.001
Floor/Room: 1 / Exterior
Priority: 3
Quantity/Unit of Measure: 50/LF
Total Deficiency Cost: \$2,740
Deficiency Description: *Rain leaders/gutters are damaged and leak.*

Description of Work: *Repair, replace rain leaders/gutters.*

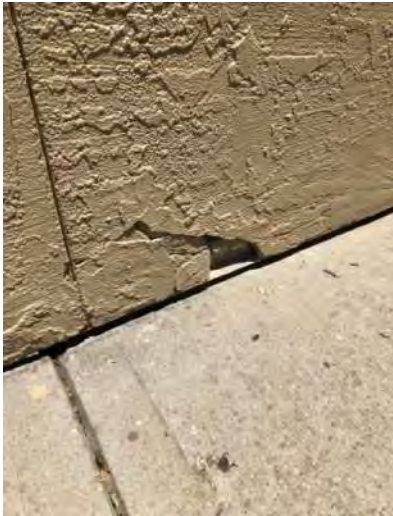
Record ID: 1044
System: B2010 - EXTERIOR WALLS

Item No.: B2010.10.009
Floor/Room: 1 / Exterior
Priority: 3
Quantity/Unit of Measure: 2/SF
Total Deficiency Cost: \$150
Deficiency Description: *Exterior cement plaster walls are damaged and spalling in several areas.*

Description of Work: *Clean, patch, and repair the cement plaster wall finish.*
