City of Cupertino

Facility Condition Assessment

Final Report

December 2, 2022

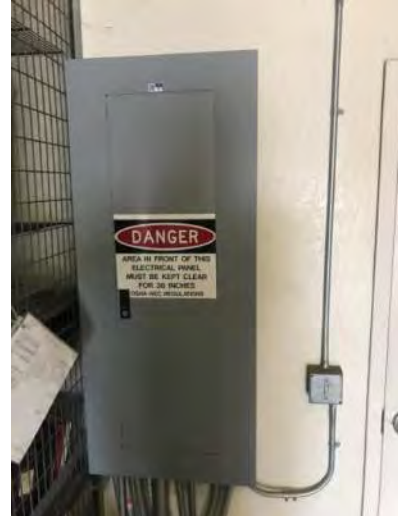
Record ID: 849
System: D5020 - ELECTRICAL SERVICE AND DISTRIBUTION
Item No.: D5020.30.1008
Floor/Room: 1
Priority: 3
Quantity/Unit of Measure: 1/EA
Total Deficiency Cost: \$21,020
Deficiency Description: *The 225A panelboard is approaching the end of its expected useful life.*
Description of Work: *Replace the existing panelboard with a new panelboard.*
Comments: *Panelboard*

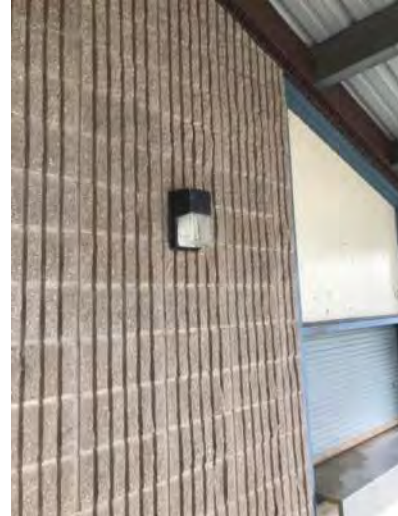
Record ID: 853
System: D5040 - LIGHTING
Item No.: D5040.50.302
Floor/Room: 1
Priority: 3
Quantity/Unit of Measure: 7/EA
Total Deficiency Cost: \$18,020
Deficiency Description: *The exterior wall mounted fixture is past its expected useful life.*
Description of Work: *Replace the existing wall mounted lighting fixture with an LED lighting fixture.*
Comments:

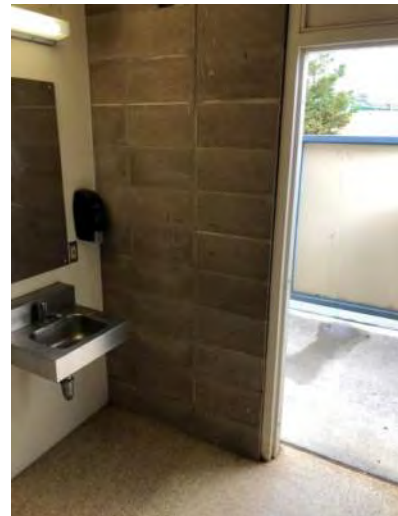
Record ID: 1046
System: C2010 - WALL FINISHES
Item No.: C2010.30.004
Floor/Room: 1 / Varies
Priority: 3
Quantity/Unit of Measure: 1,500/SF
Total Deficiency Cost: \$10,270
Deficiency Description: *Interior wall paint is in need of refresh.*
Description of Work: *Paint interior walls with 2 coat finish (includes surface prep and primer).*
Comments:

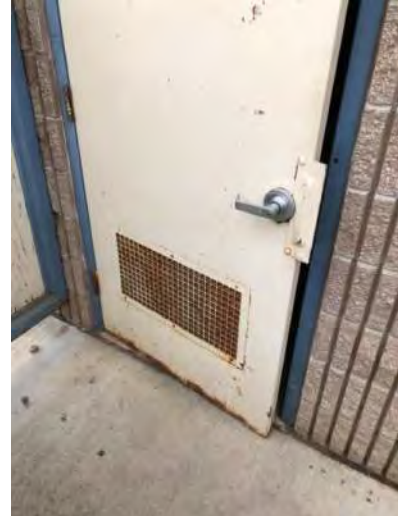
Deficiency Description: *Exterior doors, frames and hardware are approaching the end of their useful life.*

Description of Work: *Replace the exterior doors, frames and hardware.*

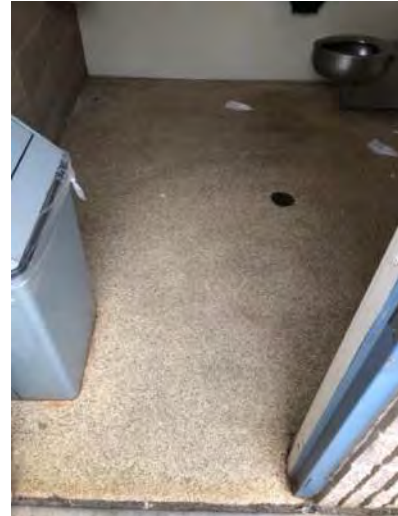
Record ID: 1048
System: C2030 - FLOORING

Deficiency Description: *Epoxy is approaching the end of its useful life.*

Description of Work: *Remove the existing epoxy and replace.*

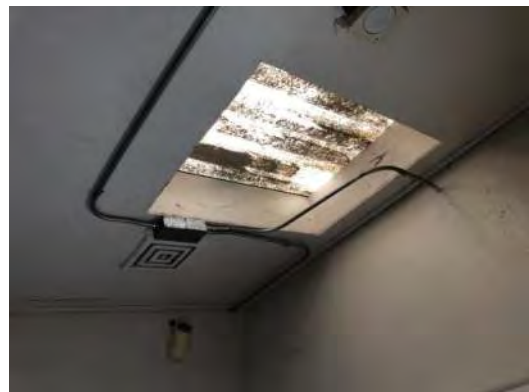
Record ID: 1049
System: B3060 - HORIZONTAL OPENINGS

Deficiency Description: *Skylights are leaking, damaged and discolored.*

Description of Work: *Remove the existing skylight and replace it with a new skylight.*

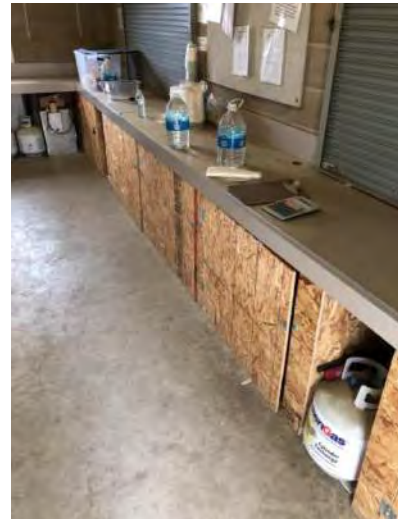
Item No.: E2010.30.009
Floor/Room: 1 / Snack Shack
Priority: 3
Quantity/Unit of Measure: 40/LF
Total Deficiency Cost: \$97,700
Deficiency Description: *Plastic Laminate Casework is at or will be approaching the end of its expected useful life.*

Description of Work: *Provide new plastic laminate casework (upper, lower, and countertop)*

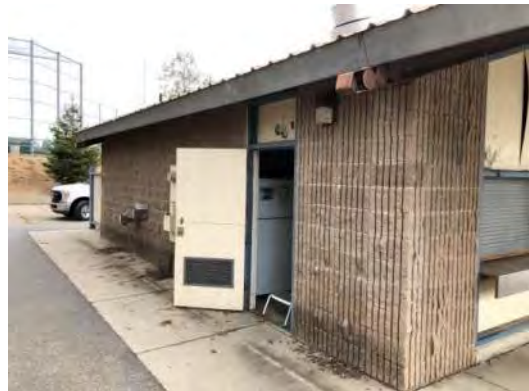
Record ID: 1051
System: B2010 - EXTERIOR WALLS

Item No.: B2010.20.004
Floor/Room: 1 / Exterior
Priority: 3
Quantity/Unit of Measure: 1,200/SF
Total Deficiency Cost: \$130,820
Deficiency Description: *Concrete masonry units exterior walls are damaged and in need of repair.*

Comments: *Exterior masonry is in poor condition. Powerwash and repair as necessary.*

Description of Work: *Repair concrete masonry units exterior walls and repaint.*

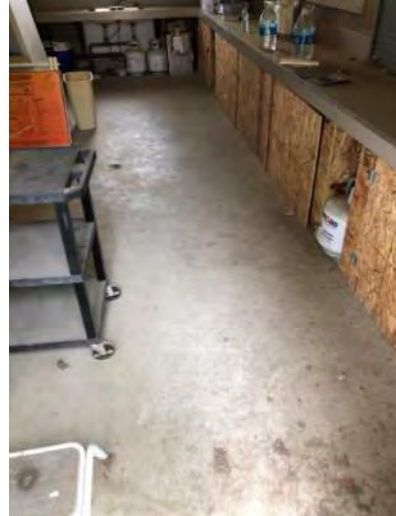
Item No.: C2030.10.001
Floor/Room: 1 / Snack Shack
Priority: 3
Quantity/Unit of Measure: 600/SF
Total Deficiency Cost: \$10,940
Deficiency Description: *Sealed concrete floor is approaching the end of its useful life.*

Description of Work: *Repair and refinish the concrete floor.*

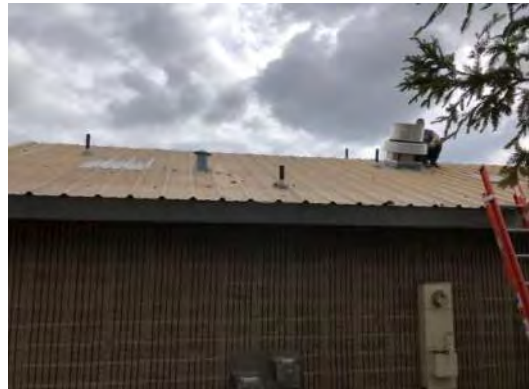
Record ID: 1055
System: B3010 - ROOFING

Item No.: B3010.10.002
Floor/Room: 1 / Exterior
Priority: 3
Quantity/Unit of Measure: 1,500/SF
Total Deficiency Cost: \$62,710
Deficiency Description: *Metal Roofing is at or approaching end of expected useful service life.*

Description of Work: *Remove and replace metal roofing.*

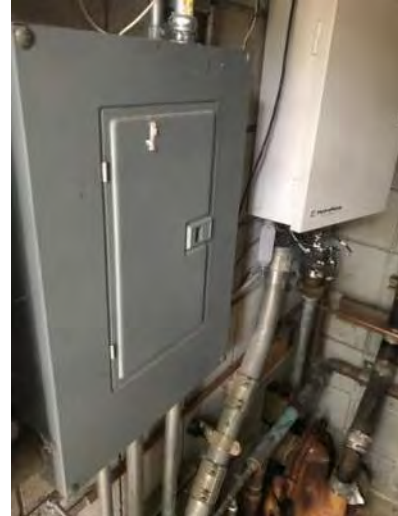
Comments: *Load Center*

Description of Work: *Replace the existing load center with a new load center.*

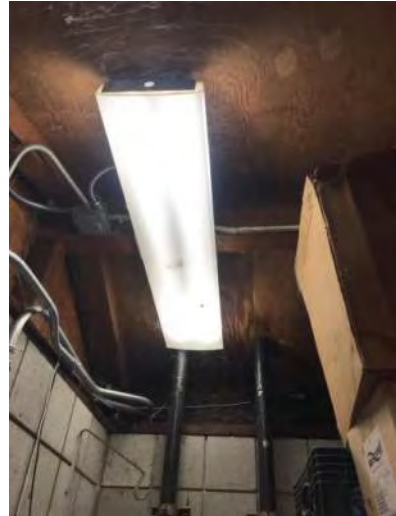
Record ID: 864
System: D5040 - LIGHTING

Item No.: D5040.50.411
Floor/Room: 1
Priority: 3
Quantity/Unit of Measure: 130/SF
Total Deficiency Cost: \$8,440
Deficiency Description: *Interior lighting system is past its expected useful life.*

Description of Work: *Provide new interior lighting and control system throughout building per current CEC T24 code.*

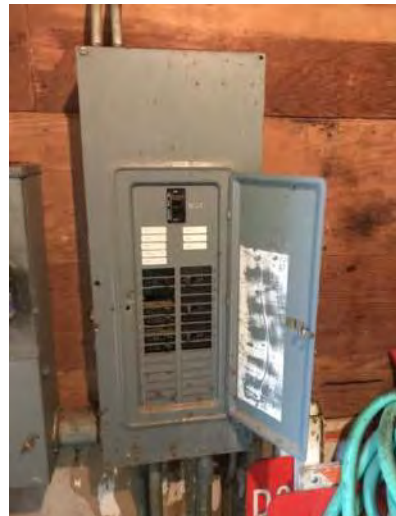
Record ID: 866
System: D5020 - ELECTRICAL SERVICE AND DISTRIBUTION

Item No.: D5020.30.4001
Floor/Room: 1
Priority: 3
Quantity/Unit of Measure: 1/EA
Total Deficiency Cost: \$5,550
Deficiency Description: *The load center is past its expected useful life.*

Comments: *Load center*

Description of Work: *Replace the existing load center with a new load center.*

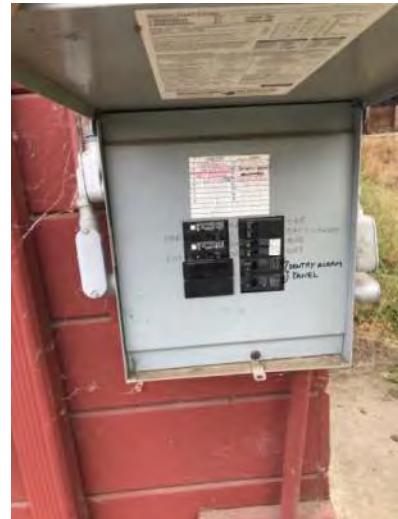
Record ID: 871
System: D5020 - ELECTRICAL SERVICE AND DISTRIBUTION
Item No.: D5020.30.4001
Floor/Room: 1
Priority: 3
Quantity/Unit of Measure: 1/EA
Total Deficiency Cost: \$5,550
Deficiency Description: *The load center is past its expected useful life.*
Description of Work: *Replace the existing load center with a new load center.*
Comments: *Load Center*

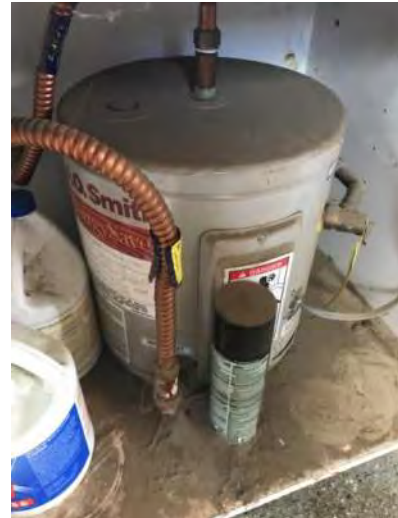
Record ID: 872
System: D2010 - DOMESTIC WATER DISTRIBUTION
Item No.: D2010.20.015
Floor/Room: 1
Priority: 2
Quantity/Unit of Measure: 1/EA
Total Deficiency Cost: \$3,440
Deficiency Description: *Electric water heater is approaching the end of its expected useful life.*
Description of Work: *Provide equipment replacement and installation.*
Comments: *Electric Water Heater*

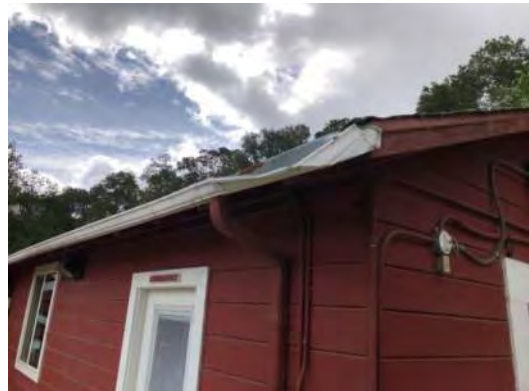
Item No.: B3020.70.001
Floor/Room:
Priority: 3
Quantity/Unit of Measure: 60/LF
Total Deficiency Cost: \$3,300
Deficiency Description: *Rain leaders/gutters are damaged and leak.*

Description of Work: *Repair, replace rain leaders/gutters.*

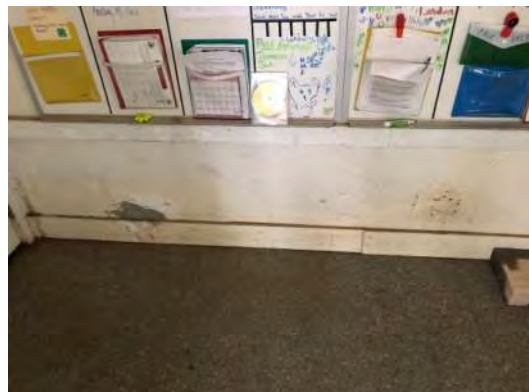
Item No.: C2010.30.004
Floor/Room:
Priority: 3
Quantity/Unit of Measure: 600/SF
Total Deficiency Cost: \$4,120
Deficiency Description: *Interior wall paint is in need of refresh.*

Description of Work: *Paint interior walls with 2 coat finish (includes surface prep and primer).*

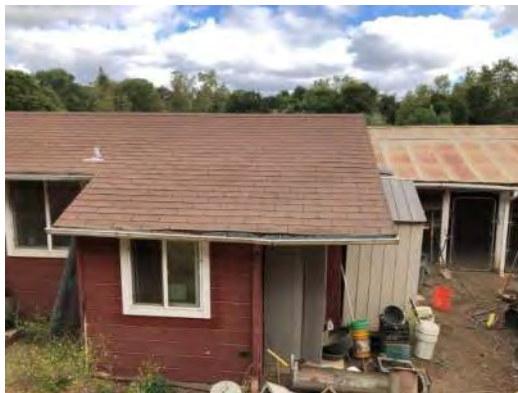
Item No.: B3010.10.001
Floor/Room:
Priority: 5
Quantity/Unit of Measure: 600/SF
Total Deficiency Cost: \$35,510
Deficiency Description: *Asphalt composition roof is in fair to poor condition with evidence of ponding, blisters & leaks.*

Comments: *Replaced in 2006*

Description of Work: *Remove and replace asphalt composition shingle roofing.*

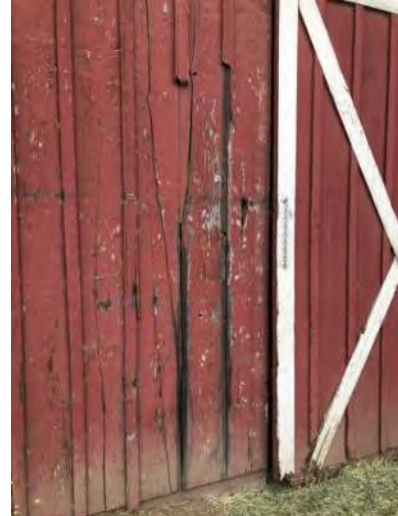
Item No.: B2010.10.003
Floor/Room:
Priority: 3
Quantity/Unit of Measure: 3,000/SF
Total Deficiency Cost: \$87,220
Deficiency Description: *Wood board siding is approaching the end of its useful life.*

Description of Work: *Replace or repair the existing wood siding. Place a new siding over building paper and plywood sheathing.*

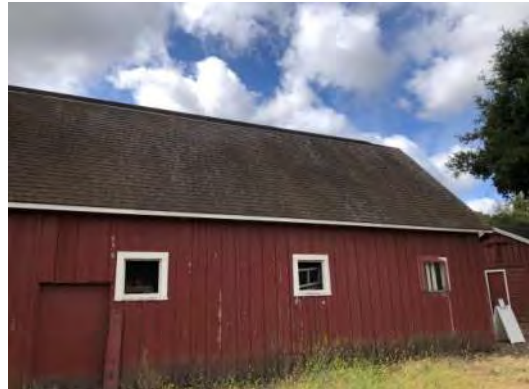
Item No.: B3010.10.001
Floor/Room:
Priority: 3
Quantity/Unit of Measure: 2,000/SF
Total Deficiency Cost: \$109,030
Deficiency Description: *Asphalt composition roof is in fair to poor condition with evidence of ponding, blisters & leaks.*

Description of Work: *Remove and replace asphalt composition shingle roofing.*

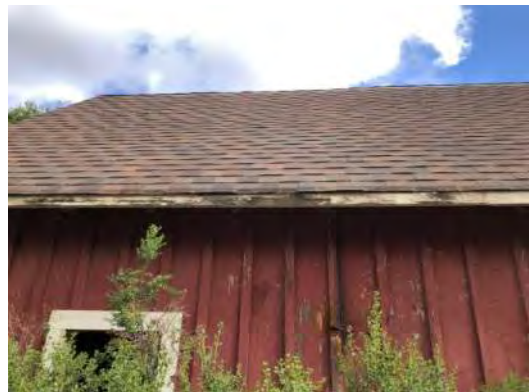
Item No.: B3010.90.009
Floor/Room:
Priority: 3
Quantity/Unit of Measure: 200/LF
Total Deficiency Cost: \$20,380
Deficiency Description: *Wood fascia and trim chipped and have peeling paint.*

Description of Work: *Clean, repair, and paint the trim and/or fascia.*

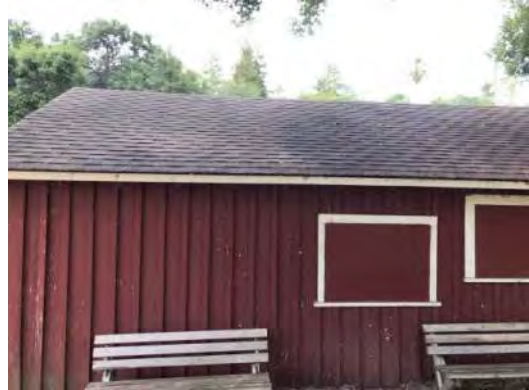
Item No.: B3010.10.001
Floor/Room:
Priority: 3
Quantity/Unit of Measure: 700/SF
Total Deficiency Cost: \$38,180
Deficiency Description: *Asphalt composition roof is in fair to poor condition with evidence of ponding, blisters & leaks.*

Description of Work: *Remove and replace asphalt composition shingle roofing.*

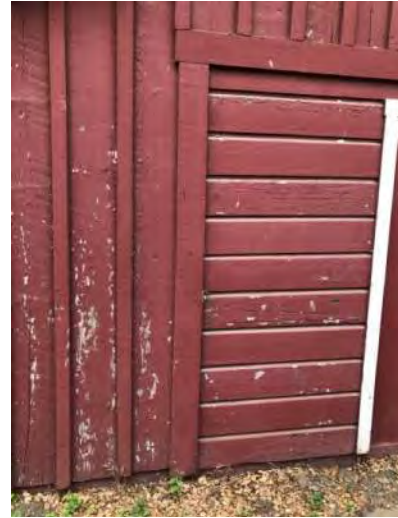
Item No.: B2010.10.003
Floor/Room:
Priority: 3
Quantity/Unit of Measure: 700/SF
Total Deficiency Cost: \$20,380
Deficiency Description: *Wood board siding is approaching the end of its useful life.*

Description of Work: *Replace or repair the existing wood siding. Place a new siding over building paper and plywood sheathing.*

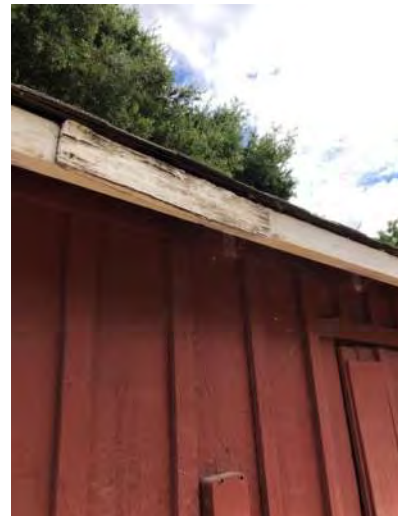
Item No.: B3010.90.009
Floor/Room:
Priority: 3
Quantity/Unit of Measure: 100/LF
Total Deficiency Cost: \$10,200
Deficiency Description: *Wood fascia and trim chipped and have peeling paint.*

Description of Work: *Clean, repair, and paint the trim and/or fascia.*

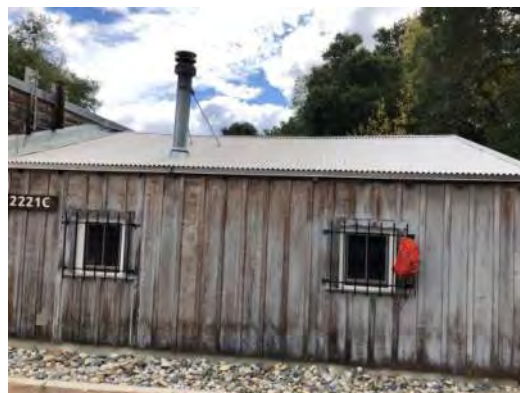
Record ID	791
System	B2010 - EXTERIOR WALLS
Item No.	B2010.10.003
Floor/Room:	1 / Exterior
Priority:	3
Quantity/Unit of Measure:	700/SF
Total Deficiency Cost:	\$20,380
Deficiency Description:	<i>Wood board siding is approaching the end of its useful life.</i>
Description of Work:	<i>Replace or repair the existing wood siding. Place a new siding over building paper and plywood sheathing.</i>
Comments:

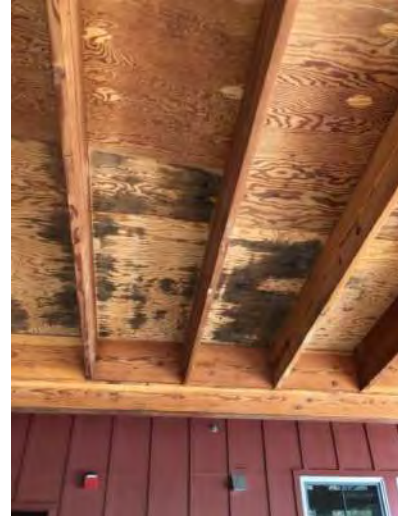
Item No.: B1020.10.001
Floor/Room: / Exterior
Priority: 3
Quantity/Unit of Measure: 275/SF
Total Deficiency Cost: \$20,010
Deficiency Description: *Wood roof framing and decking are in poor condition.*

Comments: *Signs of water damage at exterior canopy. Inspect for water intrusion and repair/replace as necessary.*

Description of Work: *Remove and replace wood roof framing and decking.*

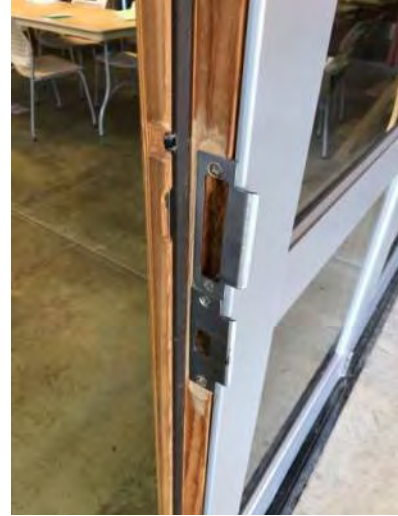
Item No.: B2050.10.001
Floor/Room:
Priority: 3
Quantity/Unit of Measure: 2/EA
Total Deficiency Cost: \$18,200
Deficiency Description: *Exterior wood entrance door is approaching the end of its useful life.*

Comments: *Facilities noted issues with wood entrance door.*

Description of Work: *Replace wood door.*

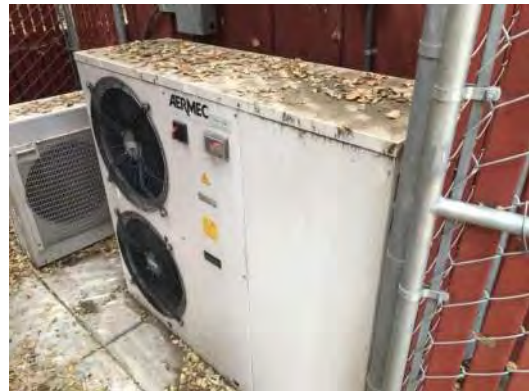
Item No.: D3030.70.042
Floor/Room: 1
Priority: 4
Quantity/Unit of Measure: 1/EA
Total Deficiency Cost: \$28,120
Deficiency Description: *Split system with fan coil and outdoor condensing unit is approaching the end of its expected useful life.*

Description of Work: *Provide equipment replacement and installation.*

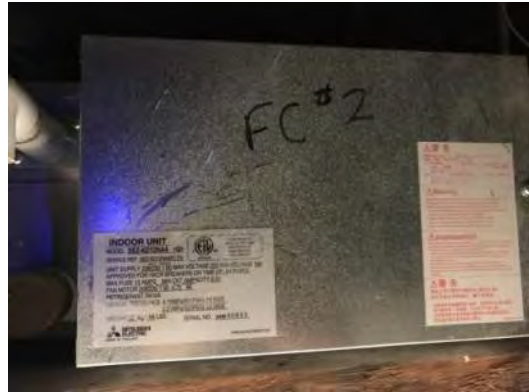
Item No.: D3030.70.011
Floor/Room: 1
Priority: 4
Quantity/Unit of Measure: 1/EA
Total Deficiency Cost: \$13,280
Deficiency Description: *Fan coil unit is approaching the end of its expected useful life.*

Description of Work: *Provide equipment replacement and installation.*

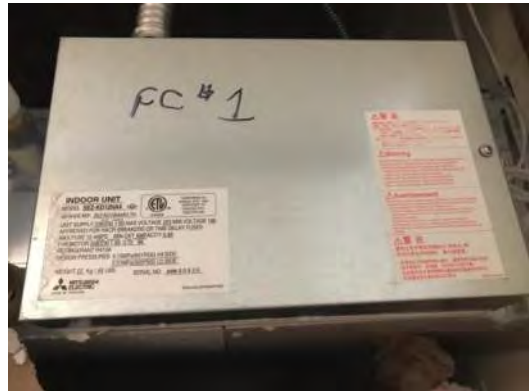
Item No.: D3030.70.011
Floor/Room: 1
Priority: 4
Quantity/Unit of Measure: 1/EA
Total Deficiency Cost: \$13,280
Deficiency Description: *Fan coil unit is approaching the end of its expected useful life.*

Description of Work: *Provide equipment replacement and installation.*

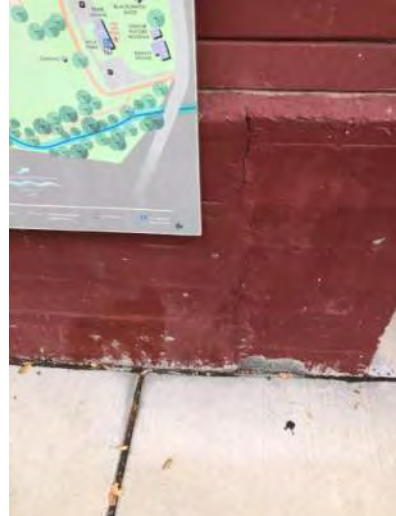
Item No.: B2010.20.005
Floor/Room:
Priority: **3**
Quantity/Unit of Measure: 6/SF
Total Deficiency Cost: \$90
Deficiency Description: *CMU walls are showing signs of wear.*

Comments: *Crack noticed in CMU. Fill crack and repaint.*

Description of Work: *Clean and repaint CMU walls.*

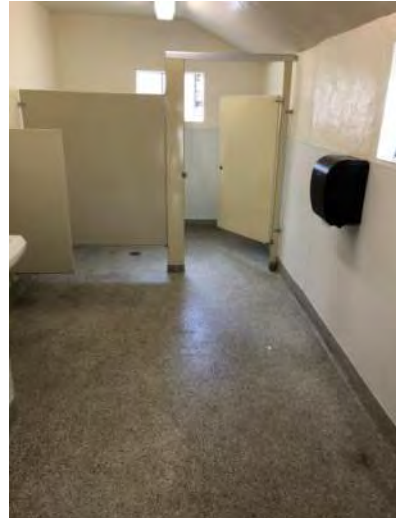
Item No.: C2030.10.002
Floor/Room:
Priority: **3**
Quantity/Unit of Measure: 450/SF
Total Deficiency Cost: \$24,550
Deficiency Description: *Epoxy is approaching the end of its useful life.*

Description of Work: *Remove the existing epoxy and replace.*

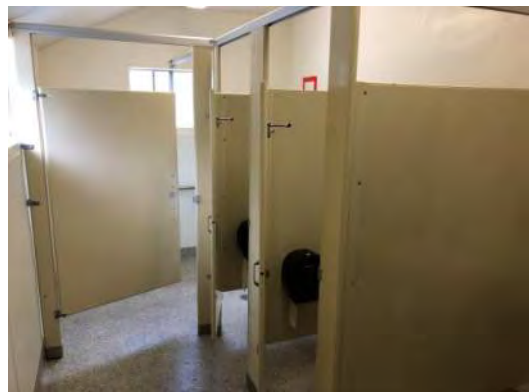
Item No.: C1090.25.001
Floor/Room:
Priority: **4**
Quantity/Unit of Measure: 5/EA
Total Deficiency Cost: \$22,740
Deficiency Description: *Toilet partitions have excessive amounts of rust.*

Description of Work: *Replace the toilet partitions*

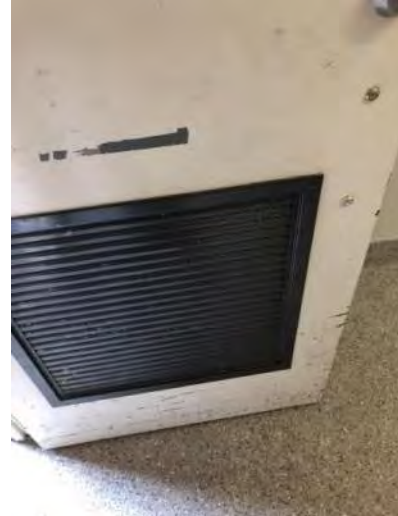
Item No.: B2050.20.002
Floor/Room:
Priority: 4
Quantity/Unit of Measure: 2/EA
Total Deficiency Cost: \$9,110
Deficiency Description: *Metal door is damaged or deteriorated.*

Description of Work: *Repair door and repaint.*

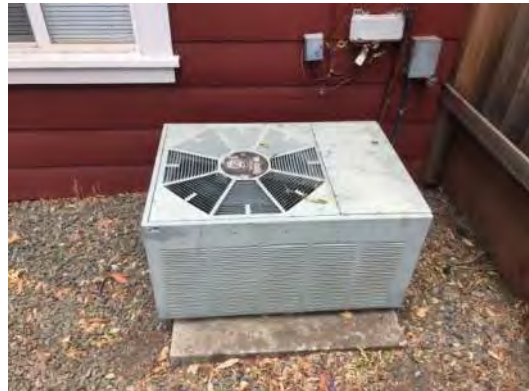
Comments: *HVAC - Split System*

Description of Work: *Provide equipment replacement and installation.*

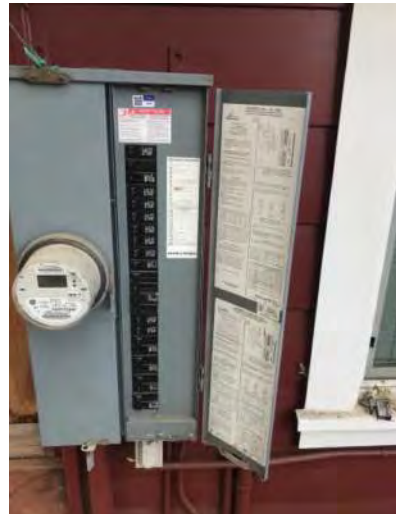
Comments: *Service Entrance*

Description of Work: *Replace the existing all-in-one combination service entrance device with a new all-in-one combination service entrance device.*

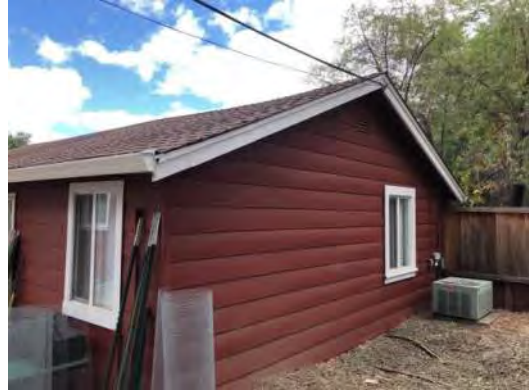
Comments: *Windows installed 1999*

Description of Work: *Replace with new frame, insulated glazing and glazing compound.*

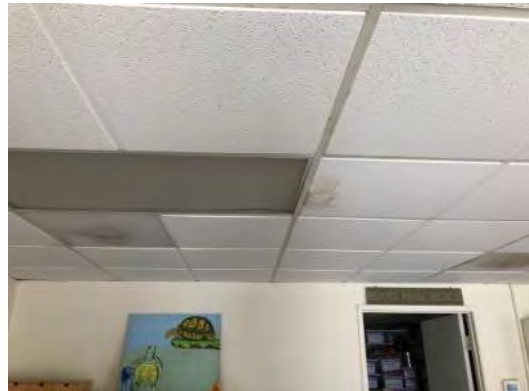
Item No.: C2050.80.001
Floor/Room:
Priority: 3
Quantity/Unit of Measure: 12/SF
Total Deficiency Cost: \$220
Deficiency Description: *Lay-in Acoustical Tile is in poor condition.*

Description of Work: *Remove existing lay-in Acoustical Tiles and replace with new lay-in Acoustical Tiles.*

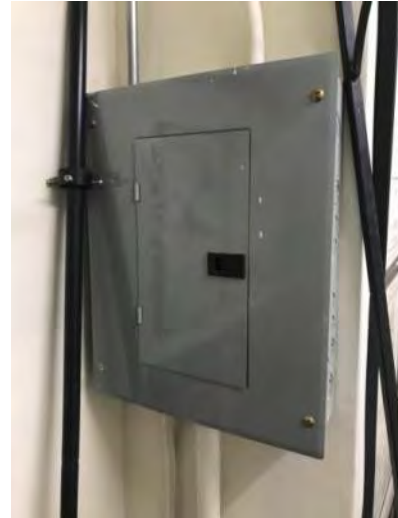
Item No.: D5020.30.4001
Floor/Room: 1
Priority: 3
Quantity/Unit of Measure: 1/EA
Total Deficiency Cost: \$5,550
Deficiency Description: *The load center is past its expected useful life.*

Description of Work: *Replace the existing load center with a new load center.*

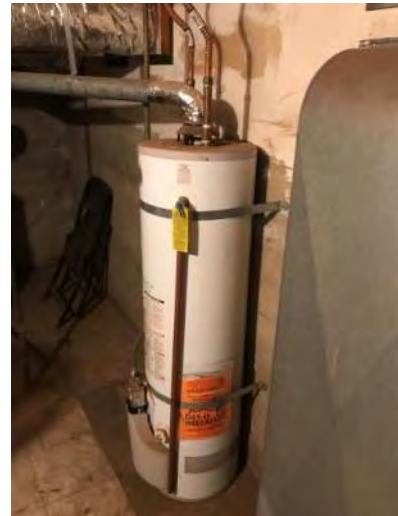
Item No.: D2010.20.002
Floor/Room: 1
Priority: 5
Quantity/Unit of Measure: 1/EA
Total Deficiency Cost: \$16,260
Deficiency Description: *Gas fired water heater is approaching the end of its expected useful life.*

Description of Work: *Provide equipment replacement and installation.*

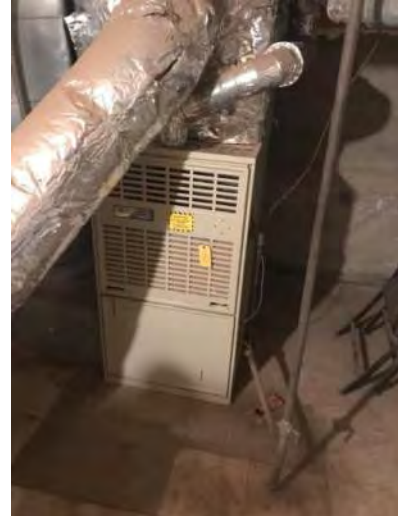
Comments: *Furnace*

Description of Work: *Provide equipment replacement and installation.*

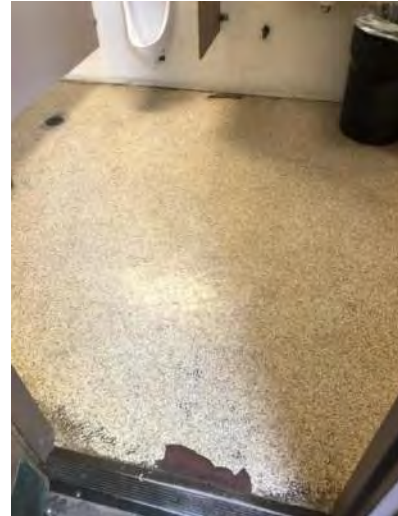
Item No.: C2030.10.002
Floor/Room:
Priority: 3
Quantity/Unit of Measure: 350/SF
Total Deficiency Cost: \$19,110
Deficiency Description: *Epoxy is approaching the end of its useful life.*

Description of Work: *Remove the existing epoxy and replace.*

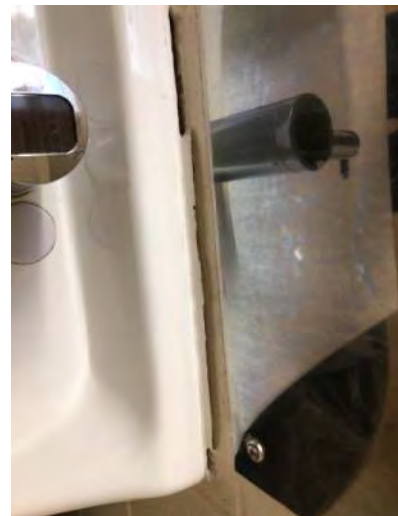
Item No.: D2010.60.030
Floor/Room:
Priority: 3
Quantity/Unit of Measure: 1/EA
Total Deficiency Cost: \$9,100
Deficiency Description: *Porcelain sink is approaching the end of its expected useful life.*

Comments: *Sink moves easily and is not properly adhered to the wall*

Description of Work: *Provide equipment replacement and installation.*

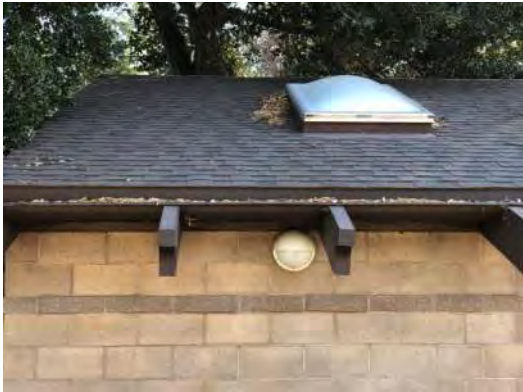
Description of Work: *Clean gutters.*

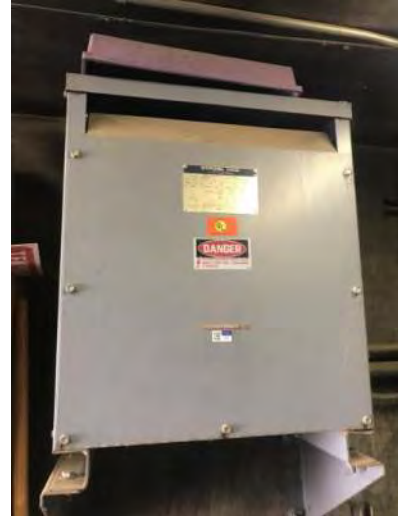
Record ID: 557
System: D5020 - ELECTRICAL SERVICE AND DISTRIBUTION
Item No.: D5020.10.216
Floor/Room: 1
Priority: 3
Quantity/Unit of Measure: 1/EA
Total Deficiency Cost: \$14,760
Deficiency Description: *The 45kVA transformer is past its expected useful life.*
Description of Work: *Replace the existing transformer with a new transformer.*
Comments: *Transformer*

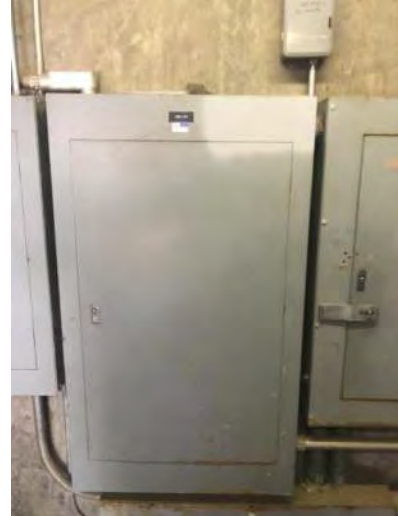
Record ID: 558
System: D5020 - ELECTRICAL SERVICE AND DISTRIBUTION
Item No.: D5020.30.1011
Floor/Room: 1
Priority: 3
Quantity/Unit of Measure: 1/EA
Total Deficiency Cost: \$20,090
Deficiency Description: *The 100A (277/480, 3P) panelboard is past its expected useful life.*
Description of Work: *Replace the existing panelboard with a new panelboard.*
Comments: *Panelboard*

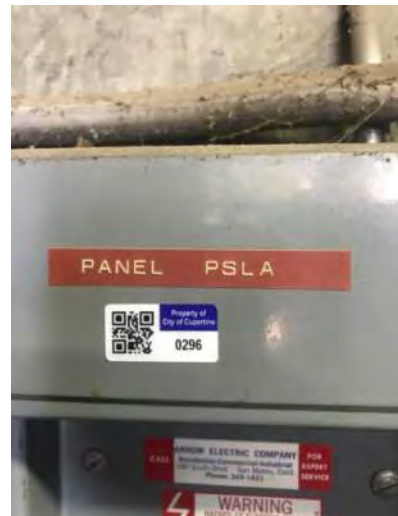
Record ID: 559
System: D5020 - ELECTRICAL SERVICE AND DISTRIBUTION
Item No.: D5020.30.1007
Floor/Room: 1
Priority: 3
Quantity/Unit of Measure: 1/EA
Total Deficiency Cost: \$12,980
Deficiency Description: *The 100A panelboard is past its expected useful life.*
Description of Work: *Replace the existing panelboard with a new panelboard.*
Comments: *Panelboard*

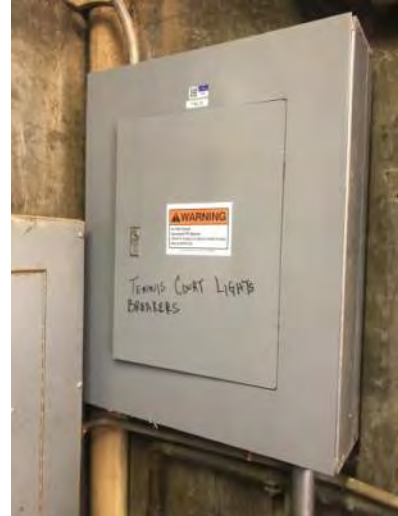
Record ID: 561
System: D5020 - ELECTRICAL SERVICE AND DISTRIBUTION
Item No.: D5020.30.4001
Floor/Room: 1
Priority: 3
Quantity/Unit of Measure: 1/EA
Total Deficiency Cost: \$5,550
Deficiency Description: *The load center is past its expected useful life.*

Comments: *Load Center*

Description of Work: *Replace the existing load center with a new load center.*

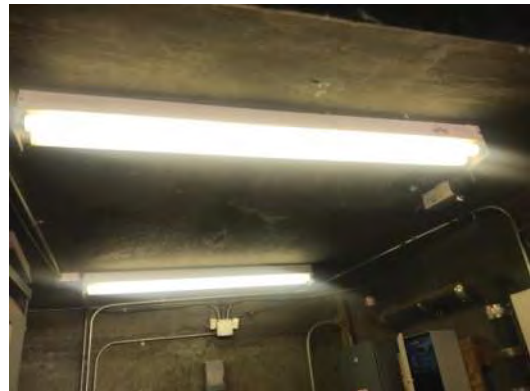
Record ID: 562
System: D5040 - LIGHTING
Item No.: D5040.50.406
Floor/Room: 1
Priority: 3
Quantity/Unit of Measure: 4/EA
Total Deficiency Cost: \$5,440
Deficiency Description: *The interior light fixtures are past their expected useful life.*

Description of Work: *Replace existing fixtures with LED fixtures.*

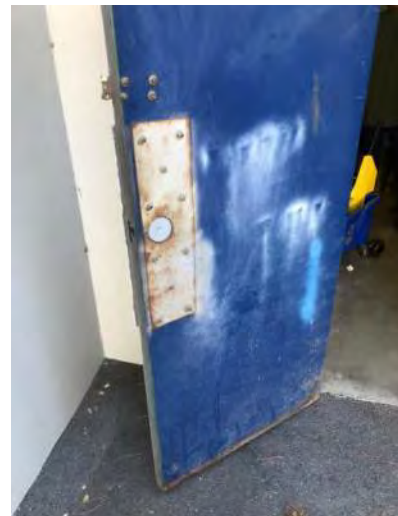
Record ID: 689
System: B2050 - EXTERIOR DOORS AND GRILLES
Item No.: B2050.20.003
Floor/Room:
Priority: 3
Quantity/Unit of Measure: 1/EA
Total Deficiency Cost: \$12,740
Deficiency Description: *Exterior doors, frames and hardware are approaching the end of their useful life.*

Description of Work: *Replace the exterior doors, frames and hardware.*

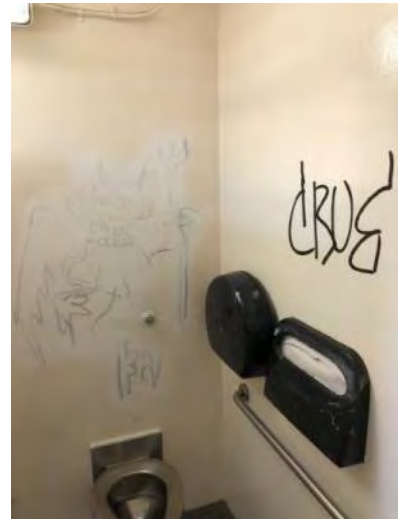
Item No.: C2010.30.004
Floor/Room:
Priority: 3
Quantity/Unit of Measure: 800/SF
Total Deficiency Cost: \$5,500
Deficiency Description: *Interior wall paint is in need of refresh.*

Description of Work: *Paint interior walls with 2 coat finish (includes surface prep and primer).*

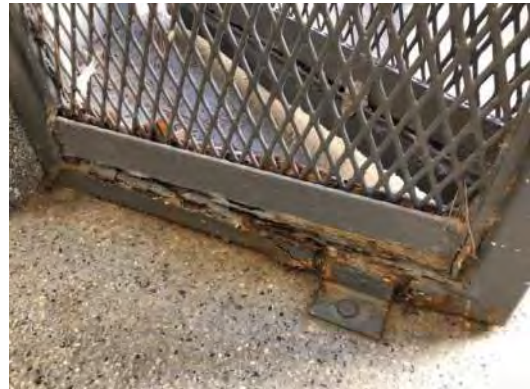
Record ID: 691
System: B2050 - EXTERIOR DOORS AND GRILLES

Item No.: B2050.70.001
Floor/Room:
Priority: 3
Quantity/Unit of Measure: 2/LS
Total Deficiency Cost: \$10,940
Deficiency Description: *Existing gate is at or approaching the end of its useful life.*

Description of Work: *Install a new gate and associated gate hardware.*

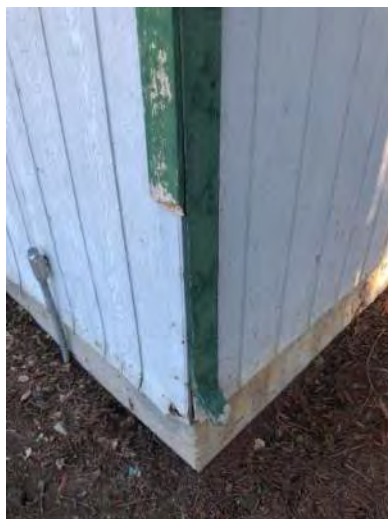
Record ID 1074
System B2010 - EXTERIOR WALLS
Item No. B2010.10.006
Floor/Room:
Priority: 3
Quantity/Unit of Measure: 64/LF
Total Deficiency Cost: \$2,340
Deficiency Description: *Trim is worn and should be replaced.*

Description of Work: *Replace trim and finish to match. Replace at the same time as siding.*

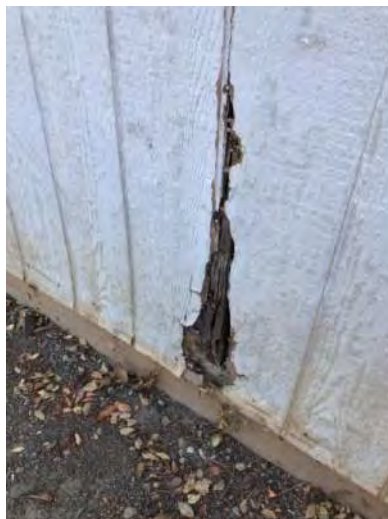
Record ID 1075
System B2010 - EXTERIOR WALLS
Item No. B2010.10.003
Floor/Room:
Priority: 3
Quantity/Unit of Measure: 430/SF
Total Deficiency Cost: \$12,520
Deficiency Description: *Wood board siding is approaching the end of its useful life.*

Description of Work: *Replace or repair the existing wood siding. Place a new siding over building paper and plywood sheathing.*

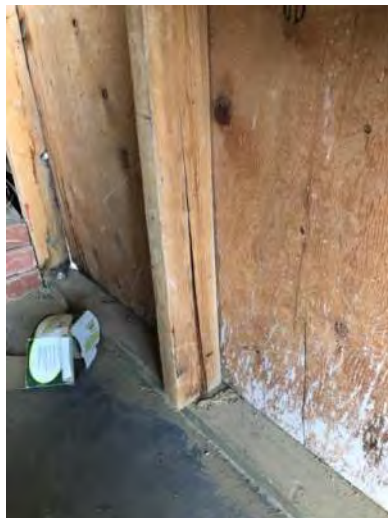
Record ID 1076
System B2010 - EXTERIOR WALLS
Item No. B2010.20.001
Floor/Room:
Priority: 3
Quantity/Unit of Measure: 126/SF
Total Deficiency Cost: \$10,090
Deficiency Description: *Wood wall framing is approaching the end of its useful life.*

Comments: *Framing is cracked and evidence of water damage visible.*

Description of Work: *Remove and replace the wood frame exterior and interior walls.*

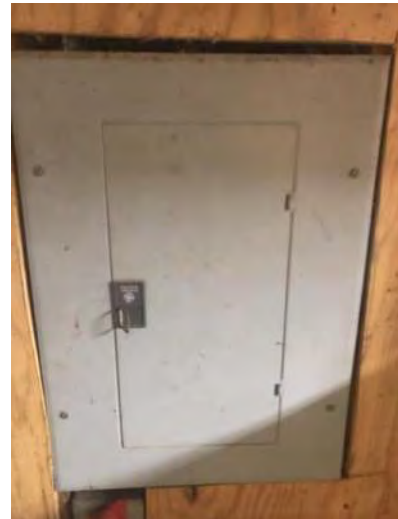
Record ID: 564
System: D5020 - ELECTRICAL SERVICE AND DISTRIBUTION
Item No.: D5020.30.4001
Floor/Room: 1
Priority: 3
Quantity/Unit of Measure: 1/EA
Total Deficiency Cost: \$5,550
Deficiency Description: *The 100A load center is past its expected useful life.*

Comments: *Load Center*

Description of Work: *Replace the existing load center with a new load center.*

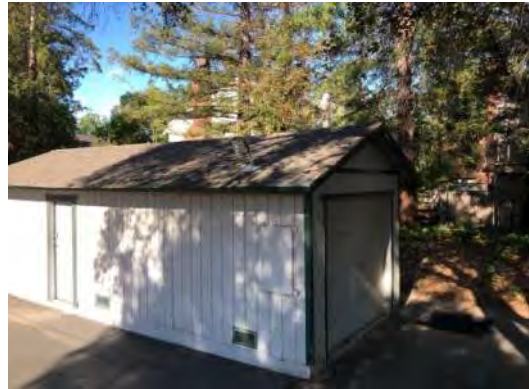
Record ID: 692
System: B3010 - ROOFING
Item No.: B3010.10.001
Floor/Room: 1
Priority: 3
Quantity/Unit of Measure: 280/SF
Total Deficiency Cost: \$15,290
Deficiency Description: *Asphalt composition roof is in fair to poor condition with evidence of ponding, blisters & leaks.*

Description of Work: *Remove and replace asphalt composition shingle roofing.*

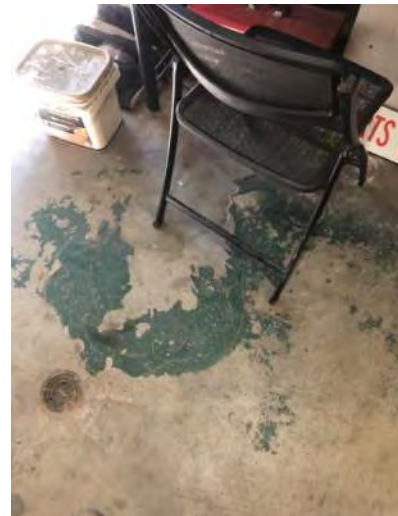
Record ID: 694
System: C2030 - FLOORING
Item No.: C2030.10.001
Floor/Room: 1
Priority: 3
Quantity/Unit of Measure: 280/SF
Total Deficiency Cost: \$5,100
Deficiency Description: *Sealed concrete floor is approaching the end of its useful life.*

Description of Work: *Repair and refinish the concrete floor.*

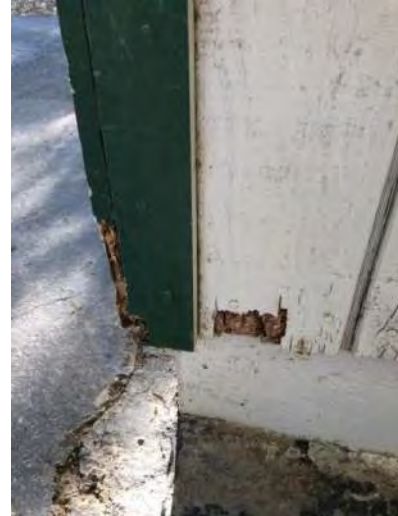
Record ID: 1077
System: B2010 - EXTERIOR WALLS

Item No.: B2010.10.006
Floor/Room:
Priority: 3
Quantity/Unit of Measure: 126/LF
Total Deficiency Cost: \$4,600
Deficiency Description: *Trim is worn and should be replaced.*

Description of Work: *Replace trim and finish to match. Replace at the same time as siding.*

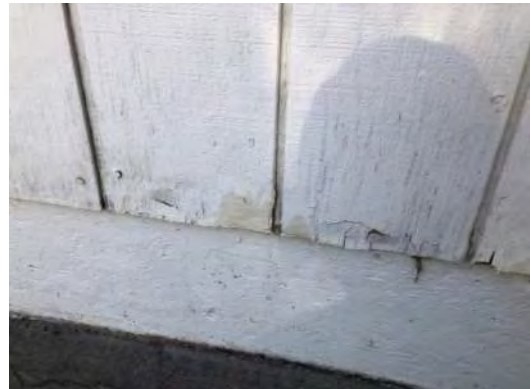
Record ID: 1078
System: B2010 - EXTERIOR WALLS

Item No.: B2010.10.003
Floor/Room:
Priority: 3
Quantity/Unit of Measure: 720/SF
Total Deficiency Cost: \$20,960
Deficiency Description: *Wood board siding is approaching the end of its useful life.*

Comments: *Siding is rotting*

Description of Work: *Replace or repair the existing wood siding. Place a new siding over building paper and plywood sheathing.*

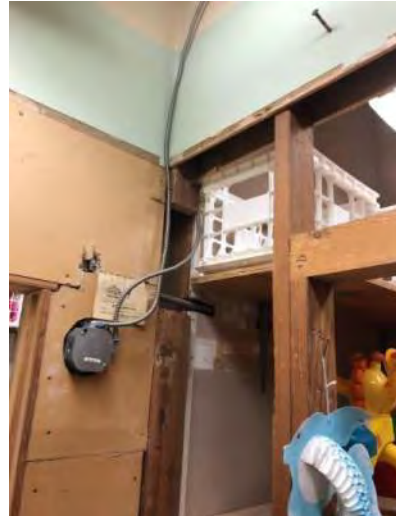
Record ID: 47
System: C1010 - INTERIOR PARTITIONS

Item No.: C1010.10.001
Floor/Room:
Priority: 3
Quantity/Unit of Measure: 200/SF
Total Deficiency Cost: \$1,550
Deficiency Description: *Painted gypsum wallboard is in poor condition with several cracks.*

Description of Work: *Remove and replace existing gypsum board with a new gypsum board and expansion joints. Tape and paint.*

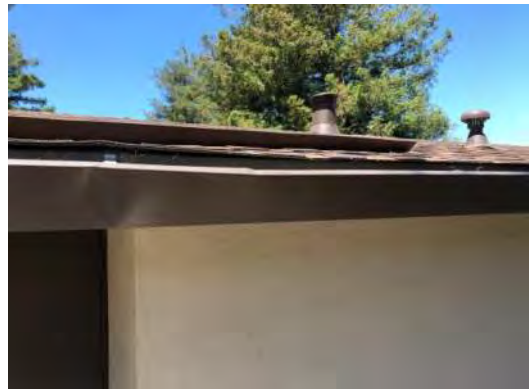
Record ID: 51
System: B3020 - ROOF APPURTENANCES

Item No.: B3020.70.001
Floor/Room:
Priority: 3
Quantity/Unit of Measure: 120/LF
Total Deficiency Cost: \$6,570
Deficiency Description: *Rain leaders/gutters are damaged and leak.*

Description of Work: *Repair, replace rain leaders/gutters.*

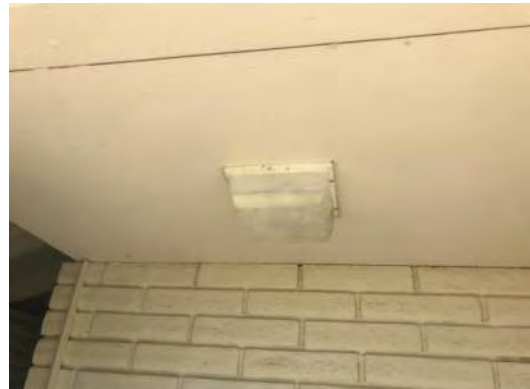
Record ID: 112
System: D5040 - LIGHTING

Item No.: D5040.50.302
Floor/Room: 1
Priority: 3
Quantity/Unit of Measure: 1/EA
Total Deficiency Cost: \$2,590
Deficiency Description: *The exterior fixture is past its expected useful life.*

Description of Work: *Replace the existing fixture with an LED lighting fixture.*

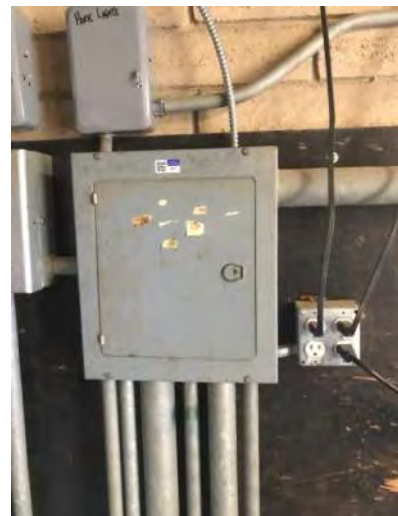
Record ID: 116
System: D5020 - ELECTRICAL SERVICE AND DISTRIBUTION

Item No.: D5020.30.4001
Floor/Room: 1
Priority: 3
Quantity/Unit of Measure: 1/EA
Total Deficiency Cost: \$5,550
Deficiency Description: *The load center is past its expected useful life.*

Comments: *Load Center*

Description of Work: *Replace the existing load center with a new load center.*

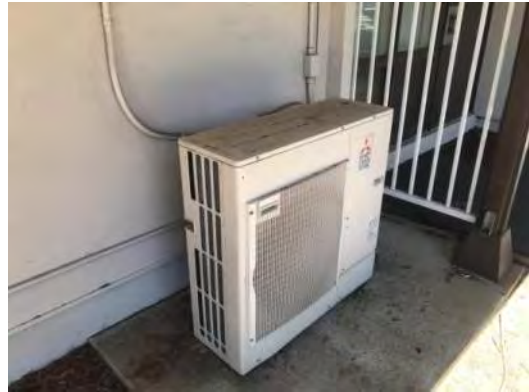
Comments: *HVAC - Split System*

Description of Work: *Provide equipment replacement and installation.*

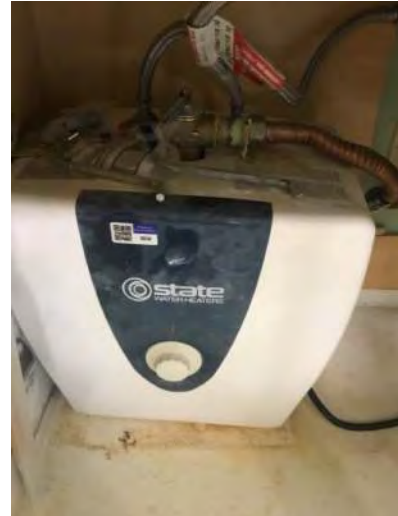
Record ID: 120
System: D2010 - DOMESTIC WATER DISTRIBUTION

Item No.: D2010.20.015
Floor/Room: 1
Priority: 3
Quantity/Unit of Measure: 1/EA
Total Deficiency Cost: \$3,590
Deficiency Description: *Electric water heater is approaching the end of its expected useful life.*

Comments: *Water Heater*

Description of Work: *Provide equipment replacement and installation.*

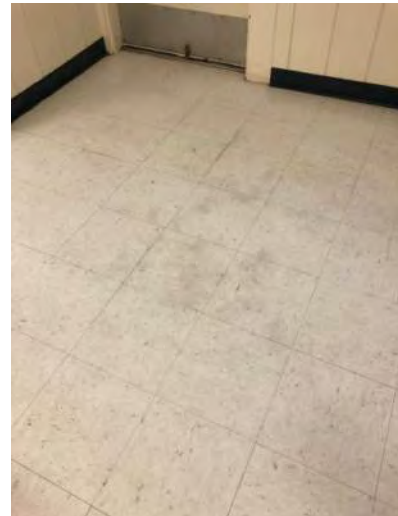
Record ID: 312
System: C2030 - FLOORING

Item No.: C2030.50.001
Floor/Room: 1
Priority: 3
Quantity/Unit of Measure: 1,800/SF
Total Deficiency Cost: \$49,080
Deficiency Description: *Vinyl composition tile is approaching the end of its useful life.*

Description of Work: *Remove the existing vinyl composition tile and replace.*

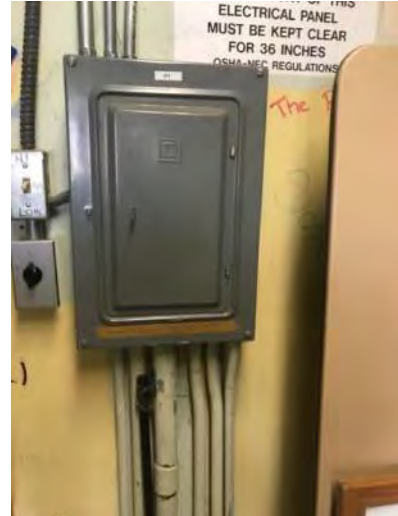
Record ID: 122
System: D5020 - ELECTRICAL SERVICE AND DISTRIBUTION
Item No.: D5020.30.4001
Floor/Room: 1
Priority: 3
Quantity/Unit of Measure: 1/EA
Total Deficiency Cost: \$5,550
Deficiency Description: *The load center is past its expected useful life.*

Comments: *Load Center*

Description of Work: *Replace the existing load center with a new load center.*

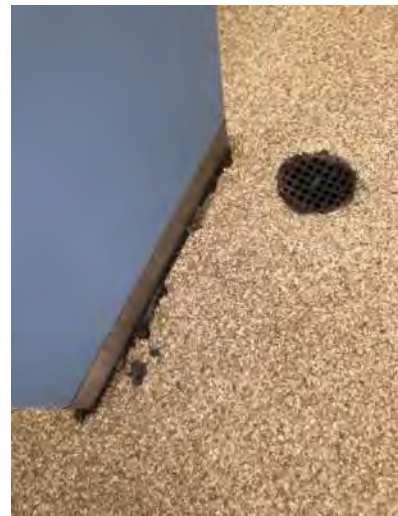
Record ID: 307
System: C2030 - FLOORING
Item No.: C2030.10.002
Floor/Room:
Priority: 3
Quantity/Unit of Measure: 300/SF
Total Deficiency Cost: \$16,370
Deficiency Description: *Epoxy is approaching the end of its useful life.*

Description of Work: *Remove the existing epoxy and replace.*

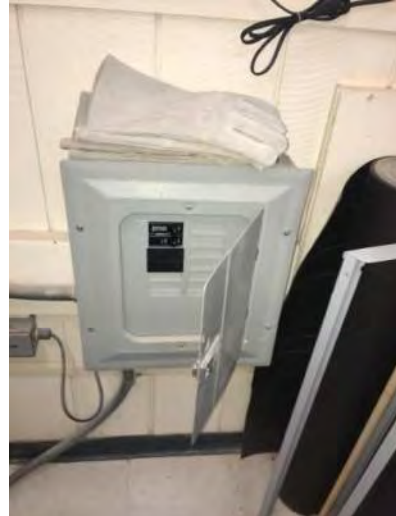
Record ID: 202
System: D5020 - ELECTRICAL SERVICE AND DISTRIBUTION
Item No.: D5020.30.4001
Floor/Room: 1
Priority: 3
Quantity/Unit of Measure: 1/EA
Total Deficiency Cost: \$5,550
Deficiency Description: *The load center is past its expected useful life.*
Description of Work: *Replace the existing load center with a new load center.*
Comments: *Load Center*

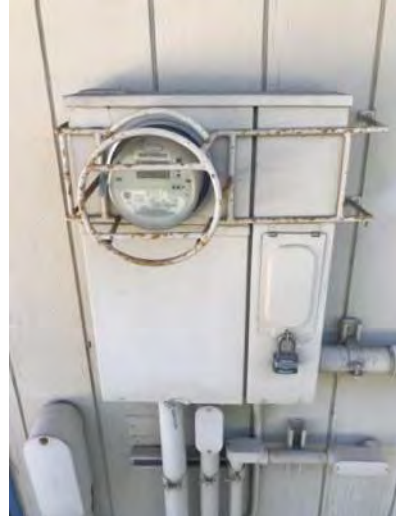
Record ID: 205
System: D5020 - ELECTRICAL SERVICE AND DISTRIBUTION
Item No.: D5020.10.001
Floor/Room: 1
Priority: 3
Quantity/Unit of Measure: 1/EA
Total Deficiency Cost: \$9,320
Deficiency Description: *The all-in-one combination service entrance device is past its expected useful life.*
Description of Work: *Replace the existing all-in-one combination service entrance device with a new all-in-one combination service entrance device.*
Comments:

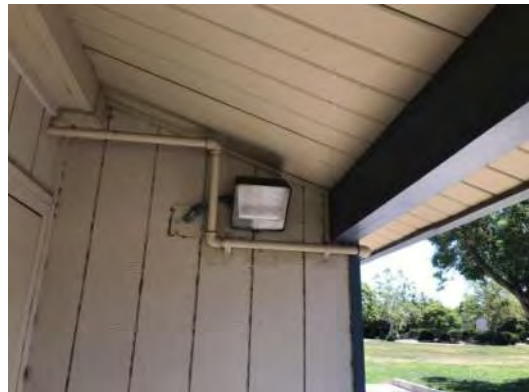
Record ID: 215
System: D5040 - LIGHTING
Item No.: D5040.50.302
Floor/Room: 1
Priority: 3
Quantity/Unit of Measure: 1/EA
Total Deficiency Cost: \$2,590
Deficiency Description: *The exterior fixture is past its expected useful life.*
Description of Work: *Replace the existing fixture with an LED lighting fixture.*
Comments:

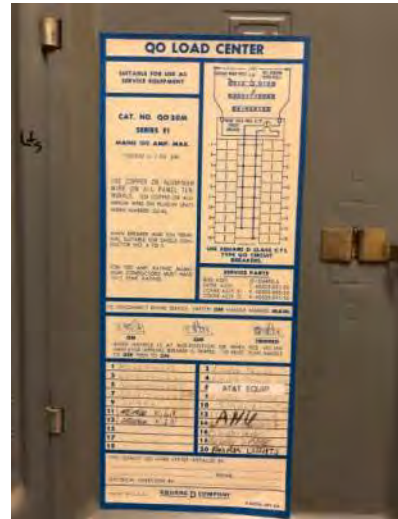
Comments: *Load Center*

Description of Work: *Replace the existing load center with a new load center.*

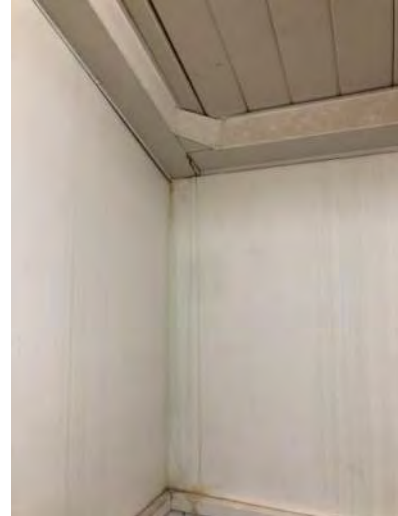
Comments: *Noticeable water stains from overhead plumbing. Suspected cause is pipe sweat.*

Description of Work: *Investigate cause of leak and provide repairs and adjustments as necessary.*

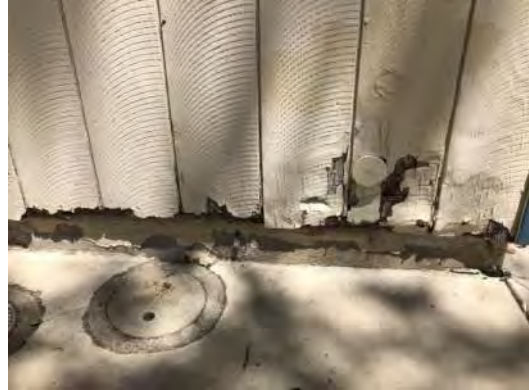
Item No.: B2010.10.003
Floor/Room:
Priority: 3
Quantity/Unit of Measure: 1,500/SF
Total Deficiency Cost: \$43,620
Deficiency Description: *Wood board siding is approaching the end of its useful life.*

Description of Work: *Replace or repair the existing wood siding. Place a new siding over building paper and plywood sheathing.*

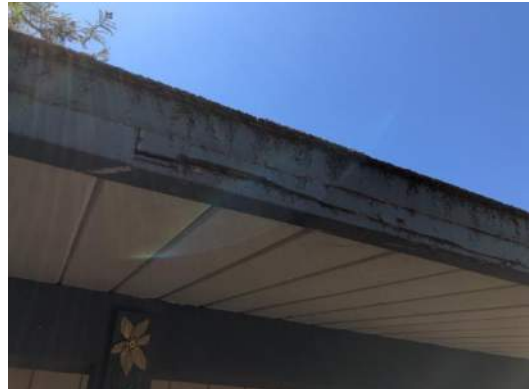
Record ID: 278
System: B3010 - ROOFING

Item No.: B3010.90.009
Floor/Room:
Priority: 3
Quantity/Unit of Measure: 200/LF
Total Deficiency Cost: \$20,380
Deficiency Description: *Wood fascia and trim chipped and have peeling paint.*

Description of Work: *Clean, repair, and paint the trim and/or fascia.*

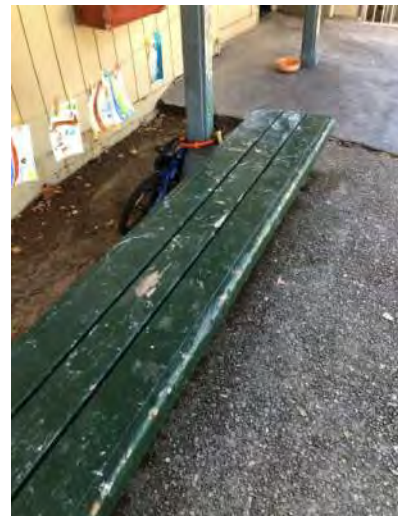
Record ID: 279
System: G2060 - SITE DEVELOPMENT

Item No.: G2060.25.004
Floor/Room:
Priority: 3
Quantity/Unit of Measure: 1/EA
Total Deficiency Cost: \$720
Deficiency Description: *Bench finish is at or approaching the end of its useful life.*

Description of Work: *Repaint and refinish bench.*

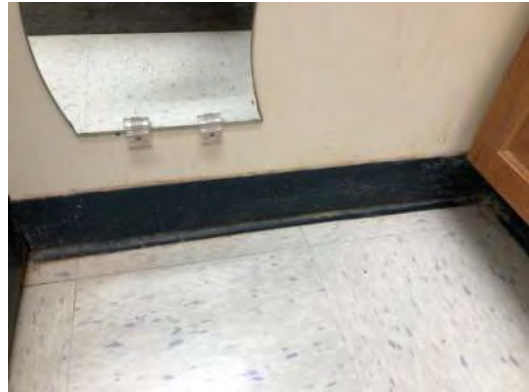
Item No.: C2030.90.001
Floor/Room:
Priority: 3
Quantity/Unit of Measure: 25/LF
Total Deficiency Cost: \$470
Deficiency Description: *6" Vinyl wall base is approaching the end of its useful life.*

Description of Work: *Replace the vinyl wall base.*
