City of Cupertino

Facility Condition Assessment

Final Report

December 2, 2022

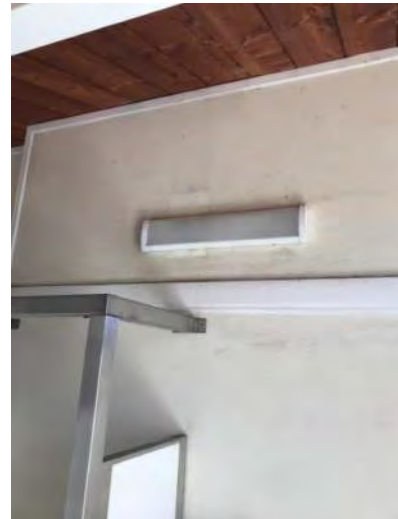
Item No.: D5040.50.406
Floor/Room: 1
Priority: 3
Quantity/Unit of Measure: 3/EA
Total Deficiency Cost: \$4,100
Deficiency Description: *The interior light fixtures are past their expected useful life.*

Description of Work: *Replace existing fixtures with LED fixtures.*

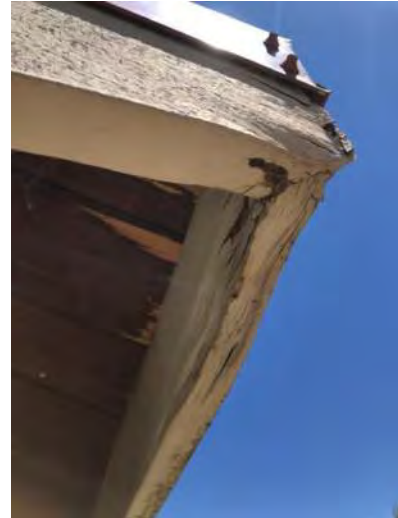
Record ID: 280
System: B3010 - ROOFING

Item No.: B3010.90.009
Floor/Room:
Priority: 3
Quantity/Unit of Measure: 80/LF
Total Deficiency Cost: \$8,160
Deficiency Description: *Wood fascia and trim chipped and have peeling paint.*

Description of Work: *Clean, repair, and paint the trim and/or fascia.*

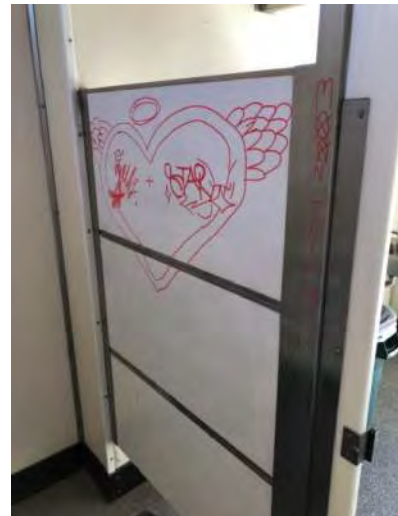
Record ID: 281
System: C1090 - INTERIOR SPECIALTIES

Item No.: C1090.25.001
Floor/Room: / Restroom(s)
Priority: 3
Quantity/Unit of Measure: 3/EA
Total Deficiency Cost: \$13,110
Deficiency Description: *Toilet partitions have excessive amounts of rust.*

Description of Work: *Replace the toilet partitions*

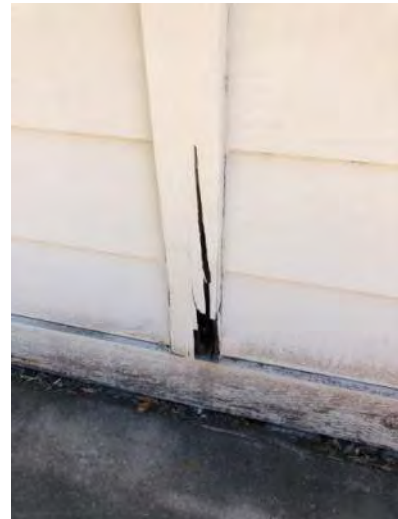
Item No.: B2010.10.006
Floor/Room:
Priority: 3
Quantity/Unit of Measure: 200/LF
Total Deficiency Cost: \$7,270
Deficiency Description: *Trim is worn and should be replaced.*

Description of Work: *Replace trim and finish to match. Replace at the same time as siding.*

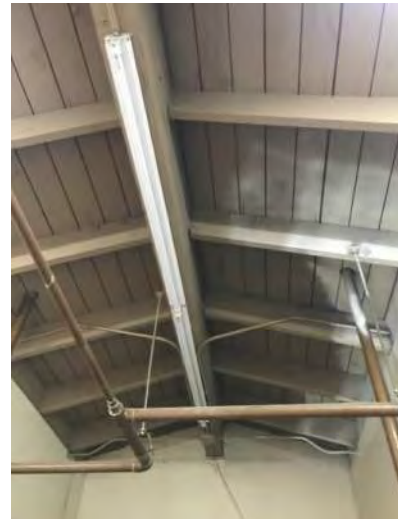
Item No.: D5040.50.406
Floor/Room: 1
Priority: 3
Quantity/Unit of Measure: 10/EA
Total Deficiency Cost: \$13,620
Deficiency Description: *The interior light fixtures are past their expected useful life.*

Description of Work: *Replace existing fixtures with LED fixtures.*

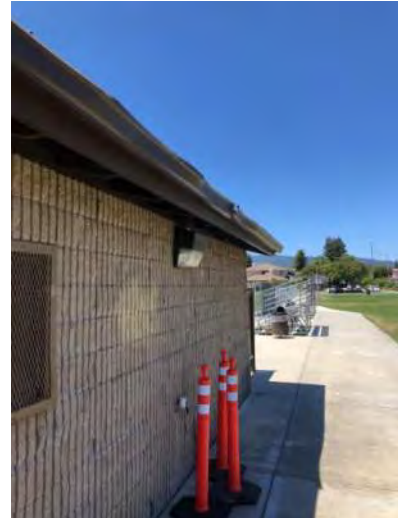
Record ID: 285
System: B3020 - ROOF APPURTENANCES

Item No.: B3020.70.001
Floor/Room:
Priority: 3
Quantity/Unit of Measure: 80/LF
Total Deficiency Cost: \$4,380
Deficiency Description: *Rain leaders/gutters are damaged and leak.*

Description of Work: *Repair, replace rain leaders/gutters.*

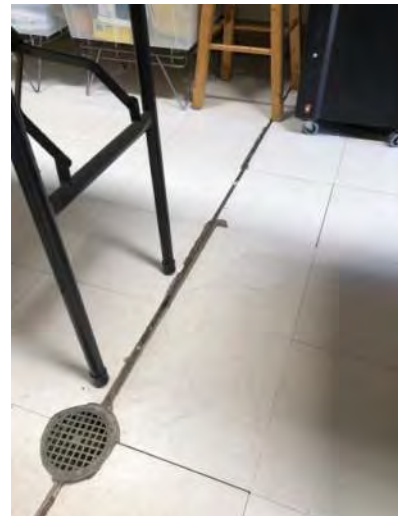
Record ID: 289
System: C2030 - FLOORING

Item No.: C2030.50.001
Floor/Room:
Priority: 3
Quantity/Unit of Measure: 260/SF
Total Deficiency Cost: \$7,120
Deficiency Description: *Vinyl composition tile is approaching the end of its useful life.*

Description of Work: *Remove the existing vinyl composition tile and replace.*

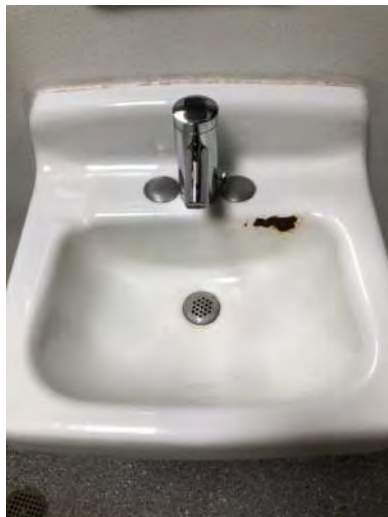
Deficiency Description: *Porcelain sink is approaching the end of its expected useful life.*

Description of Work: *Provide equipment replacement and installation.*

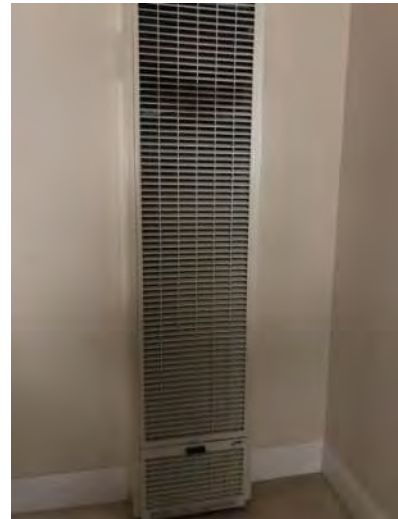
Item No.: D3020.70.008
Floor/Room: 1
Priority: 5
Quantity/Unit of Measure: 1/EA
Total Deficiency Cost: \$2,000
Deficiency Description: *Radiant wall heater is approaching the end of its expected useful life.*

Comments: *Radiant Heater*

Description of Work: *Provide equipment replacement and installation.*

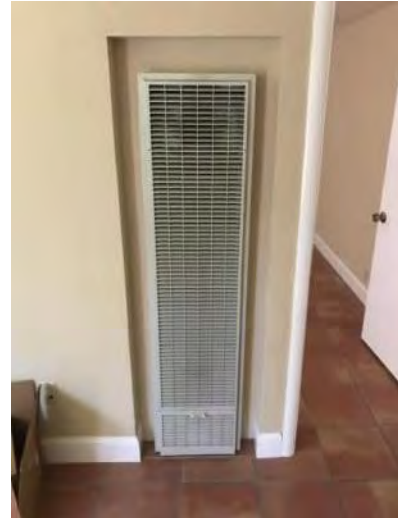
Record ID: 640
System: D3020 - HEATING SYSTEMS

Item No.: D3020.70.008
Floor/Room: 1
Priority: 5
Quantity/Unit of Measure: 1/EA
Total Deficiency Cost: \$2,000
Deficiency Description: *Radiant wall heater is approaching the end of its expected useful life.*

Comments: *Radiant Heater*

Description of Work: *Provide equipment replacement and installation.*

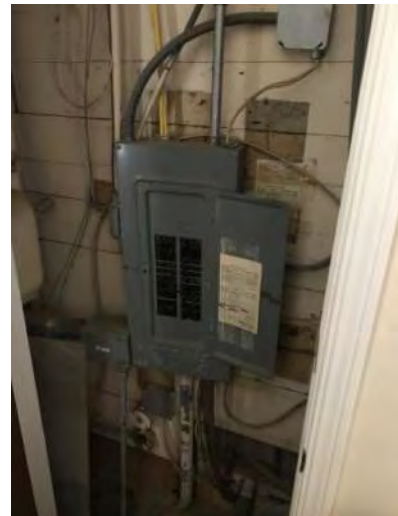
Record ID: 642
System: D5020 - ELECTRICAL SERVICE AND DISTRIBUTION

Item No.: D5020.30.4001
Floor/Room: 1
Priority: 3
Quantity/Unit of Measure: 1/EA
Total Deficiency Cost: \$5,550
Deficiency Description: *The load center is past its expected useful life.*

Comments: *Load Center*

Description of Work: *Replace the existing load center with a new load center*

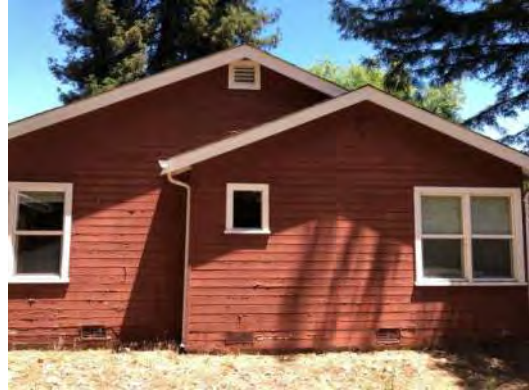
Item No. B2010.10.003
Floor/Room: 1
Priority: 3
Quantity/Unit of Measure: 2,740/SF
Total Deficiency Cost: \$79,690
Deficiency Description: *Wood board siding is approaching the end of its useful life.*

Description of Work: *Replace or repair the existing wood siding. Place a new siding over building paper and plywood sheathing.*

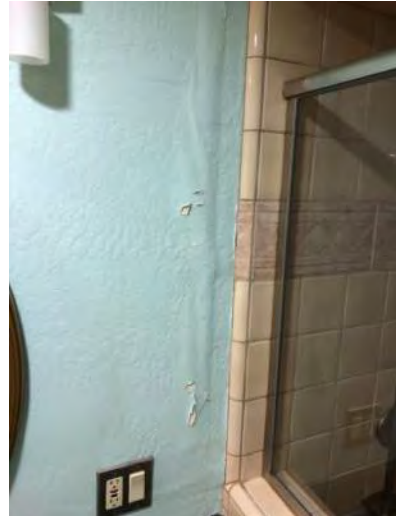
Record ID 735
System C2010 - WALL FINISHES

Item No. C2010.70.001
Floor/Room: 1 / Restroom
Priority: 3
Quantity/Unit of Measure: 2,000/SF
Total Deficiency Cost: \$45,450
Deficiency Description: *Painted gypsum wallboard is showing signs of wear.*

Description of Work: *Patch and paint the gypsum wallboard.*

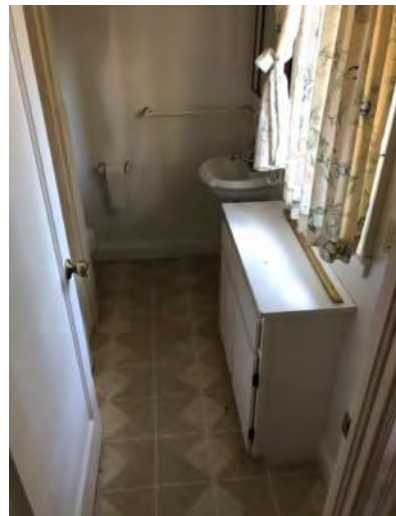
Record ID 736
System C2030 - FLOORING

Item No. C2030.50.002
Floor/Room: 1 / Restroom
Priority: 3
Quantity/Unit of Measure: 40/SF
Total Deficiency Cost: \$1,870
Deficiency Description: *Sheet vinyl is approaching the end of its useful life.*

Description of Work: *Remove the existing sheet vinyl and replace.*

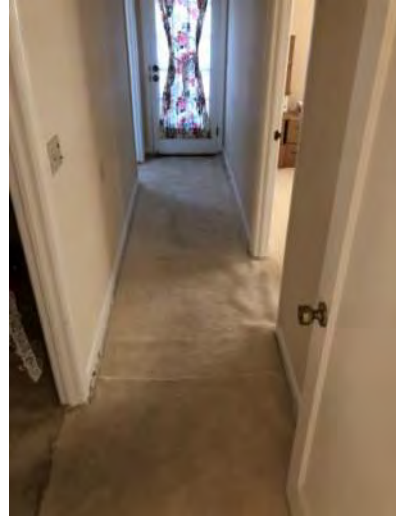
Item No.: C2030.75.002
Floor/Room: 1 / Varies
Priority: 3
Quantity/Unit of Measure: 1,000/SF
Total Deficiency Cost: \$29,080
Deficiency Description: *Rolled carpeting is approaching the end of its useful life.*

Description of Work: *Remove existing rolled carpeting and replace it with new 40 oz. nylon carpet.*

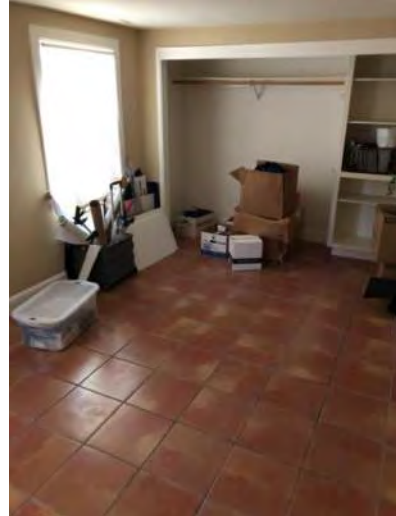
Record ID: 1033
System: C2030 - FLOORING

Item No.: C2030.20.001
Floor/Room: 1
Priority: 3
Quantity/Unit of Measure: 400/SF
Total Deficiency Cost: \$28,820
Deficiency Description: *Ceramic tile floor is approaching the end of its useful life.*

Description of Work: *Remove the existing ceramic tile flooring and replace.*

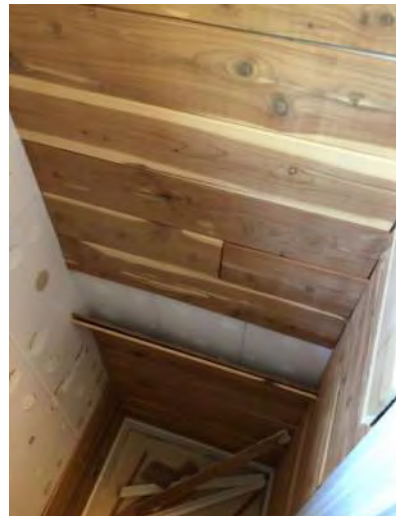
Record ID: 1034
System: C2010 - WALL FINISHES

Item No.: C2010.20.001
Floor/Room: 1 / Closet
Priority: 3
Quantity/Unit of Measure: 50/SF
Total Deficiency Cost: \$1,470
Deficiency Description: *Paneling is not in serviceable condition.*

Description of Work: *Remove and replace existing wood wall panels.*

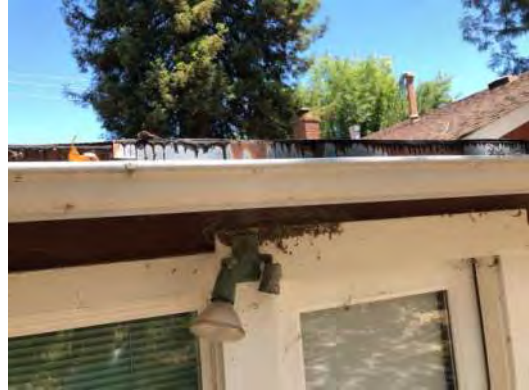
Item No.: B3020.70.001
Floor/Room: 1 / Exterior
Priority: 3
Quantity/Unit of Measure: 200/LF
Total Deficiency Cost: \$10,940
Deficiency Description: *Rain leaders/gutters are damaged and leak.*

Description of Work: *Repair, replace rain leaders/gutters.*
